APPENDIX D

PRESSURE DROP TRACES FROM  
PFBC SIMULATOR FILTER TEST WRTX-9 AND WRTX-11

Two cross flow filter elements were successfully tested under simulated PFBC conditions for over 1300 hours, thus representing the longest successful test campaign on this barrier filter technology. The filter operation was terminated when the dust loading on the filter outlet increased up to 100 ppm and the system permeability profiles suggested that a breach had developed on at least one of the elements. Post test inspection of the filter system revealed that one of the elements had developed a longitudinal crack on the ceramic flange, and the flange corners of both elements were crushed by the metal clamping plates. Neither filter showed any signs of delamination failure which had historically plagued the first generation of cross flow filters.

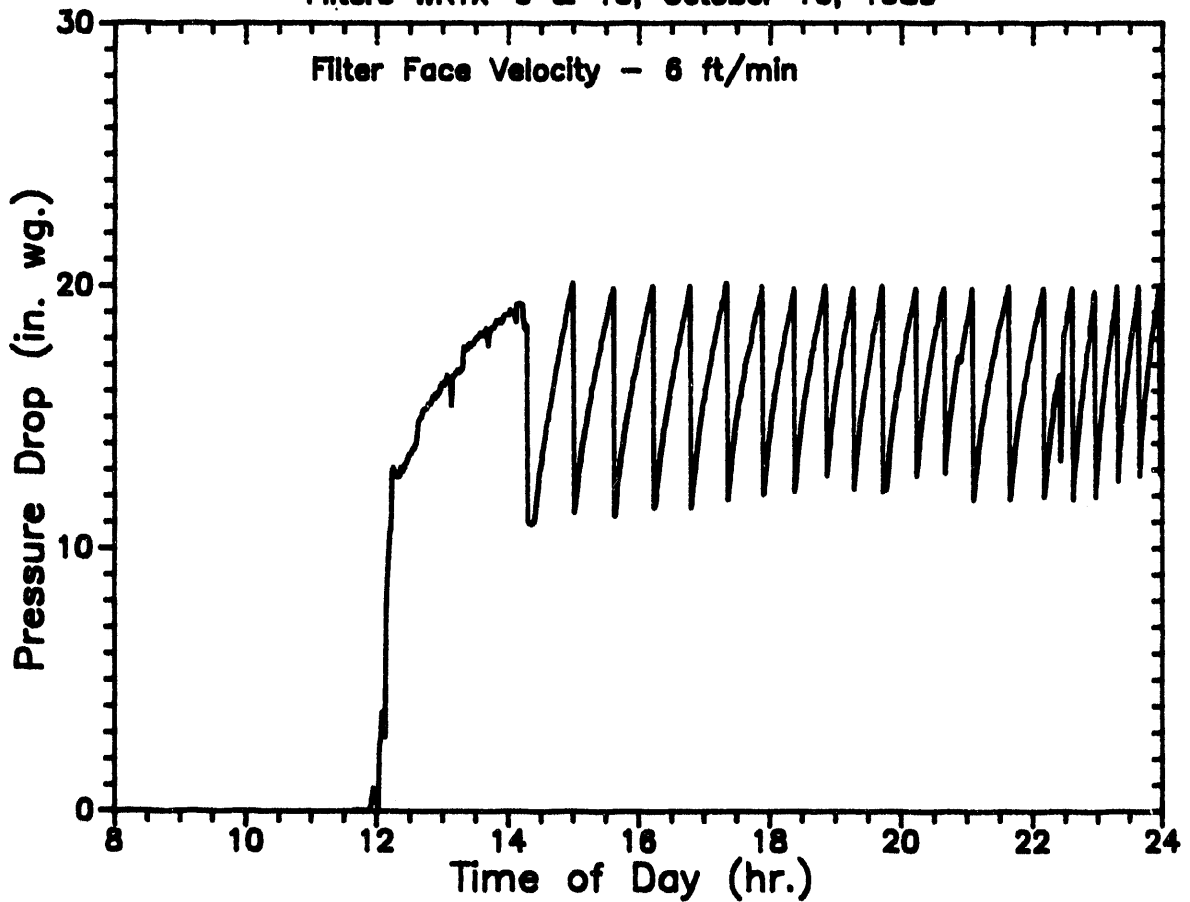
Spike in cycle 2227 is system pressure drop caused by compressor shutdown, corrected, no flame out.

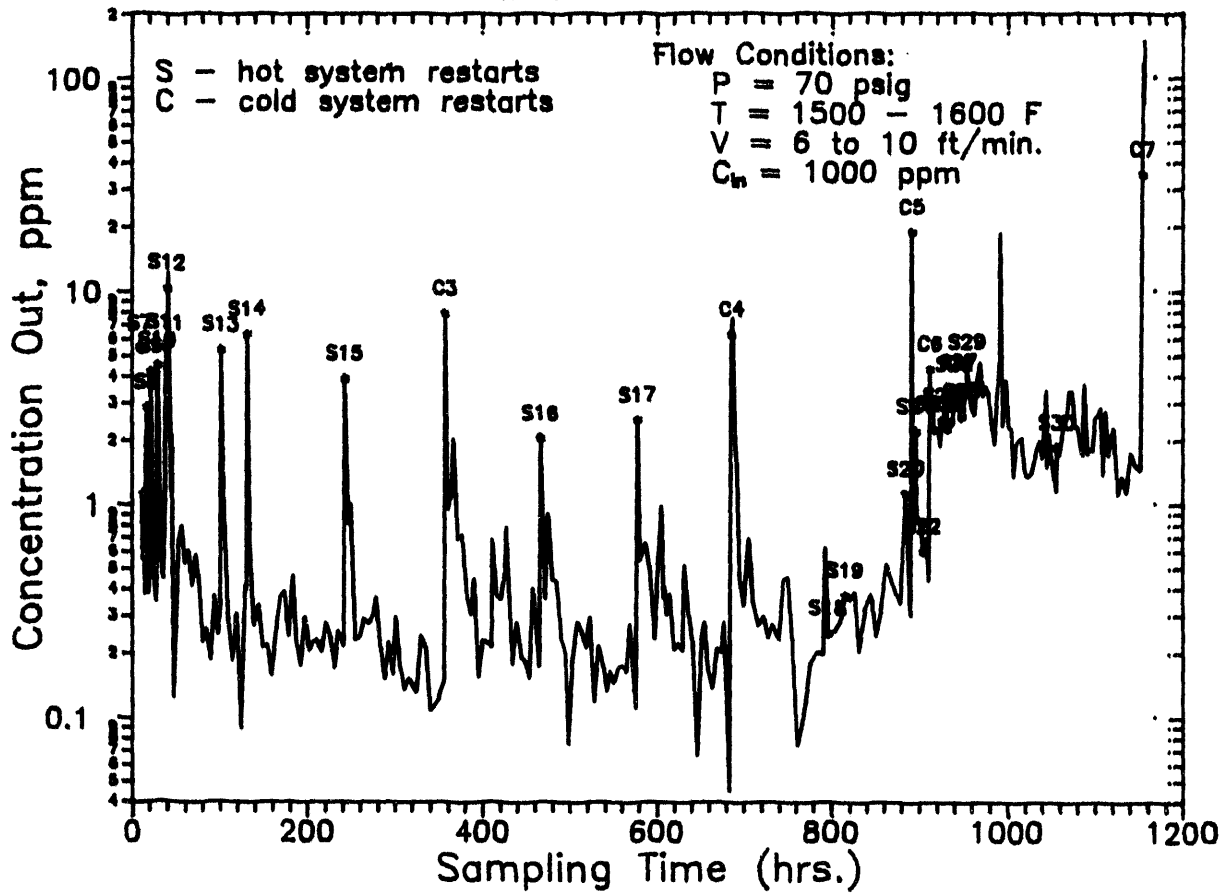
Figure E.6 - Filter Outlet Loading Profiles During PFBC Simulator Test

The outlet dust loading profiles for the entire test campaign are shown in Figure E.6, wherein the test interruptions are marked by the "S" and "C" symbols designating the warm startups (from a warm standby condition at 600°F temperature) and cold startups (from ambient temperature conditions) respectively. It is interesting to note in this chart that, with the exception of C7, all other startups were marked by a 10 ppm spike in the outlet loading (not necessarily dust) which subsides to less than 1 ppm within a few hours of hot operation. Figure E.7 shows a typical sequence of dust samples extracted by the sample probe following an interim shutdown. The initial samples consistently show a black patch on the filter paper, the samples subsequently become lighter and after about 10 hours show a faint smearing of the beige color which is characteristic of the PFBC ash. This trend in the dust profile indicates that the internal 316 stainless steel components develop corrosion scale from exposure to the damp shutdown conditions. After the system has been reheated the black scale is released. It is concluded that the 10 ppm spikes occurring over the

first 1300 hours of testing are, in fact, the corrosion scale released by the internal steel lining, and the actual PFBC dust penetration throughout the bulk of the test campaign was less than 1 ppm.

From the dust loading traces in Figure E.6 it appears that the filter elements developed an initial breach after shutdown C6 (increase from less than 1 ppm to about 4 ppm) which increased in severity after shutdown C7 when the loadings exceeded 100 ppm. The overall system permeability, defined as the reciprocal of the normalized pressure drop, was analyzed for the post C6 shutdown test periods. As shown in Figure E.8 the permeability did not show an increase until after shutdown C7 suggesting that the first stage of failure after C6 was a small crack which only allowed seepage of dust cake, whereas the second stage of failure was a large crack which permitted significant bypassing of dust laden gases into the clean side of the system.

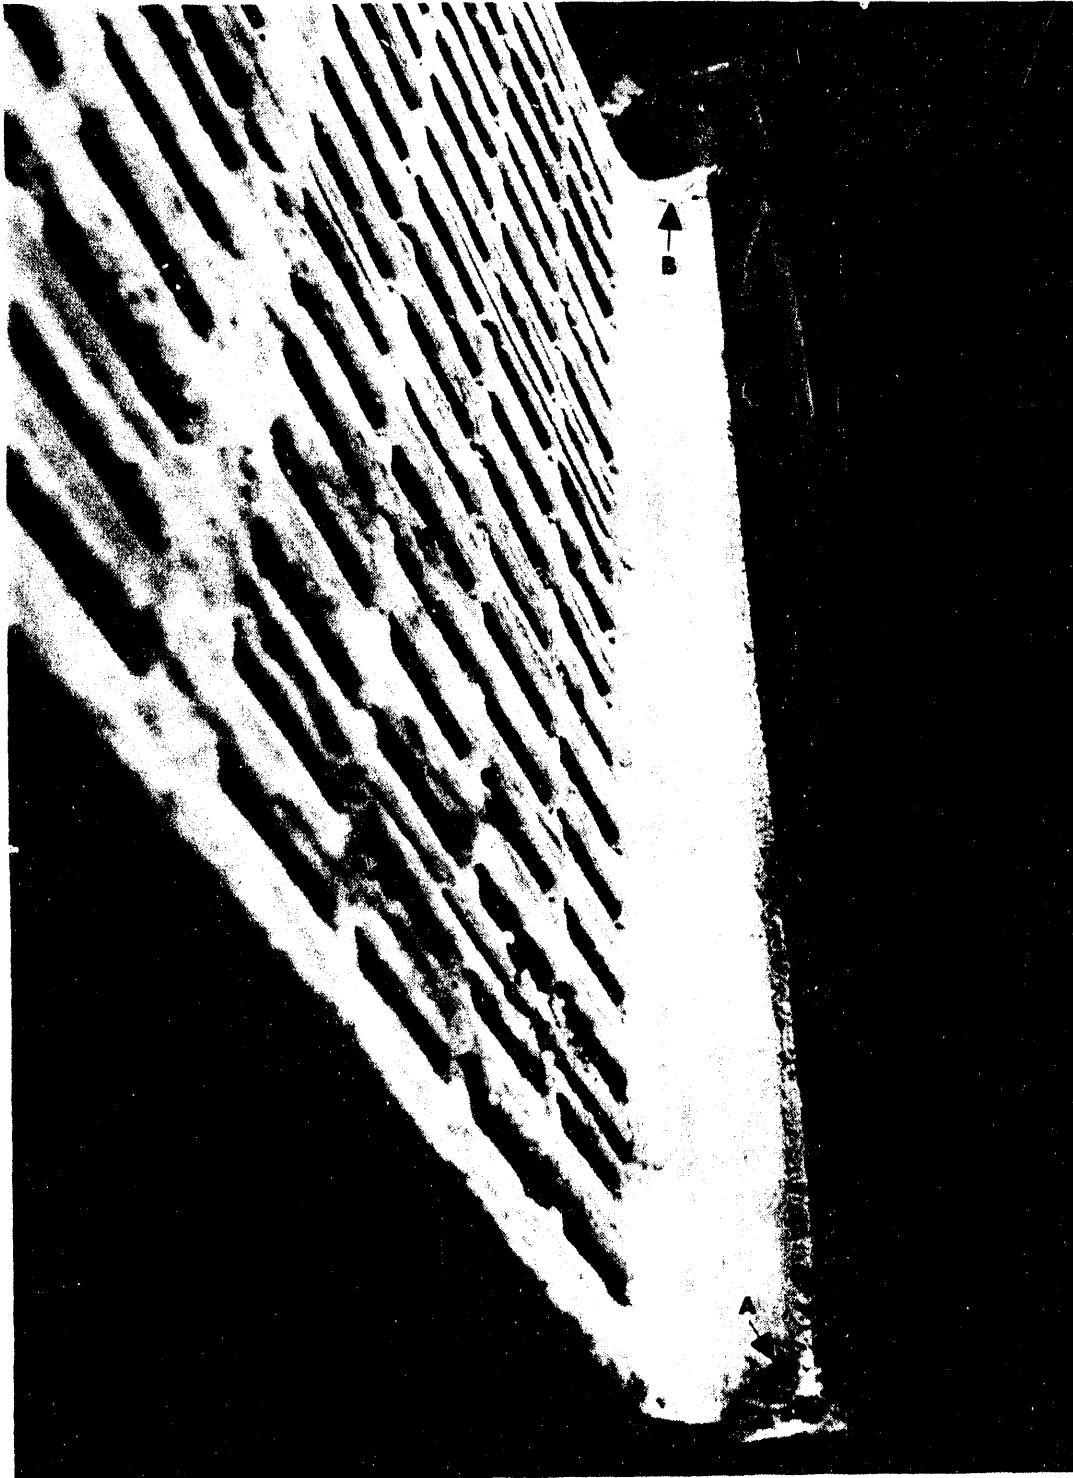
Figure E.10 - Top View of Filter, Shows Crushing and Cracking on Flange Corners and Accumulation of Dust in the Fixture Cavity

The flange surfaces were examined after removal of all four clamping plates. The flange corners of both filters showed severe crushing and/or cracking damage, as typified in Figure E.10. The gaps between the flanges and the metal fixture were completely filled with fly ash.

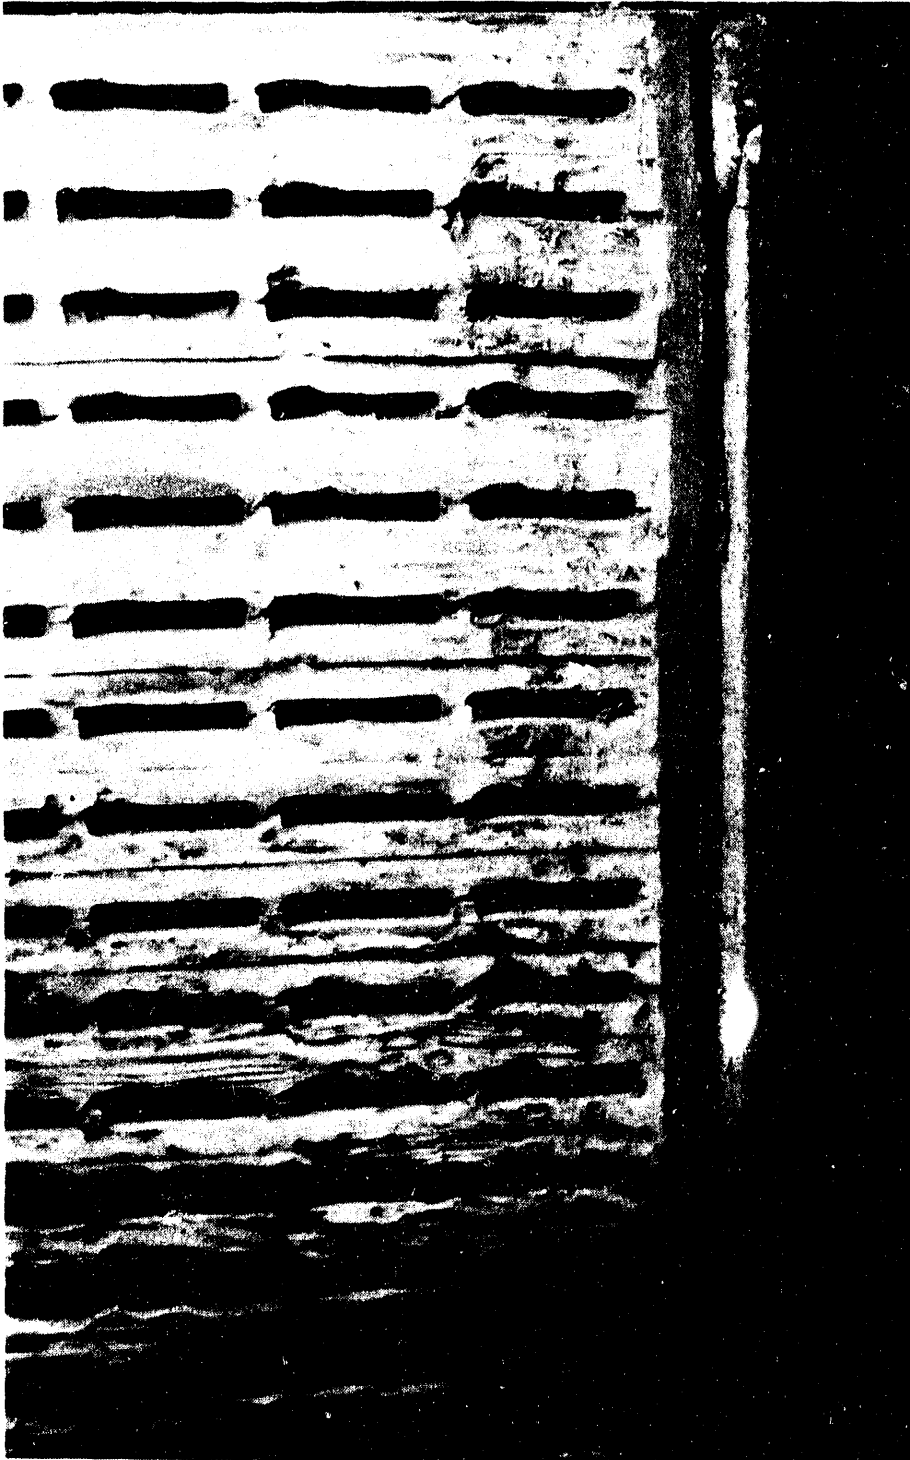
Figure E.11 - Frontal View of Filter WRTX-10, Shows Longitudinal Crack Along the Fillet of the Flange

The most significant failure was a longitudinal crack along one of the flanges on filter WRTX-10, as shown in Figure E.11. The crack appeared to have started at the corners and propagated through the fillet and caused a separation of the filter body from the flange.

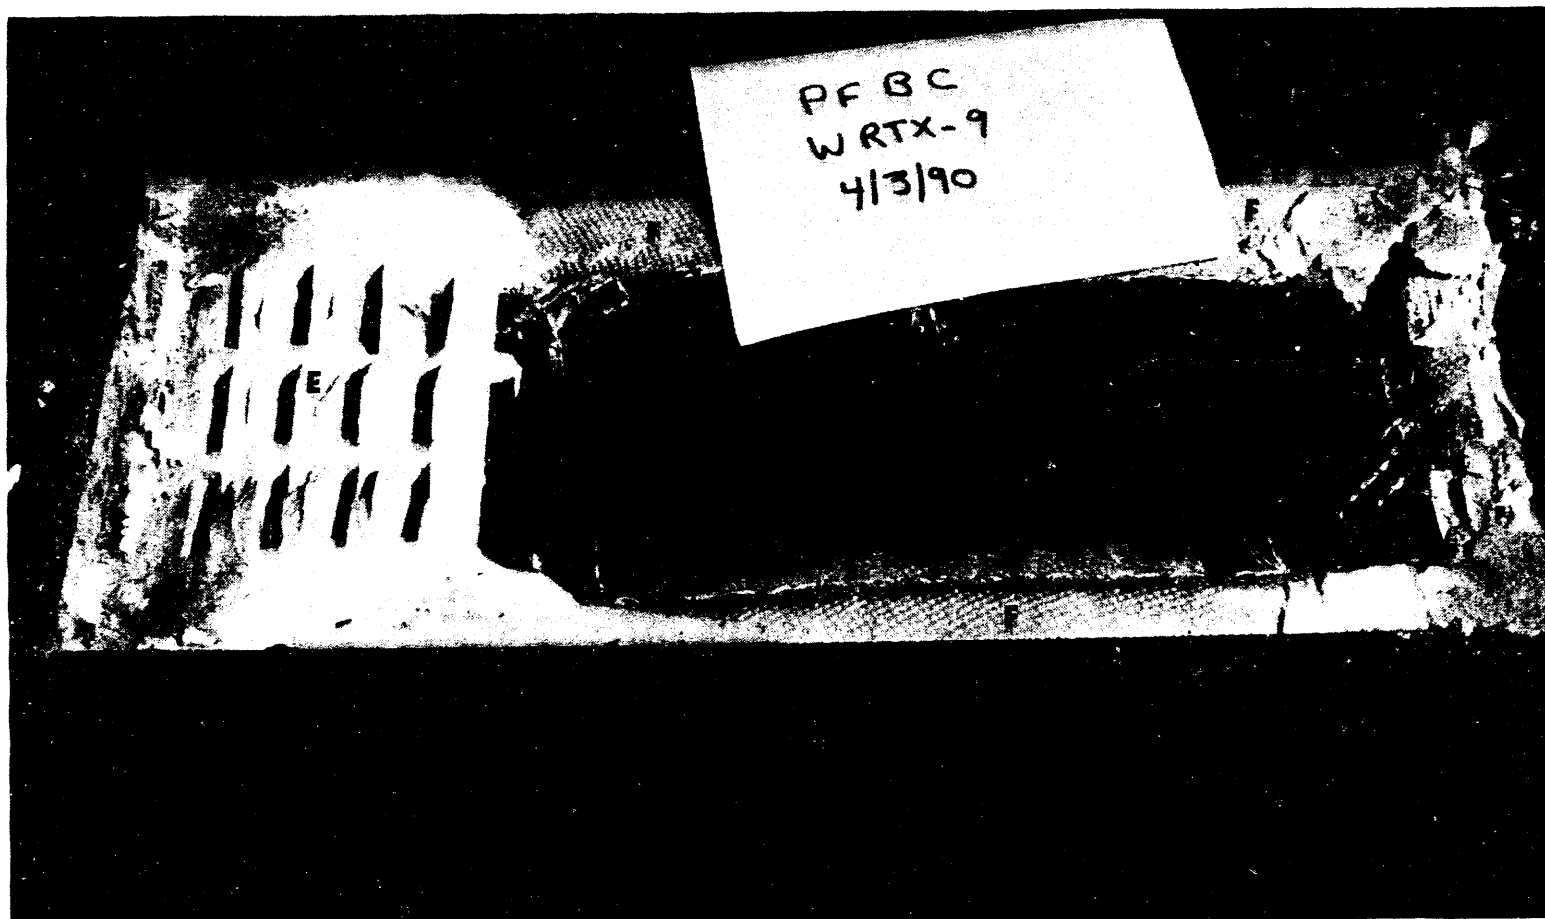
Figure E.12 - Remnant of Filter WRTX-9 Which Broke During the Element Removal;  
Note the Collection of Dust on Corners of Mount Indicating Flange  
Cracks During Service

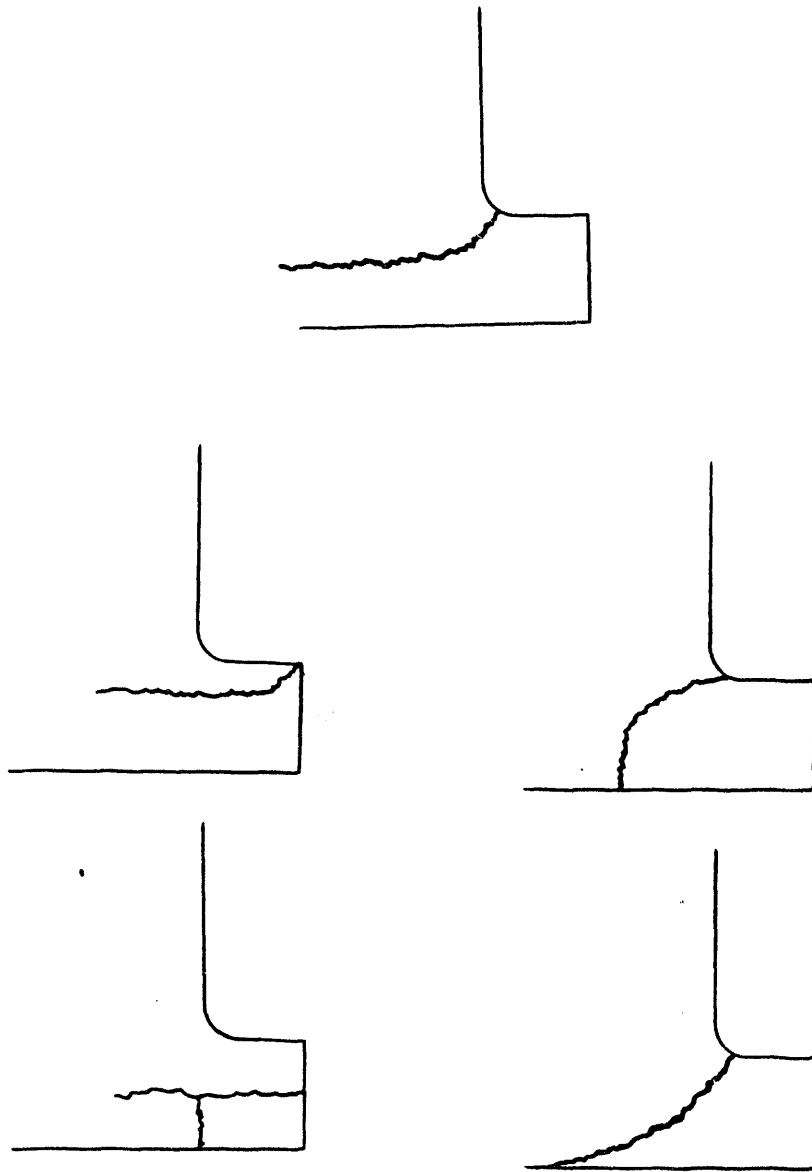
Figure E.13 - Fracture Profiles on WRTX-9 and WRTX-10 Filters

Figure E.13 describes, in schematic form, the shapes of the various fractures formed on these filters during operation.

- The fractures in the flanges and in the bases of the filters appear to have always started in the regions of the end corners of the flanges.
- The holder appears to have exerted considerable loads on each filter by "pinching" tight its base via fly-ash compressed between the vertical walls of the holder and the sides of the filter.

- In general, the cracking of the filters appears to have been caused by concentrated stresses, some constant, some cyclic (including thermal fatigue), resulting from the methods of supporting and clamping the filters. Grinding of the filters prior to the installation might have been a contributing factor to some additional spalling.
