APPENDIX I

1. CHARACTERIZATION OF THE ASH AND CHAR FINES USED
IN SIMULATOR TESTING
2. CHARACTERIZATION OF ALUMINA/MULLITE FILTERS EXPOSED
IN THE WESTINGHOUSE PFBC DURABILITY TEST FACILITY

2. CHARACTERIZATION OF ALUMINA/MULLITE FILTERS EXPOSED IN THE WESTINGHOUSE PFBC DURABILITY TEST FACILITY

**DESCRIPTION OF CROSS FLOW FILTER DURABILITY
DURING PFBC SIMULATOR THERMAL TRANSIENT TESTING**

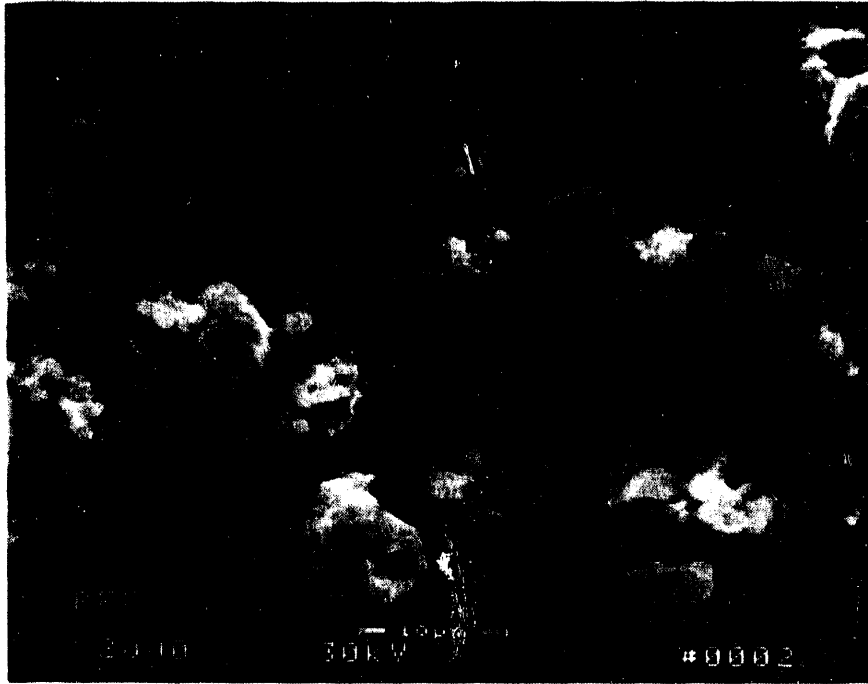
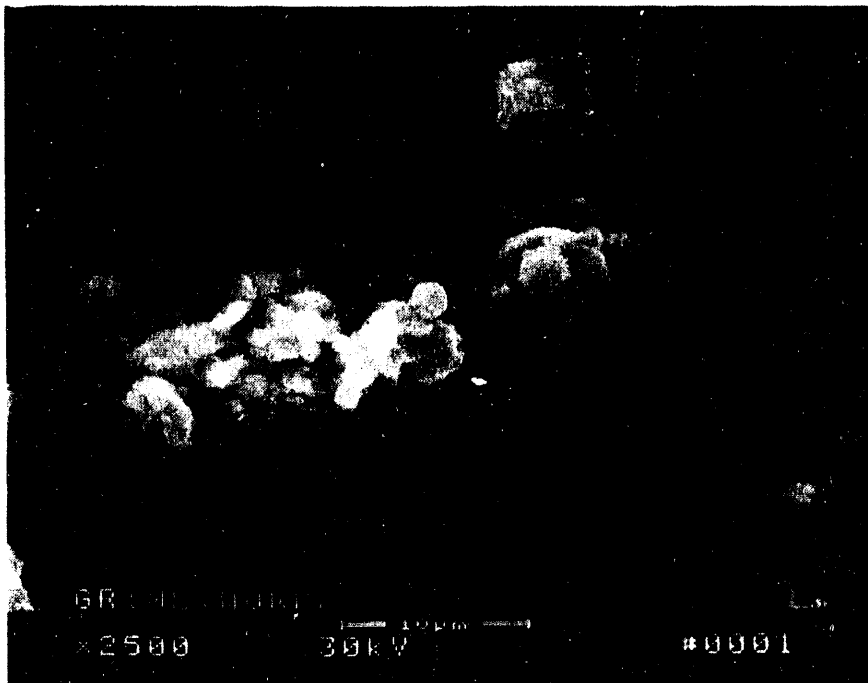
The cenosphere formations shown in Figure I.1.1 are typical of ash formed under combustion gas environments. The 10-20 μm cenospheres contain micron and submicron fines which frequently are released during processing. Interdispersed in the Exxon ash are irregularly shaped particles, agglomerates, and infrequently larger ($>20 \mu\text{m}$) particles. As determined by coulter counter analysis, the 50% mass mean diameter of the pulverized Exxon fines and Grimethorpe filter catch fines is 6.1 and 5 μm , respectively (Figure I.1.3).

Figure I.1.1 - Scanning Electron Micrographs of the Exxon and Grimethorpe PFBC Ash Fines

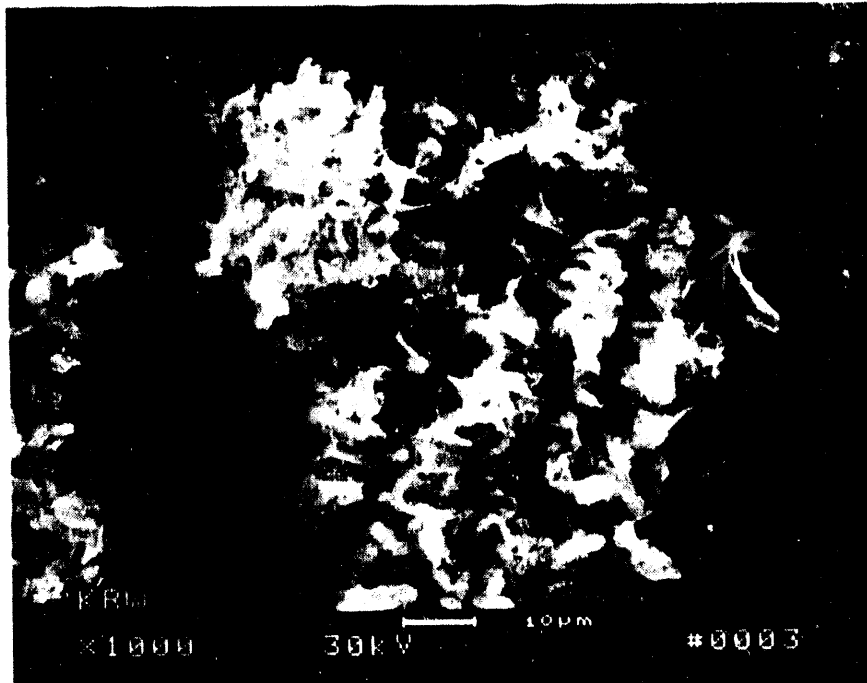
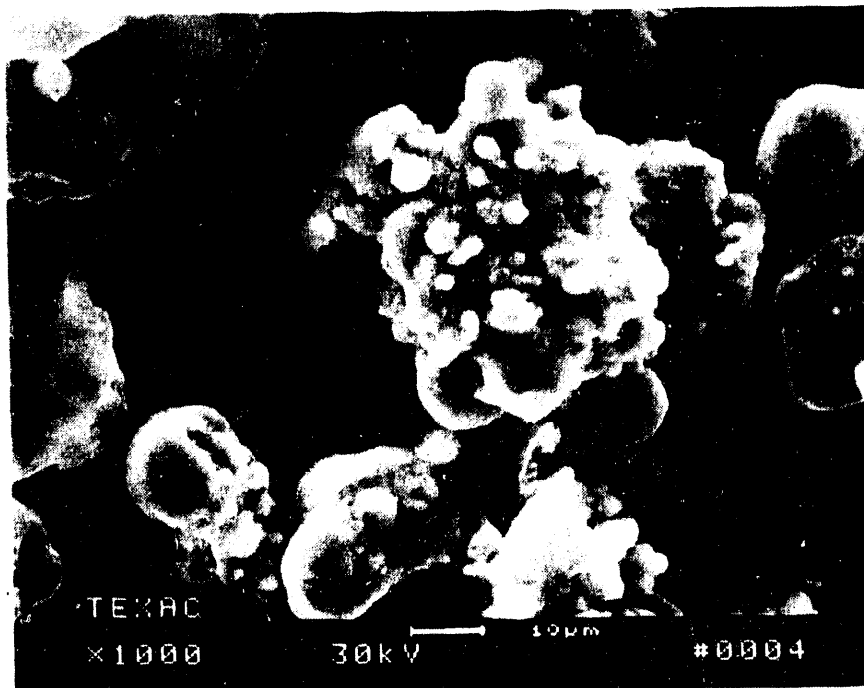
In contrast with the spherical ash formations are the jagged and irregularly shaped char particles formed in the KRW fluidized bed gasifier (Figure I.1.2). Greater than 97% of the rather nondescript, mottled KRW fines are less than 20 μm . As identified by coulter counter analysis, the 50% mass mean diameter of the KRW filter catch char is 4 μm . Cascade impactor data for fines carried to the filter during testing at KRW were identified to have a drag equivalent diameter of 0.46 μm . Unfortunately we are not able to identify whether the coulter counter sample material is representative of the cascade impactor material.

Figure I.1.2 - Scanning Electron Micrographs of the KRW Fluid Bed and Texaco Entrained Bed Gasifier Char Fines.

Unlike the KRW gasifier fines, the char formation which results during entrained bed gasification at Texaco is morphologically similar to the ash fines formed under PFBC conditions. Cenosphere formations and agglomerates can be identified in the Texaco fines, as well as submicron fines and particles which exceed 20 μm in diameter. The 50% mass mean diameter of the Texaco filter catch material is 5.3 μm . Again the mass mean diameter is based on coulter counter analysis.

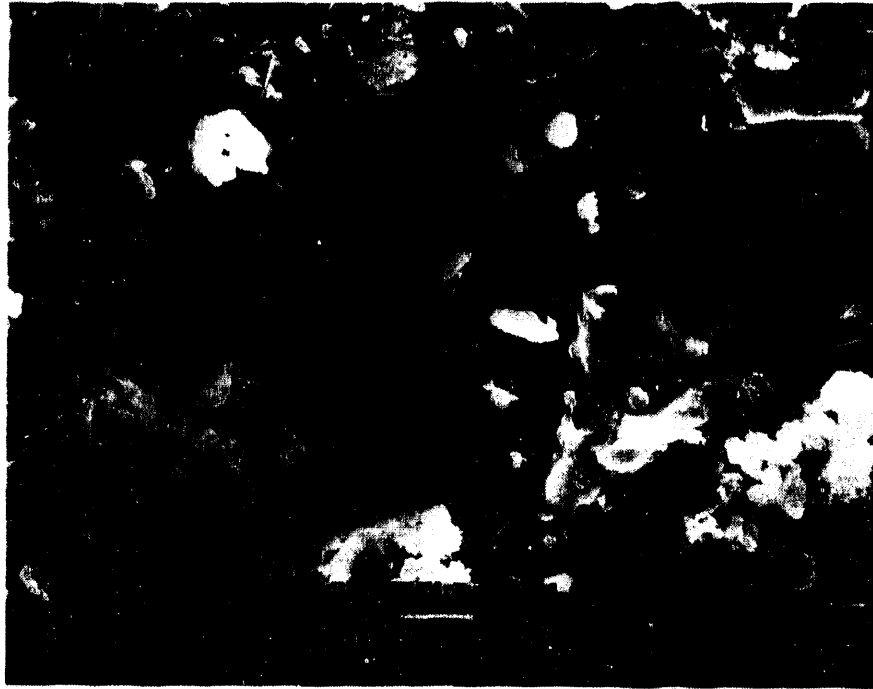
The actual surface of the alumina/mullite dirty gas channel from the 1300 hour exposed filter was characterized, and is shown in Figure I.2.5. Note the relative abundance of "blunted" crystals which are considered to be the ends of the mullite rods which are embedded in the "amorphous" phase. After 1300 hours in the simulated PFBC environment, the dirty channel surface "amorphous" phase is retained, while mullite appears to be surfacing.

Figure I.2.5 - Surface Morphology of the 1300 Hour PFBC Exposed Alumina/Mullite Filter Dirty Gas Channel

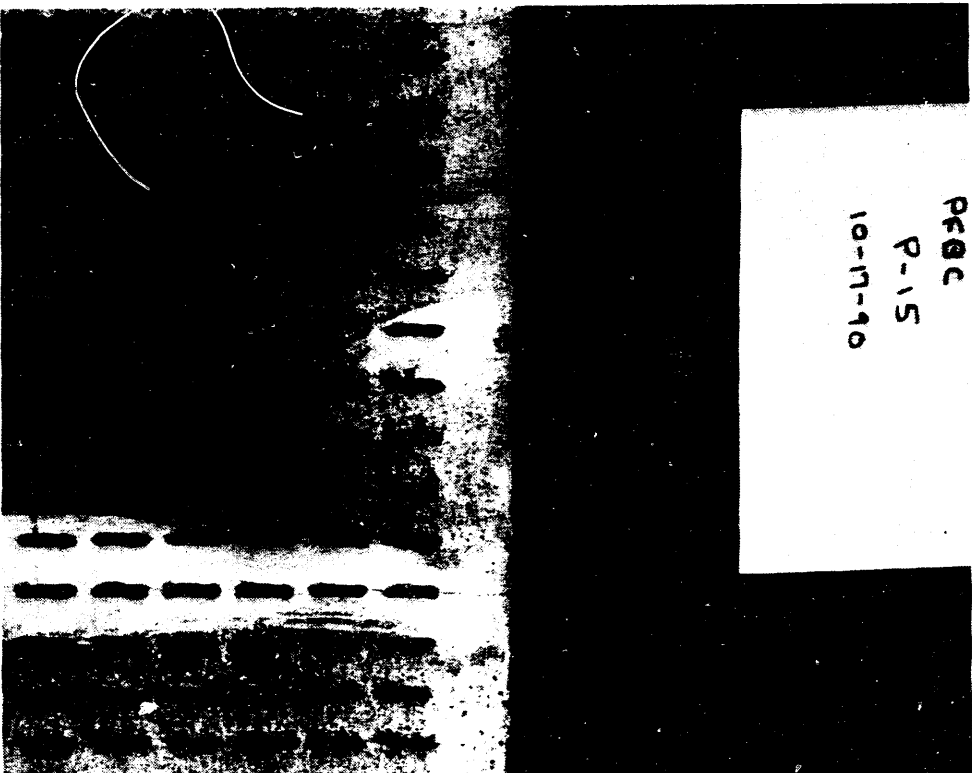
The cross flow filter designated as WRTX-48 was located in the top holder of plenum #1 during the initial simulated turbine trip transient test. After 335 hours of testing at 1550°F with 472 pulse cycles, 2 mild transients, and 1 severe transient, a dirty gas channel delamination crack occurred in WRTX-48. The delamination crack was located at the 12th dirty gas channel (Figure J.3), farthest from the plenum. The twelfth and thirteenth channels were not identically matched along the mid-rib bond, particularly at the top closed section of the filter element. The fourteenth through eighteenth dirty channels had "near perfect" alignment between mid-rib bonds.

The delamination crack which may have started at the top closed section of the filter appeared to have traveled along the mid-rib bond section of the dirty channels until it reached the thicker central bond section. At that point, the crack cut through the dirty channel wall (not through the thicker central bond section), and ran along the clean-to-clean channel seam for approximately two inches. The delamination crack appeared to have stopped at approximately three dirty channels above the flange area, initially keeping the entire filter body intact. These comments describe the delamination crack that ran along the filter face that was opposite from the baffle plate which separated the two filter plenums (Side A). Due to the thick AREMCO paint along the face of the filter which was closest to the baffle plate, several areas of the crack path could not be followed (Side B).

The delamination crack along Side A was identified to have occurred in the portion of the filter element which contained wider dirty channels. Wider dirty gas channels are considered to represent the top section of the filter plate stack, adjacent to where weights are applied during filter element production. Alternately, the delamination crack along Side B appeared to have occurred in the tighter dirty

Figure J.3 - Dirty Gas Channel Delamination Crack in
Cross Flow Filter WRTX-48

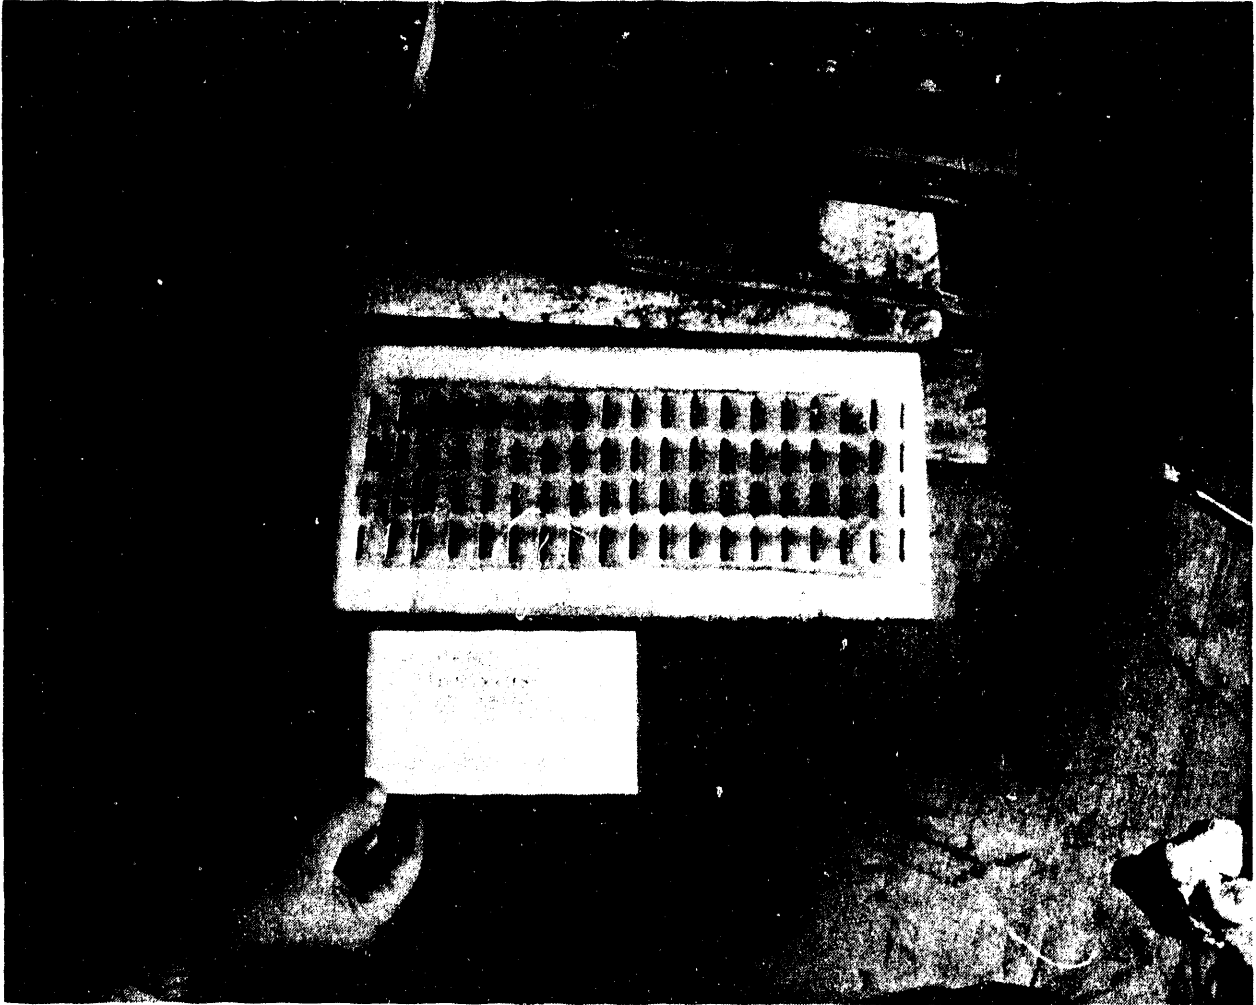
A "rusty-colored" haze was evident along the bottom (underside) of the filter where the clean gas channels were located. The haze appeared to extend along the entire four inch width of the filter (from flange edge-to-flange edge as shown in Figure J.4). The section of the filter that was closer to the plenum appeared to have a "darker" and wider hazy band in comparison to the section of the filter that was located farthest from the plenum. A clean gap was evident between these two bands. A similar hazy band coloration is evidenced on the top filter surface. All of the clean channels appeared to be free of fines.

Figure J.4 - Dust Track Pattern Along the Clean Gas Channels
in Cross Flow Filter WRTX-48

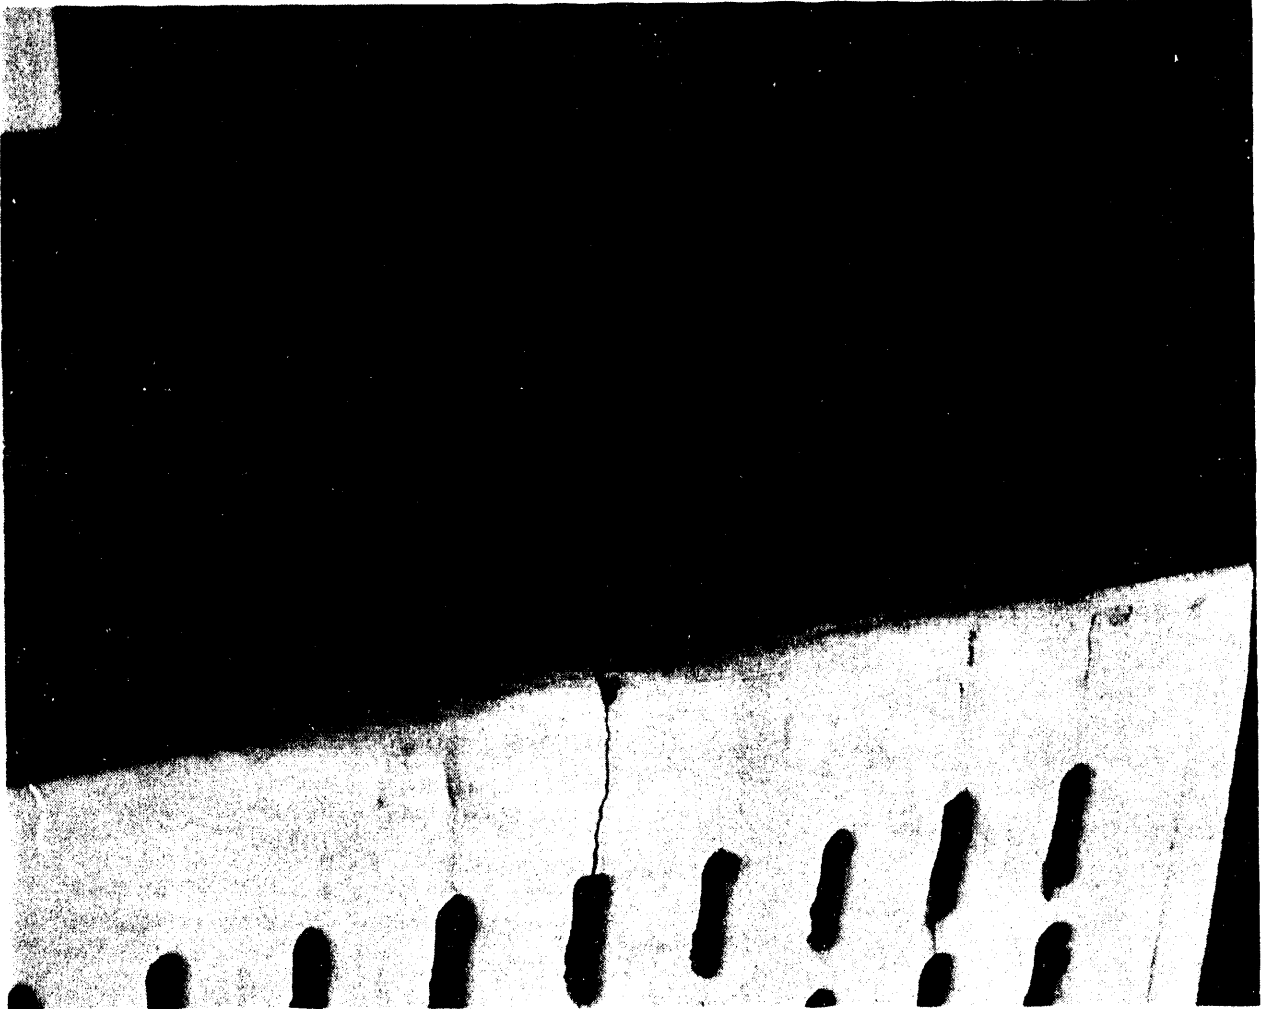
Initially an open seam had been identified in the top closed section of the filter prior to use, and was patched with Nextel cloth and AREMCO paint. After testing, sections of the cloth were no longer attached to the filter, and debonding along the dirty gas channel mid-ribs occurred, resulting in the formation of a partial delamination (Figure J.6). The partial delamination or crack appeared to have started along the top closed section of the filter in dirty gas channel No. 14. The crack extended through the dirty channel mid-rib bonds in the upper section of the filter. The last dirty channel above the thicker central rib was the location where the crack cut through the plate, and then ran down the clean-to-clean channel seam. The crack did not appear to travel completely through the flange section. The crack path was evident along the opposite face of the filter which had been adjacent to the baffle plate. The location of this crack appeared to be at bolt No. 5. of the clamp. The patched crack appeared to be located in the tighter dirty gas channel portion of the filter. This section was considered to have been at the bottom of the stacked plates during firing and manufacturing of the filter body. Neither the partial delamination crack nor fines were evident along the bottom (underside) of the filter flange (Figure J.7).

Figure J.6 - Patched Cracked Area of Cross Flow Filter WRTX-53
After Durability and Transient Testing

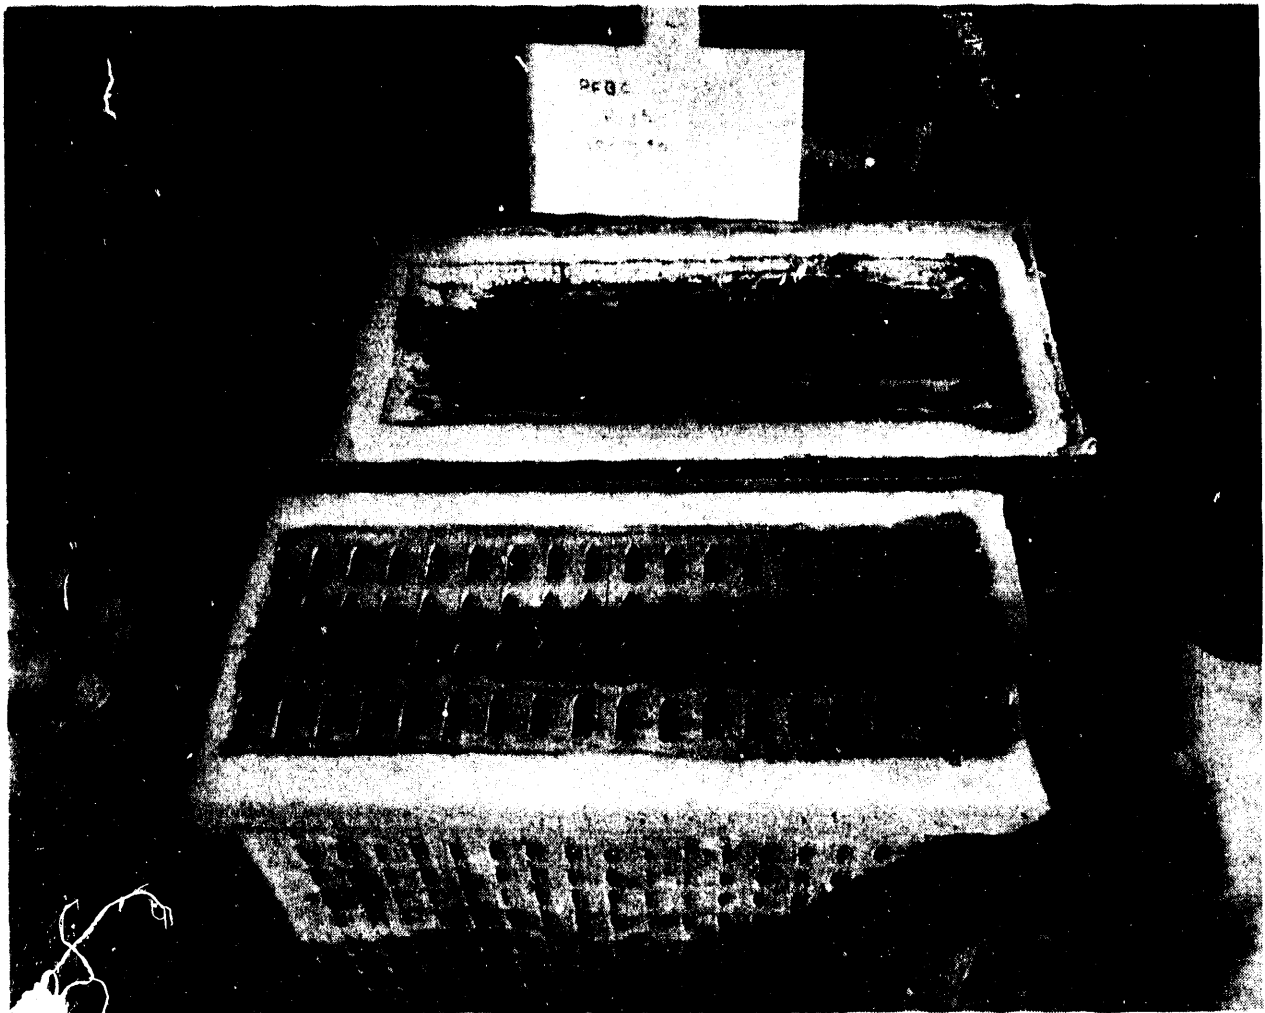
Figure J.7 - Absence of Dust Along the Clean Gas Channel Surface of
Cross Flow Filter WRTX-53

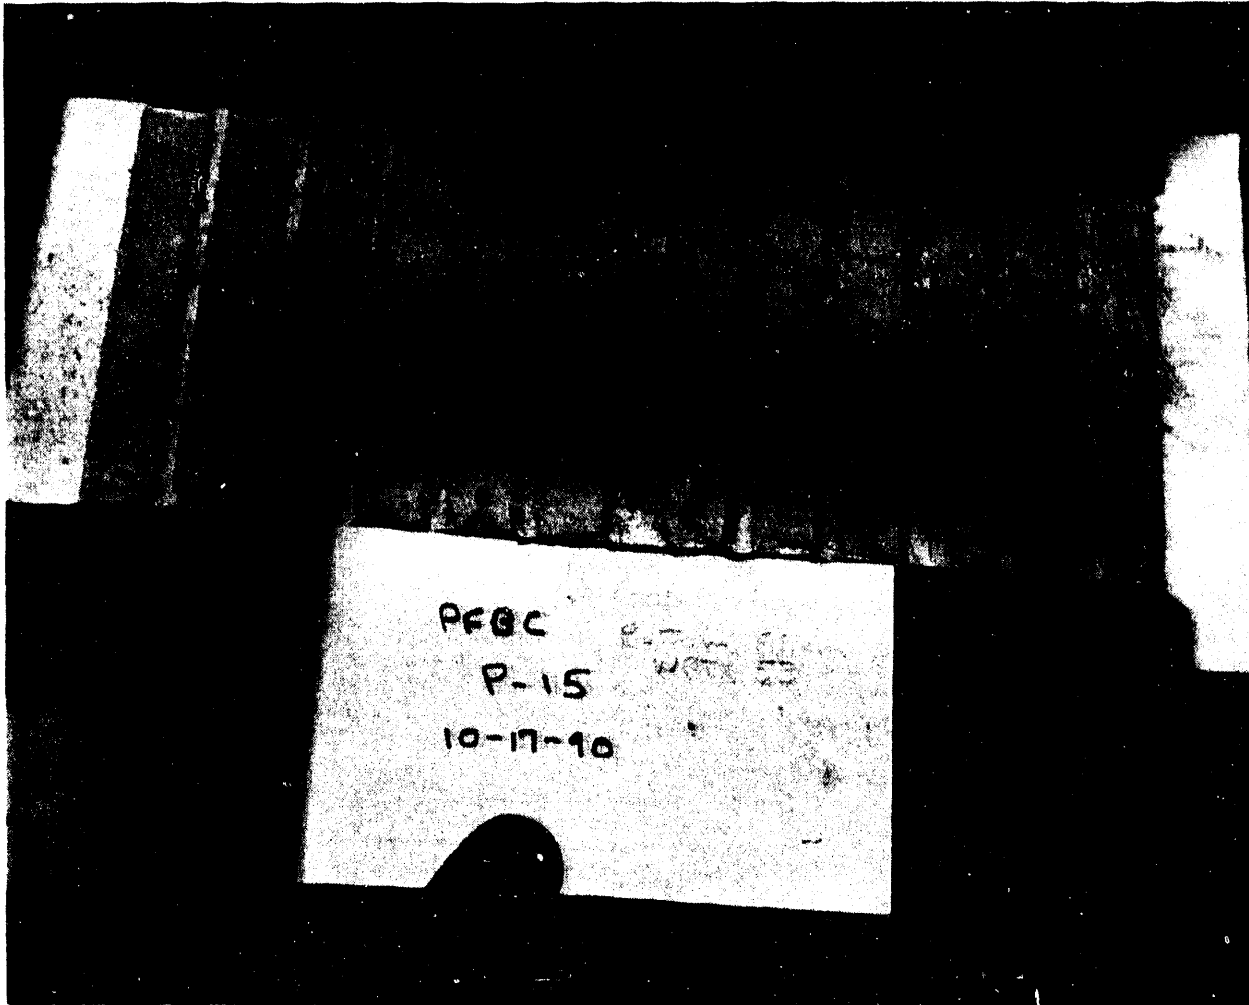
A complete delamination crack was evident along the 9th dirty channel (Figure J.8). Initially the mid-rib bonds in this channel were well matched and bonded. The delamination was slightly to the left of the central bolt (No. 4). Caked fines were readily evident along the delaminated dirty gas channel. The mid-ribs along this section were also covered with a "greyish" perhaps "wet" mat of fines.

Figure J.8 - Debonding of the Mid-Rib Bonds in Cross Flow Filter WRTX-53

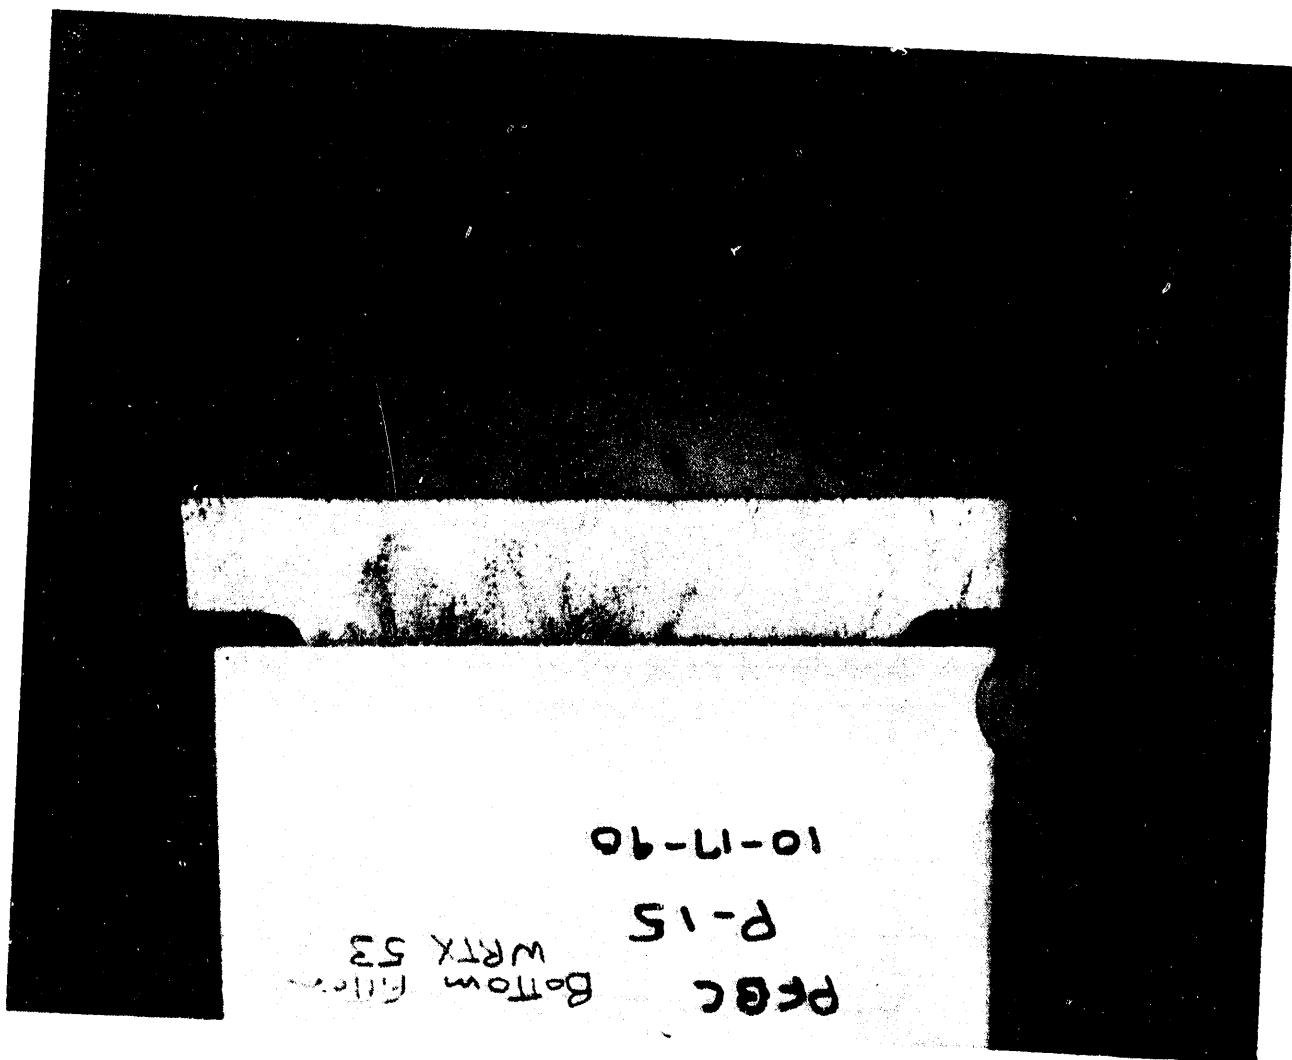
Figure J.9 - Dust Track Patterns Along the Poorly Bonded Section
Of the Filter Flange Below the Last Dirty Gas Channel

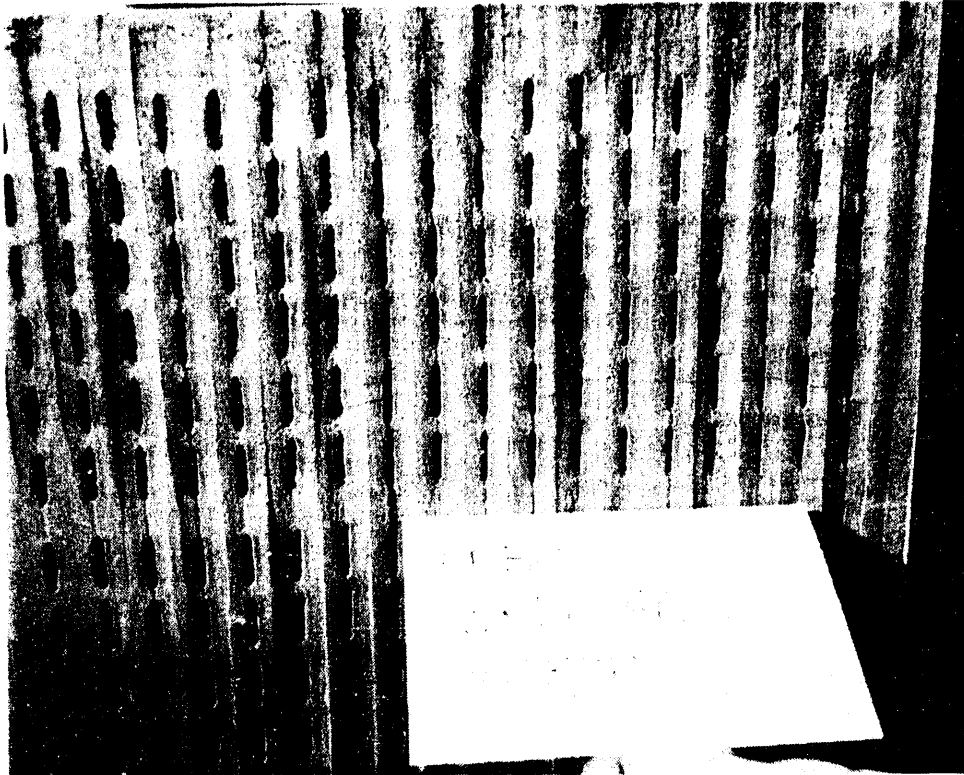
The cross flow filter designated as WRTX-66 was located in the bottom holder of plenum #2. After 38 hours of testing at 1550°F with 3 pulse cycles, 2 mild transients, and 1 severe transient, a complete horizontal crack was observed through the upper section of the filter body (Figure J.10). The crack appeared to have originated along the side of the filter that was directly opposite from the plenum. Again this section of the filter contained the tighter dirty gas channels, indicating the side of the filter which had been at the bottom of the stack of plates during firing and production of the filter element body.

The horizontal crack ran from the bottom of the 5th dirty gas channel located at the side of the filter that was opposite of the plenum, to the top of the 5th dirty gas channel located at the side of the filter that was closest to the plenum.

Figure J.10 - Horizontal Crack Formation Through Cross Flow Filter WRTX-60 Resulting During Thermal Transient Testing

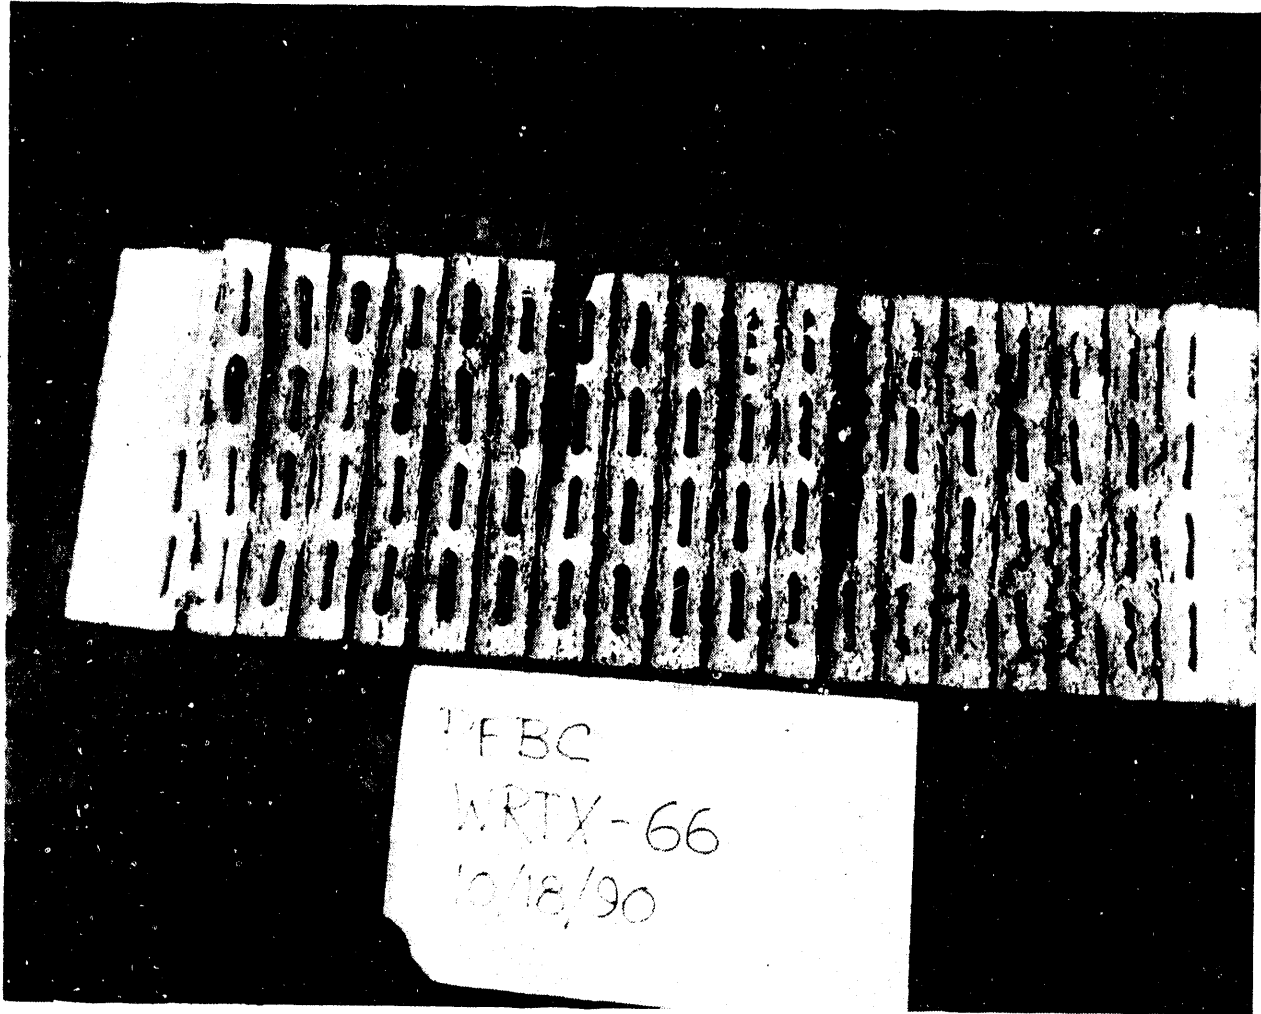
Figure J.11 - Cracked Surface Of Cross Flow Filter WRTX-66

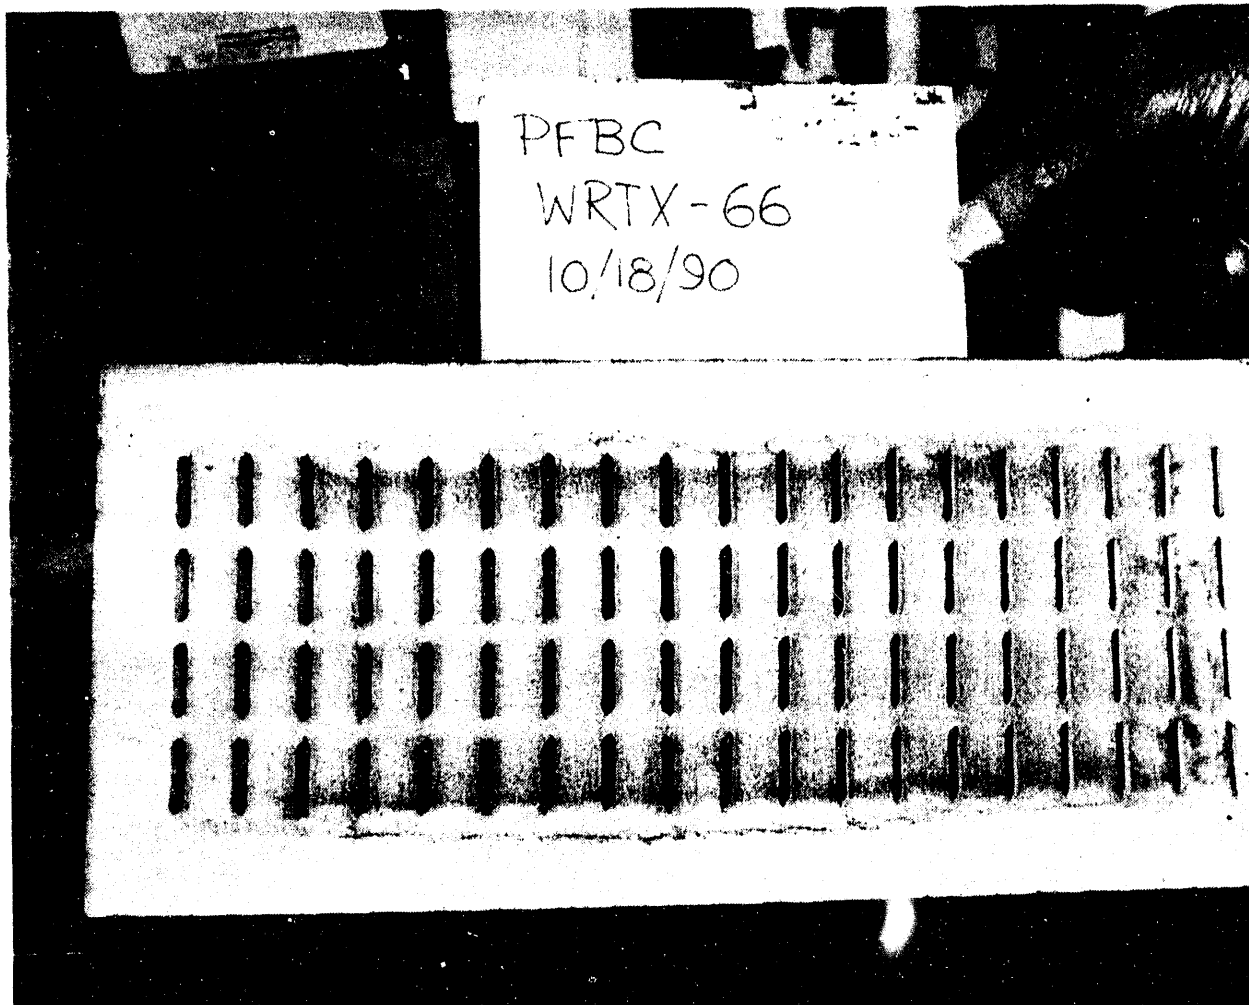
Fines were not generally observed in the clean gas channels along the horizontal crack, except possibly in the last two clean channels (No. 17 and No. 18) farthest from the plenum (Figure J.11). Along the mid section of the horizontal crack, the clean channels appear to be free of fines. There was no apparent evidence of fines traveling to the bottom of the clean gas channels at the base of the flange (Figure J.12).

Figure J.12 - Absence Of Dust Along the Clean Gas Channel Surface
Of Cross Flow Filter WRTX-66

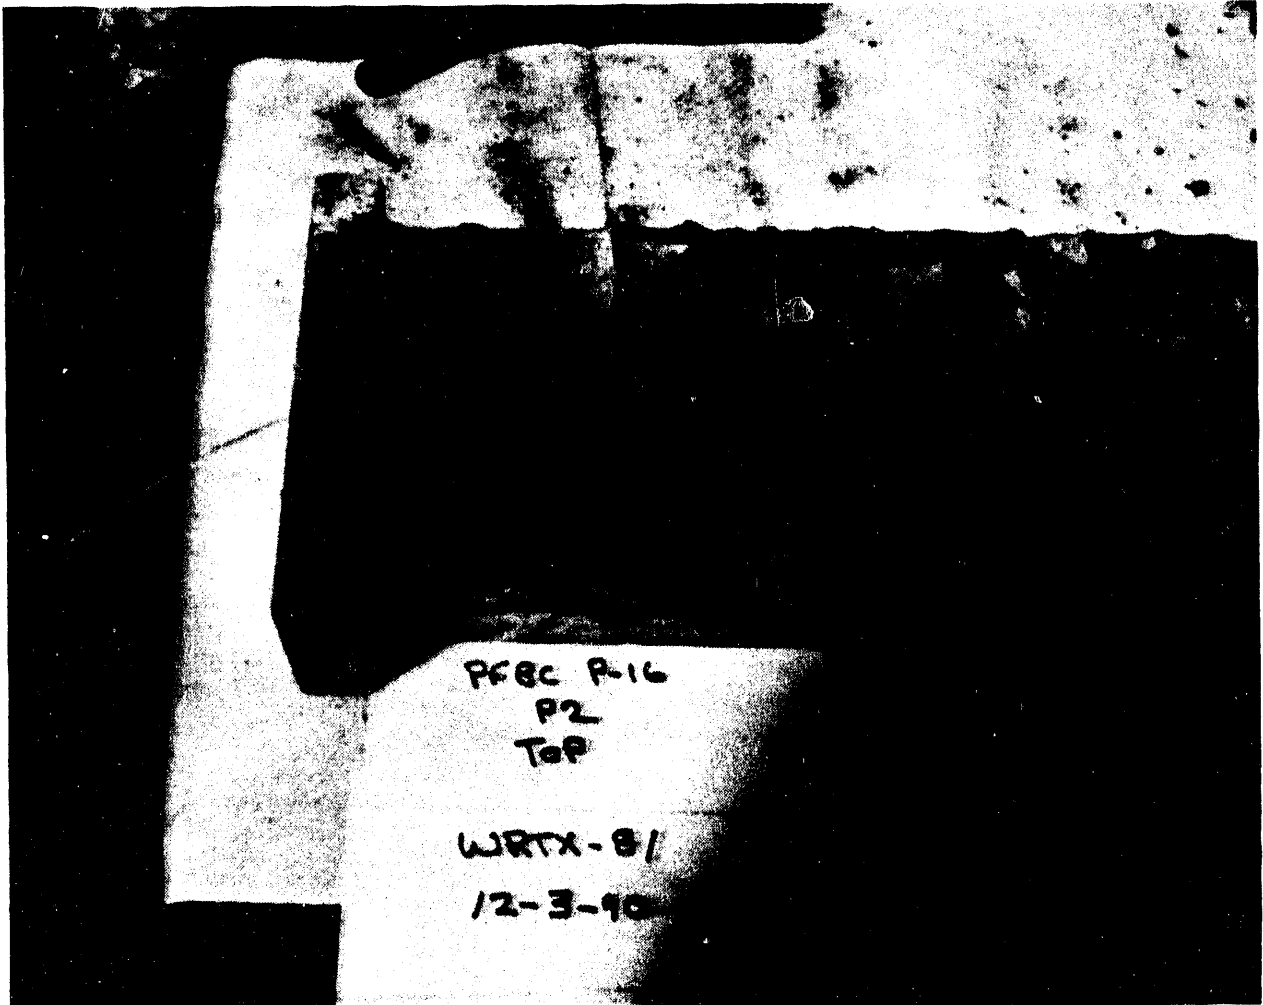
No visible identification could be made relative to which side of the filter had been weighted during filter fabrication. What was evident, however, was that the position of delamination along dirty gas channel No. 15 corresponded to the position of bolt No. 3. The delamination crack which formed along dirty gas channel No. 15 was located between bolt No. 5 and No. 6.

Figure J.16 - Delamination Along Dirty Gas Channel Column No. 15
Which Resulted in Cross Flow Filter WRTX-81 After
Turbine Trip Transient Testing
