ADVANCED SECOND GENERATION CERAMIC CANDLE FILTERS

Topical Report

DOE/NETL Contract No. DE-AC21-94MC31147

Siemens Westinghouse Power Corporation
Science and Technology Center
1310 Beulah Road
Pittsburgh, PA 15235-5098

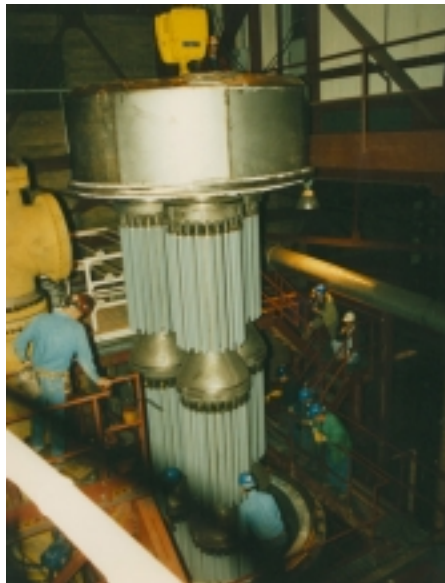
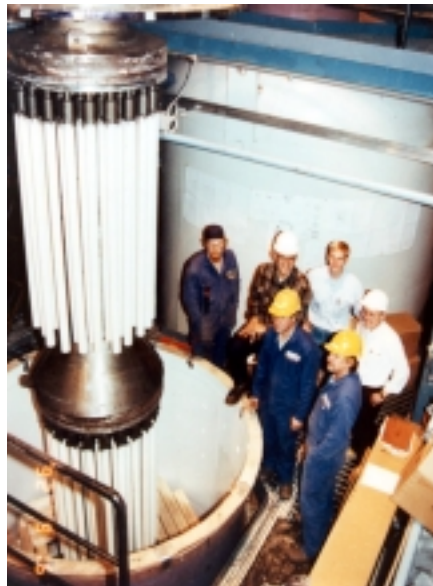
AEP PFBC Tidd Demonstration Plant

Foster Wheeler PCFBC Facility

Figure 1.1 — Siemens Westinghouse Advanced Particulate Filtration systems.

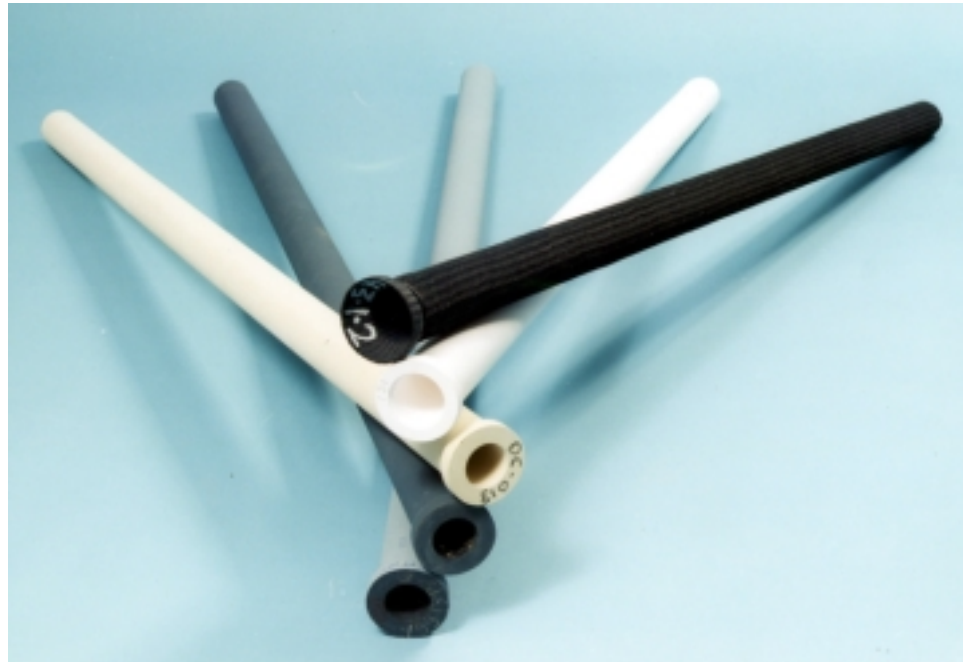
Figure 1.2 — First generation monolithic and advanced second generation candle filters.

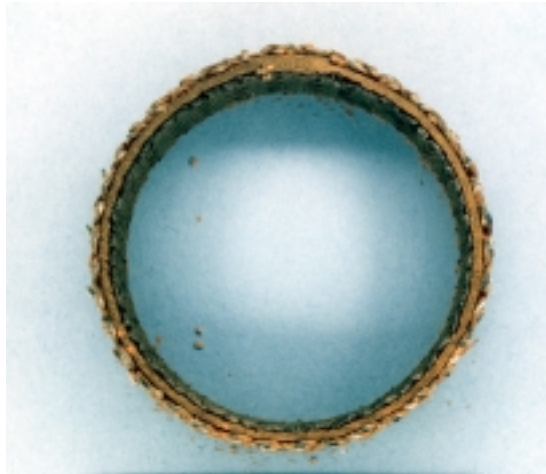
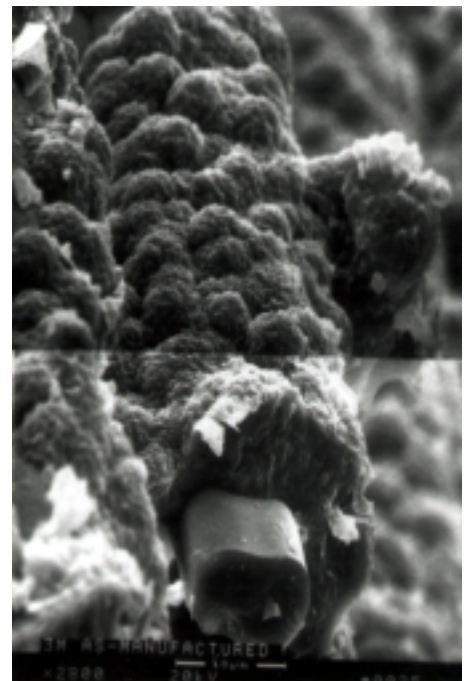
Figure 2.1 — 3M CVI-SiC CFCC composite filter matrix: (a) Composite structure: Outer confinement layer; Middle lapped filtration layer; Inner triaxial braid structural support; (b) External CVI-SiC surface; (c) CVI-SiC coated Nextel™ 312 fiber.

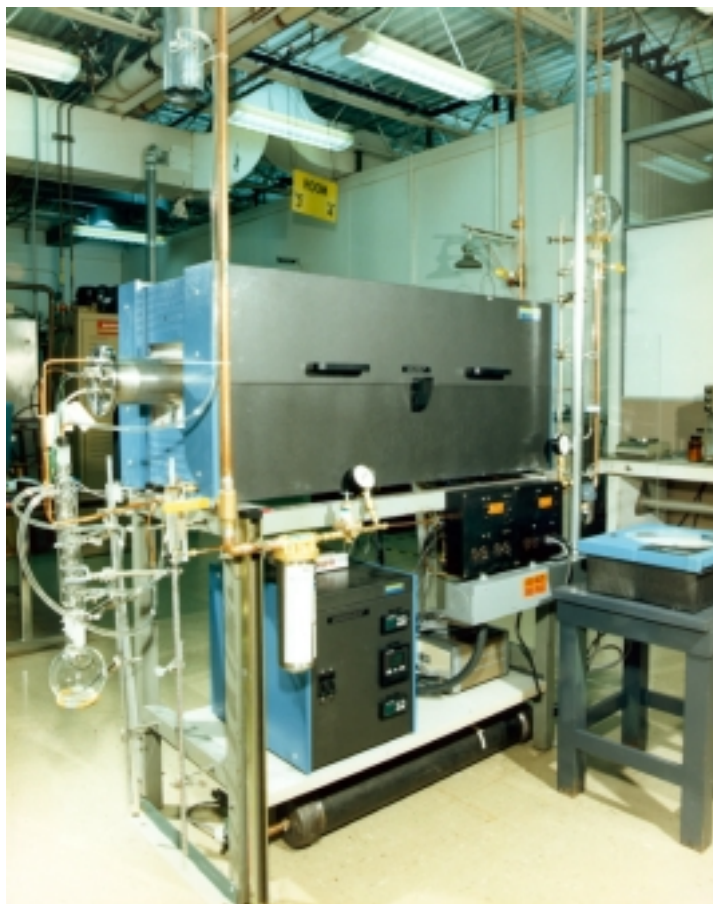
Figure 2.5 — Bench-scale, high temperature, flow-through test facility.

High temperature, flow-through testing was similarly conducted in 1995 for the nonoxide-based, advanced, second generation filters using mini-candles of the 3M CVI-SiC composite matrix, and discs of the DuPont SiC-SiC composite matrix. Post-test characterization of each material included c-ring compression testing at 870°C (~1600°F) of the as-manufactured and flow-through-tested mini-candles, and 4-point bend, ¼-point flexural strength testing at 870°C (~1600°F) of the as-manufactured and flow-through-tested filter discs. A summary of these results follows.

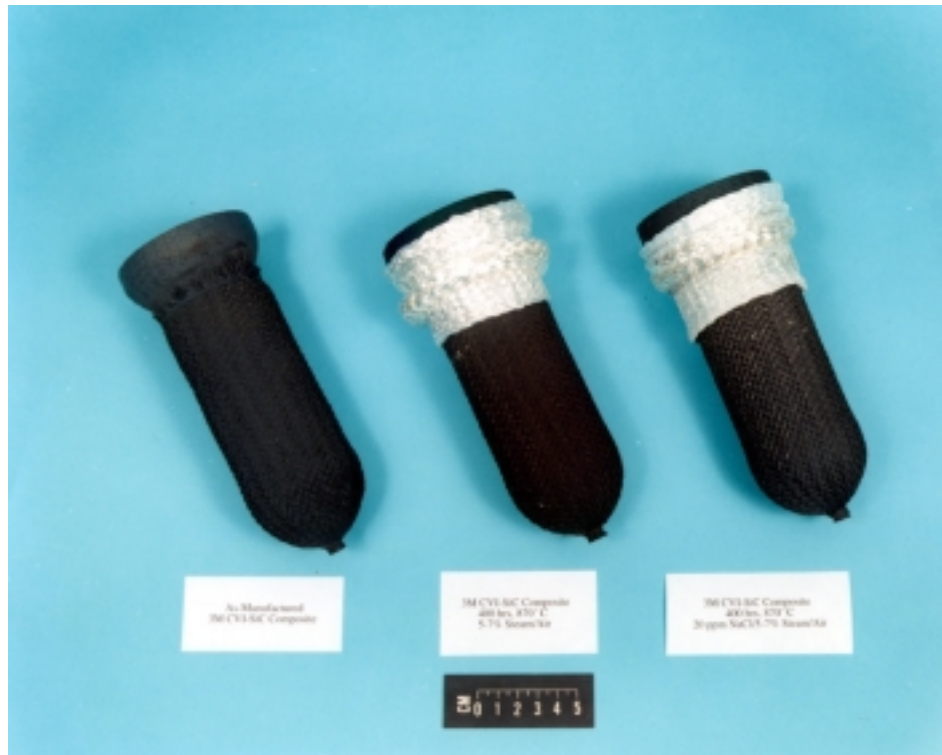
Figure 2.6 — 3M CVI-SiC mini-candles after exposure to high temperature flow-through testing.

After exposure to either the high temperature steam/air or alkali/steam/air flow-through environment, the 3M CVI-SiC mini-candles appeared to be intact, retaining their initial configuration (Figure 2.6). What was readily apparent was the very brittle nature of the outer confinement layer along the alkali/steam/air-exposed 3M CVI-SiC composite matrix. In several locations, the fiber bundles of the confinement layer weave were broken or missing.

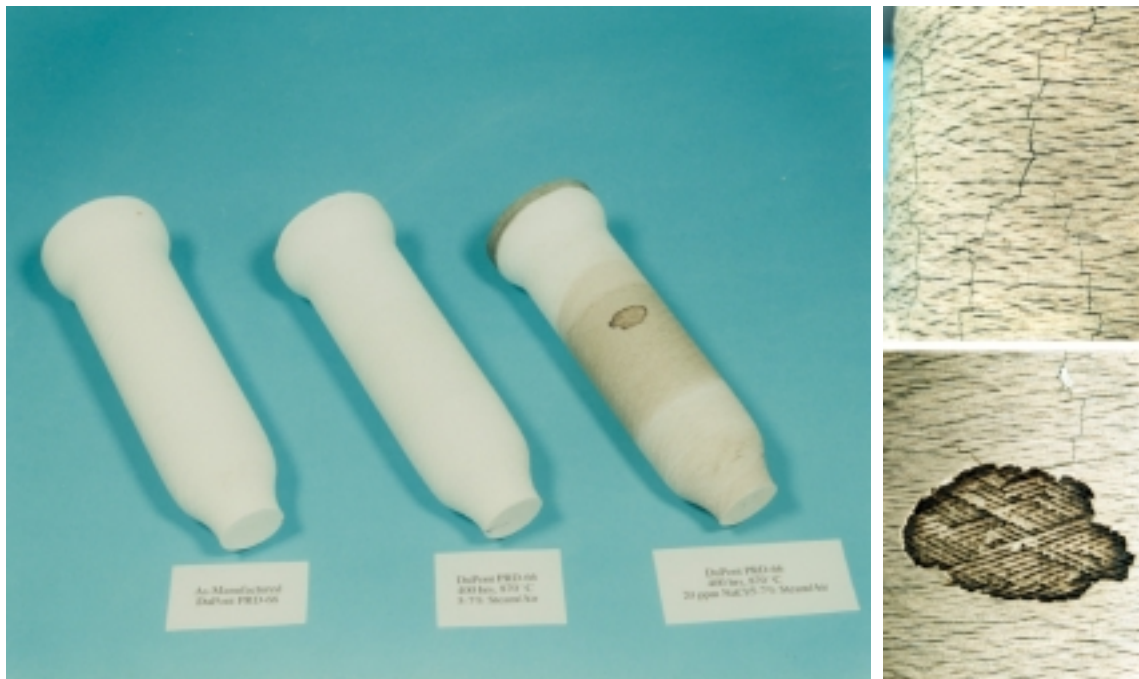
Figure 2.8 — Cracks and spalled areas of the o.d. surface membrane of the 400 hour, 870°C, 20 ppm NaCl/5-7% steam/air-exposed DuPont PRD-66 filter matrix.

After 400 hours of exposure in the 870°C (~1600°F) steam/air and alkali/steam/air environment, the DuPont PRD-66 mini-candles generally remained intact. However, along the outer membrane surface of the alkali/steam/air-exposed mini-candle, numerous longitudinal cracks were evident (Figure 2.8). In addition, an ~1 cm x ~1.5 cm section of the membrane and several of the underlying structural support fibers were removed along the alkali/steam/air-exposed mini-candle.

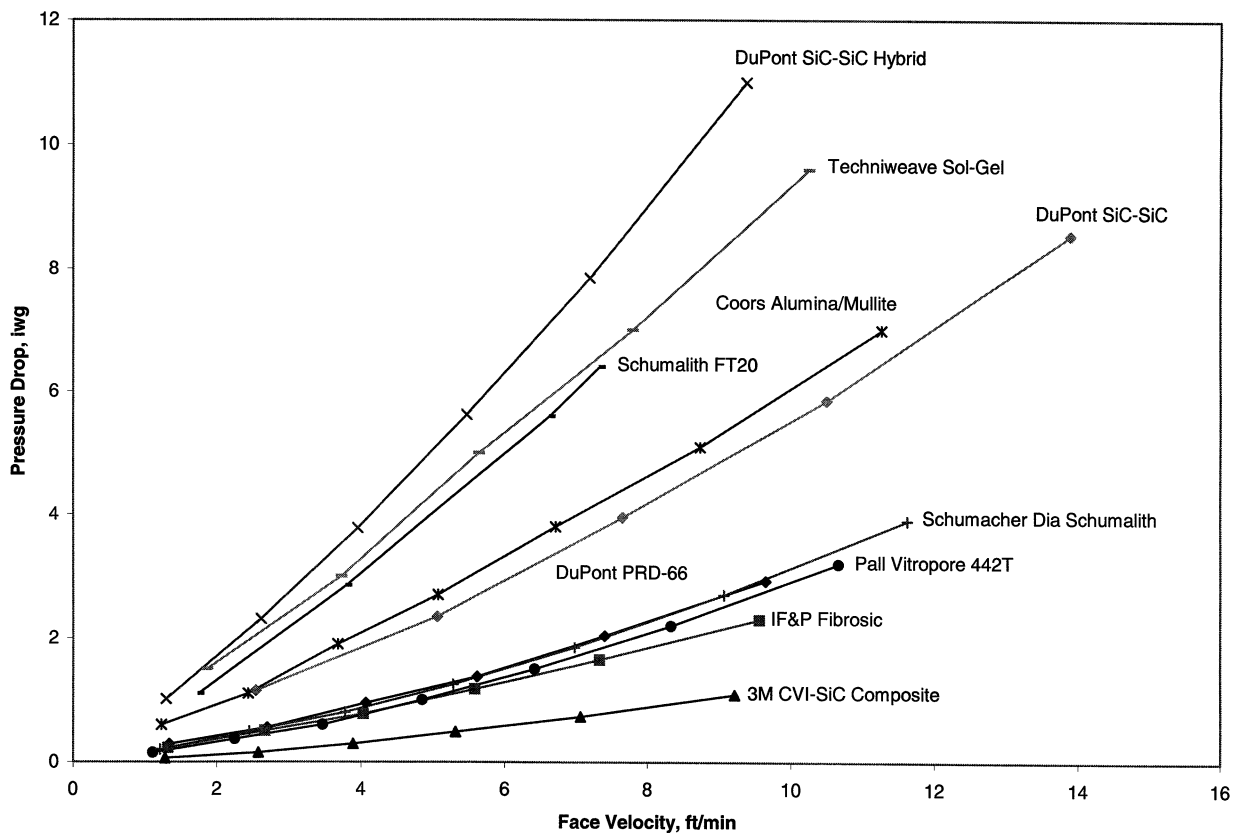
Figure 2.12— Room temperature gas flow resistance of the first generation monolithic and advanced second generation candle filters.

In conjunction with first generation monolithic filter elements, the room temperature, gas flow resistance of the as-manufactured, 1.5 m, 3M CVI-SiC composite, DuPont PRD-66, and IF&P Fibrosic™ candle filters, and 1.4 m DuPont SiC-SiC candle filter is shown in Figure 2.12. These data indicate the relatively high initial permeability of the porous, light weight, second generation filter elements.

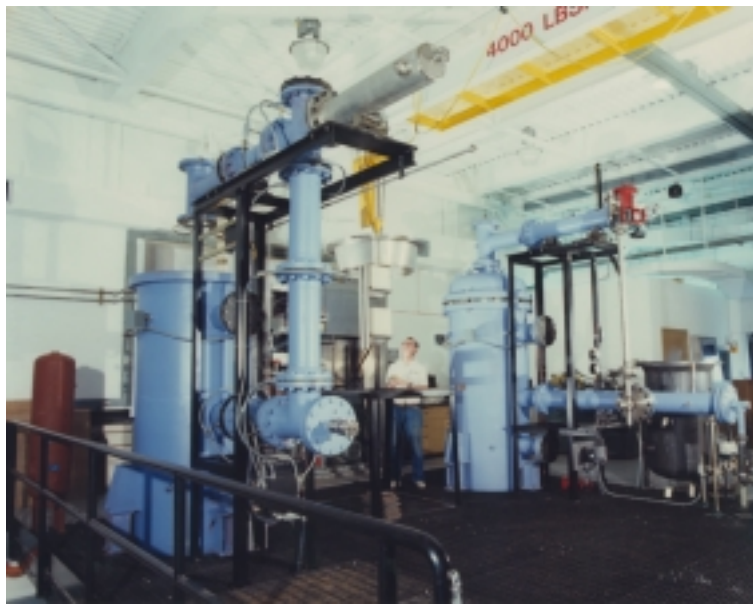
Figure 3.1 — Siemens Westinghouse PFBC simulator test facility.

In order to evaluate the performance of the advanced second generation filter elements, an array which included a 1.5 m DuPont PRD-66 filter, a 1.5 m 3M CVI-SiC composite filter, a 1.4 m DuPont SiC-SiC composite filter, and a 1.5 m IF&P Fibrosic™ candle filter was installed in the Siemens Westinghouse PFBC simulator test facility in Pittsburgh, Pennsylvania (Figure 3.1). Initially, the filter array was heated to temperatures of 843°C (1550°F) prior to initiating thermal transient testing. A series of seven increasing severity thermal transients were delivered to the array which reduced the outer surface temperature of the filter elements by 6-100°C and 20-240°C within the first 5 and 60 sec, respectively, after transient initiation. After each transient, a rapid reheat was conducted in order to return to processing operating temperatures of 843°C (1550°F) within one hour after transient initiation. Nine maximum thermal transients followed. Subsequently the array was subjected to ten accelerated pulse cleaning cycles and a final maximum severity thermal transient.

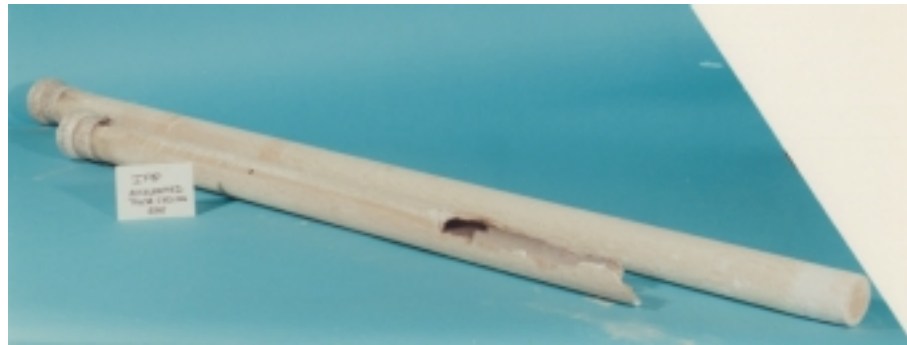
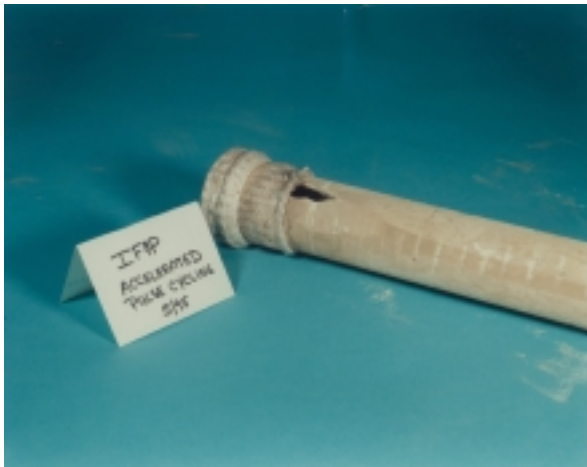
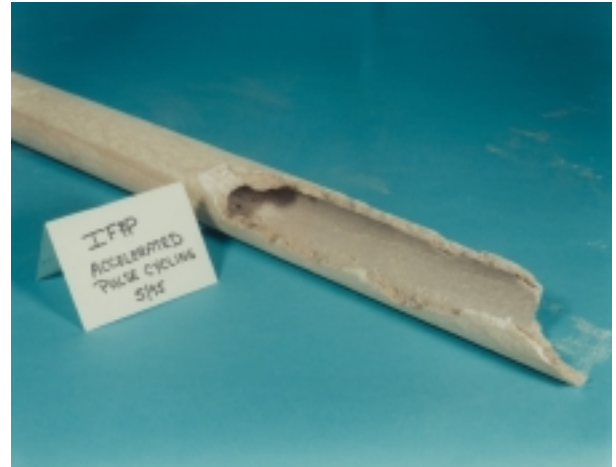
Figure 3.3 — Fractured IF&P Fibrosic™ candle filter after exposure to 1645 accelerated pulse cycles in the simulated PFBC operating environment.

Gas flow stream lines were evident along the i.d. wall of the fractured IF&P Fibrosic™ candle. These lines which were ~180° from the large hole that resulted below the flange, were considered to have resulted from repeated pulse cycling. Further inspection of the i.d. surface near the flange indicated that the surface of the infiltrate that was used to provide additional strength along the flange had partially separated from the support matrix.

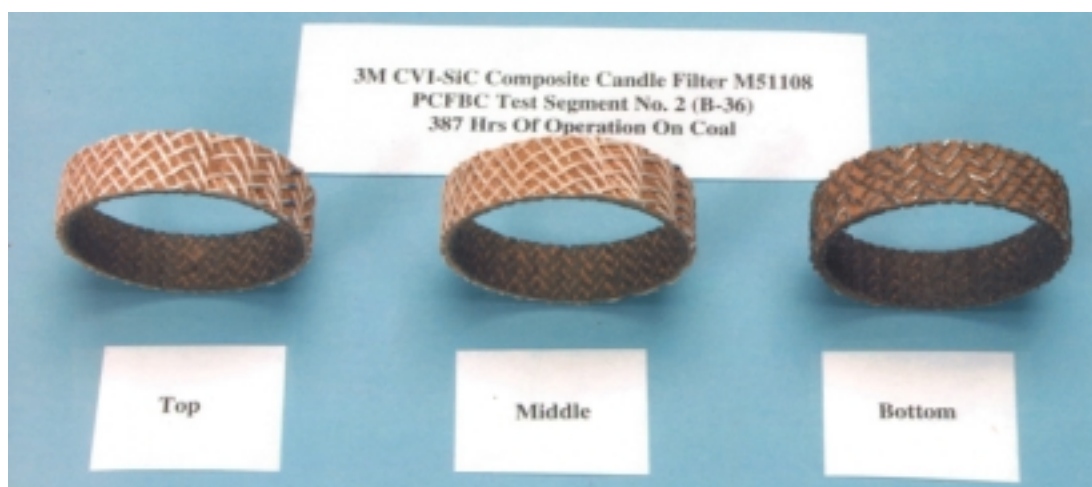
Figure 3.8 — Removal of the CVI-SiC coating along the outer confinement layer of the 3M CVI-SiC composite filter element after 387 hours of operation at AEP.

Post-test room temperature, gas flow resistance measurements of the intact PFBC-exposed 3M filter indicated that the pressure drop across the element was ~220 inches of water gauge (in-wg) at a gas face velocity of 10 ft/min. The room temperature pressure drop across the ash coated 3M filter was relatively high in comparison to alternate filter elements that were exposed to similar PFBC test conditions. This was attributed to the adherence of the dust cake along and within the outer confinement layer, as well as through the filtration mat and triaxial support braid. Variation in the color of the filter matrix was observed along the outer surface of the filter element (Figure 3.8). This was attributed to removal of the external CVI-SiC outer coating exposing the underlying confinement fibers along the top two-thirds of the filter element.

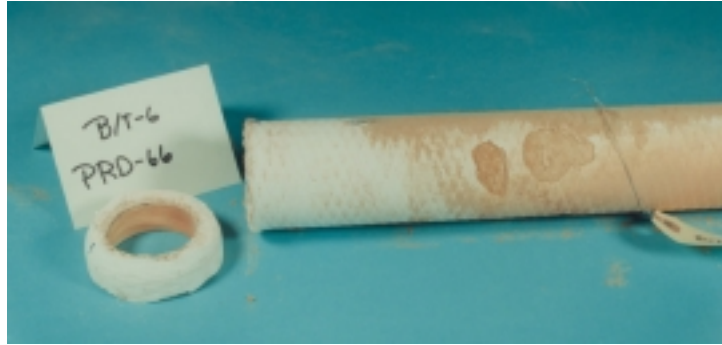
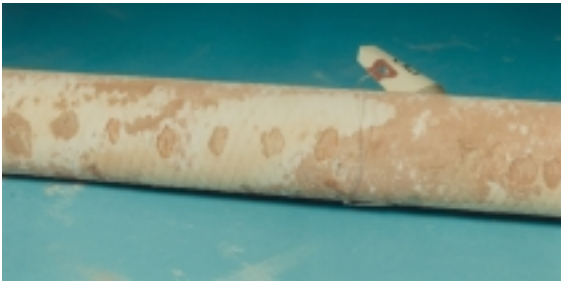
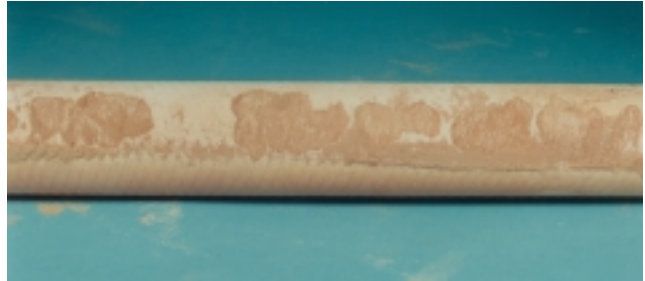
Figure 3.10 — Divot formations along the length of the DuPont PRD-66 filter elements after testing at AEP.

candles, near the bottom end cap. Areas of the outer membrane and underlying support fibers were removed in 'divot-like' line formations along the surface of the remaining intact and fractured filter elements (Figure 3.10). Localized 'divoting' was also observed below the gasket sleeve that was installed around the filter flange, and along alternate isolated areas of the filter body.

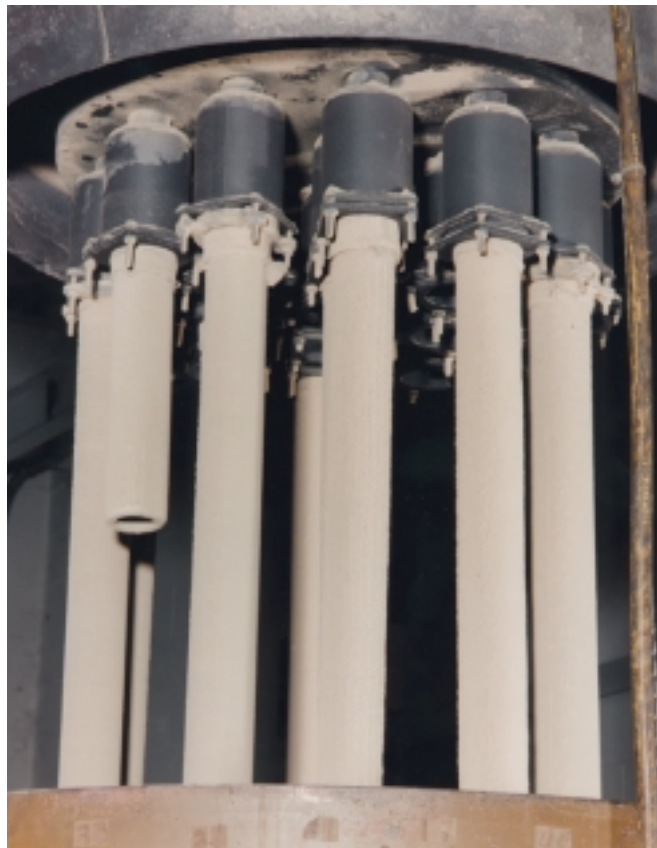
Figure 4.2 — Filter array at the conclusion of Siemens Westinghouse qualification testing.

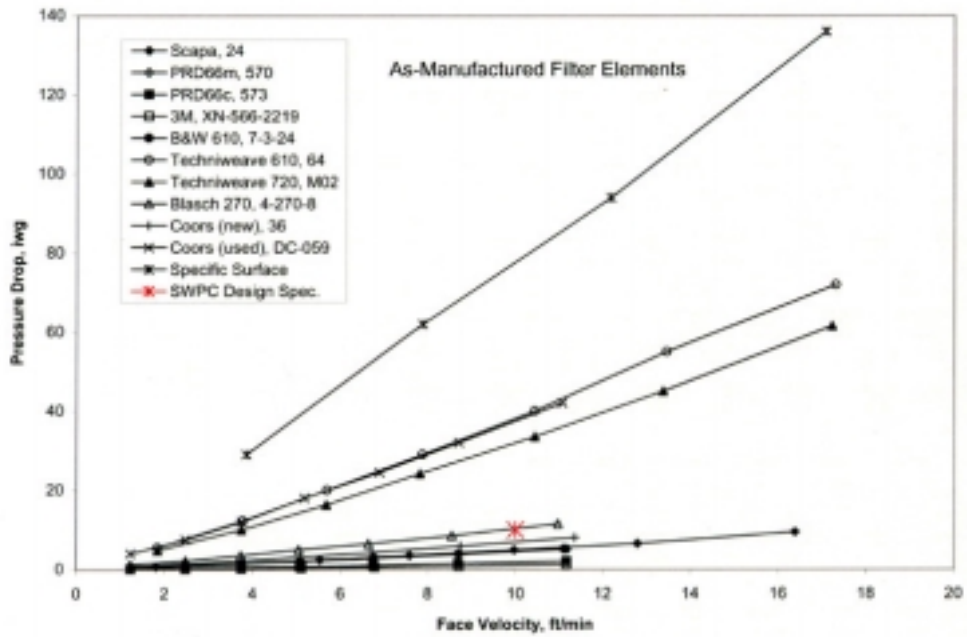
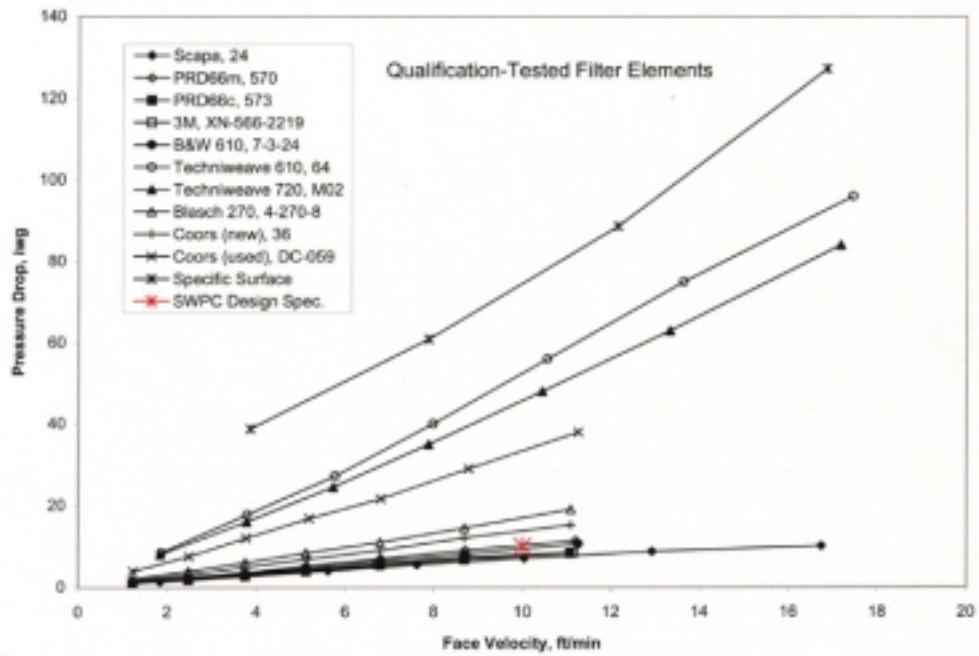
Figure 4.3 — Gas flow resistance of the qualification-tested filter elements prior to and after exposure in the Siemens Westinghouse PFBC simulator test facility.

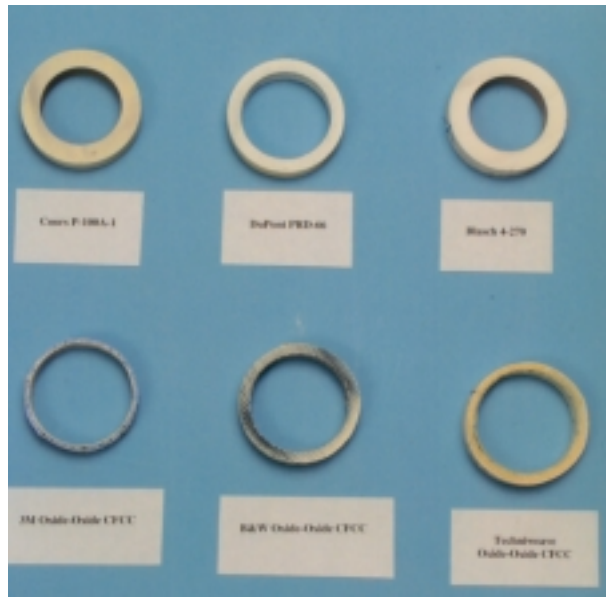
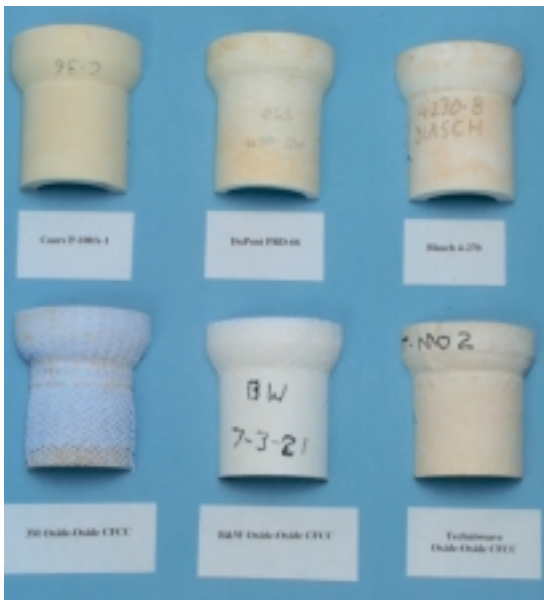
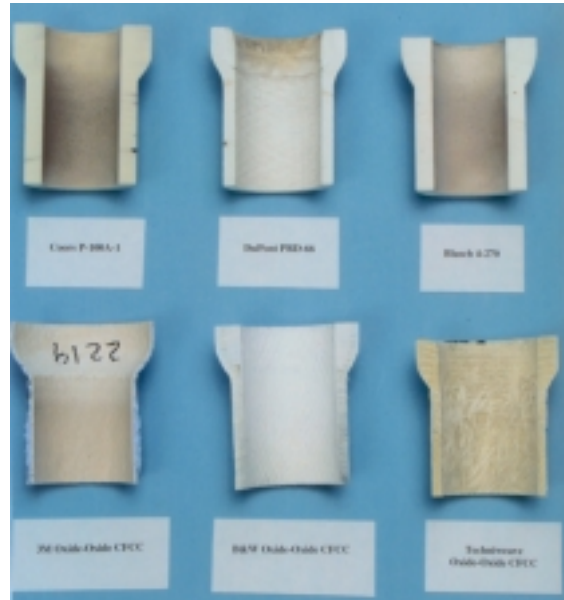
Figure 4.4 — Variation in the wall thickness and flange contour of the monolithic and advanced filter elements.

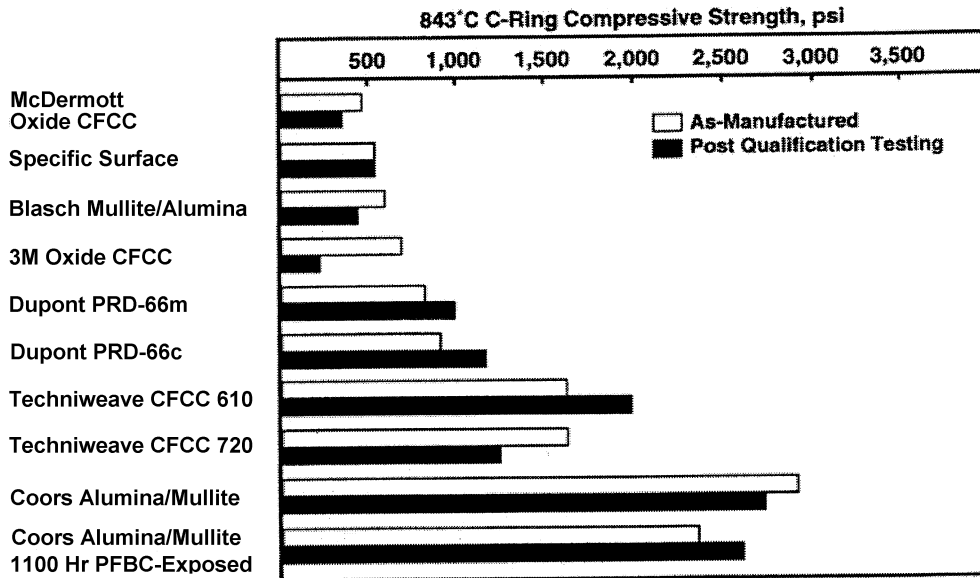
Figure 4.5 — Bulk strength of the as-manufactured and qualification-tested advanced monolithic and composite candle filters.

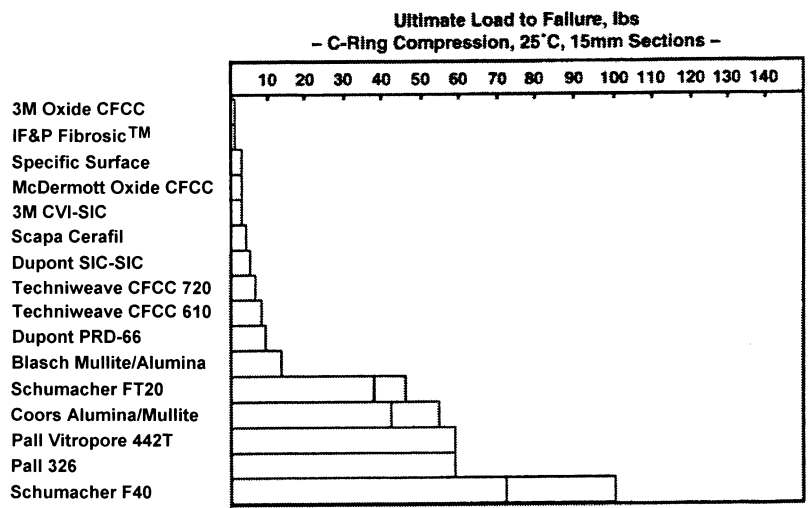
Figure 4.6 — Load bearing capabilities of the as-manufactured porous ceramic candle filters.

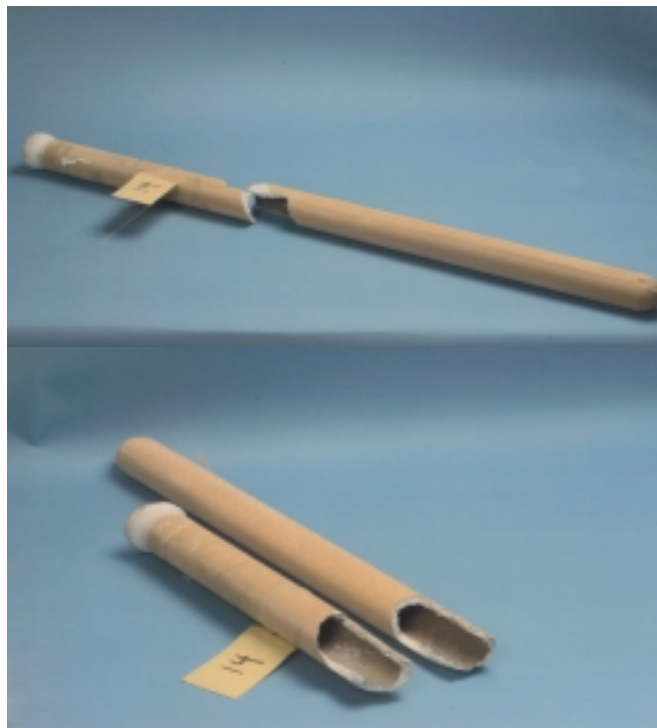
Figure 4.7 — Failure of the Scapa Cerafil™ filter element during Siemens Westinghouse simulated PFBC qualification testing.

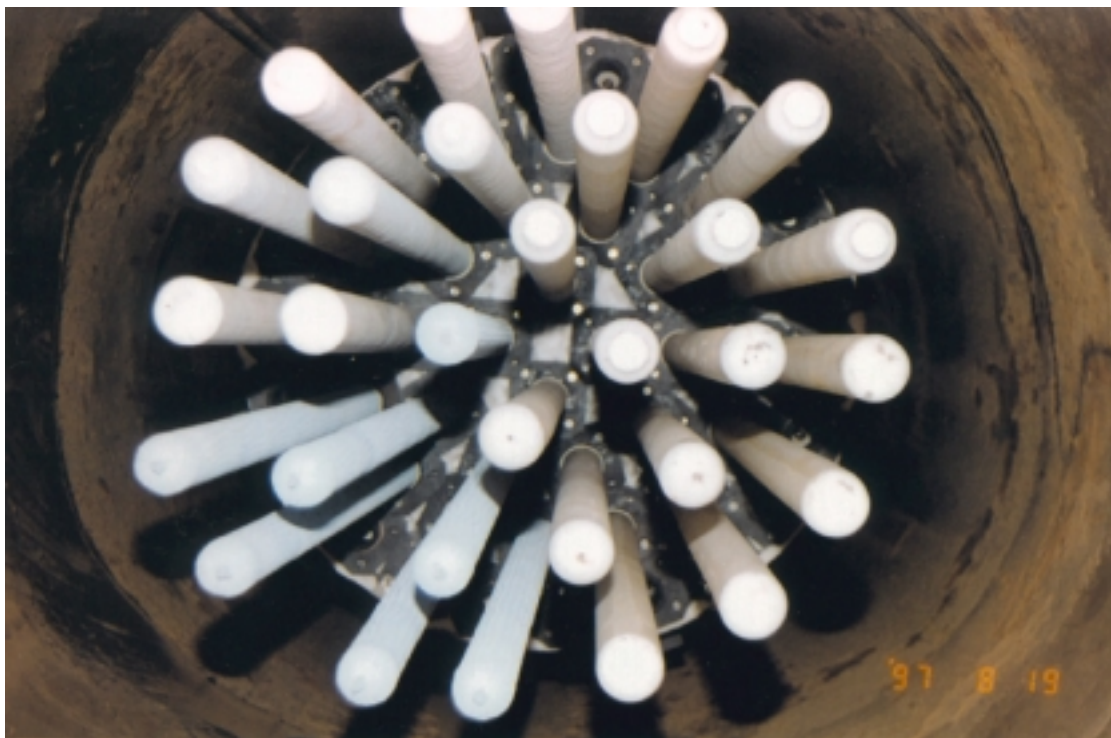
Figure 4.9 — Advanced composite filter element testing at the Foster Wheeler test facility in Karhula, Finland.

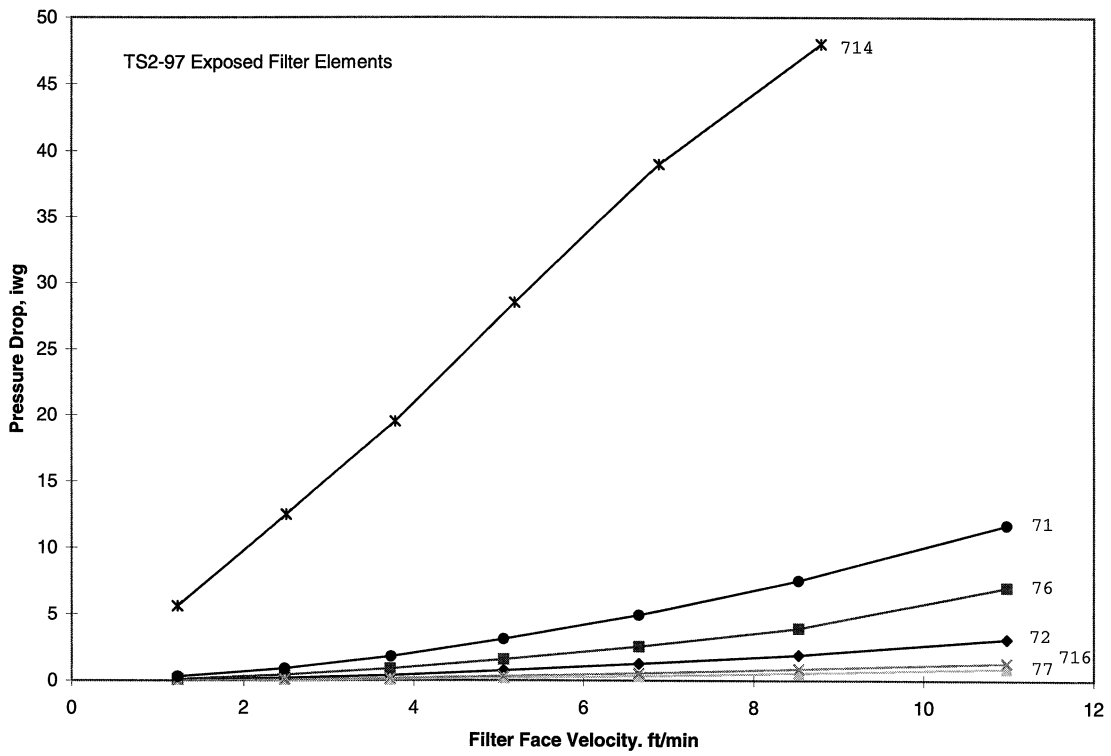
Figure 4.10 — Gas flow resistance of the 3M CVI-SiC candle filters.

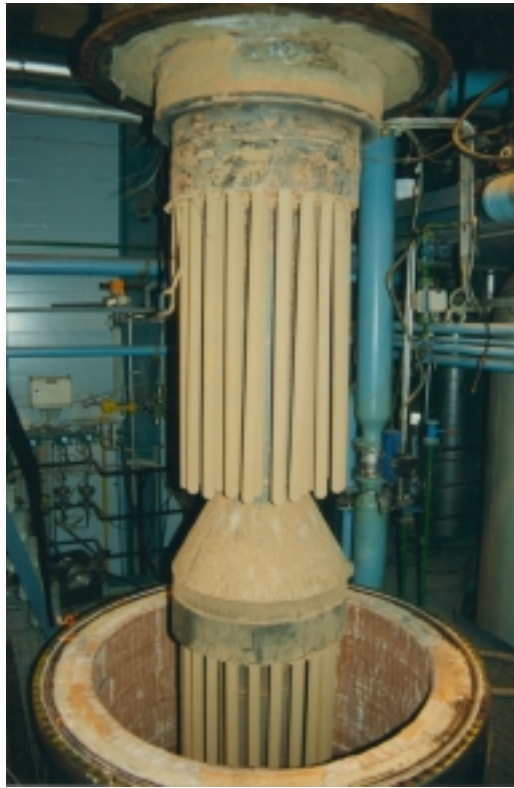
Figure 4.11 — Siemens Westinghouse Advanced Particulate Filtration system at the conclusion of testing at the Foster Wheeler PCFBC test facility in 1997.
