**PARTICULATE HOT GAS STREAM CLEANUP
TECHNICAL ISSUES**

Task 1 ASSESSMENT OF ASH CHARACTERISTICS

FINAL REPORT

SRI-ENV-99-8484-T1F

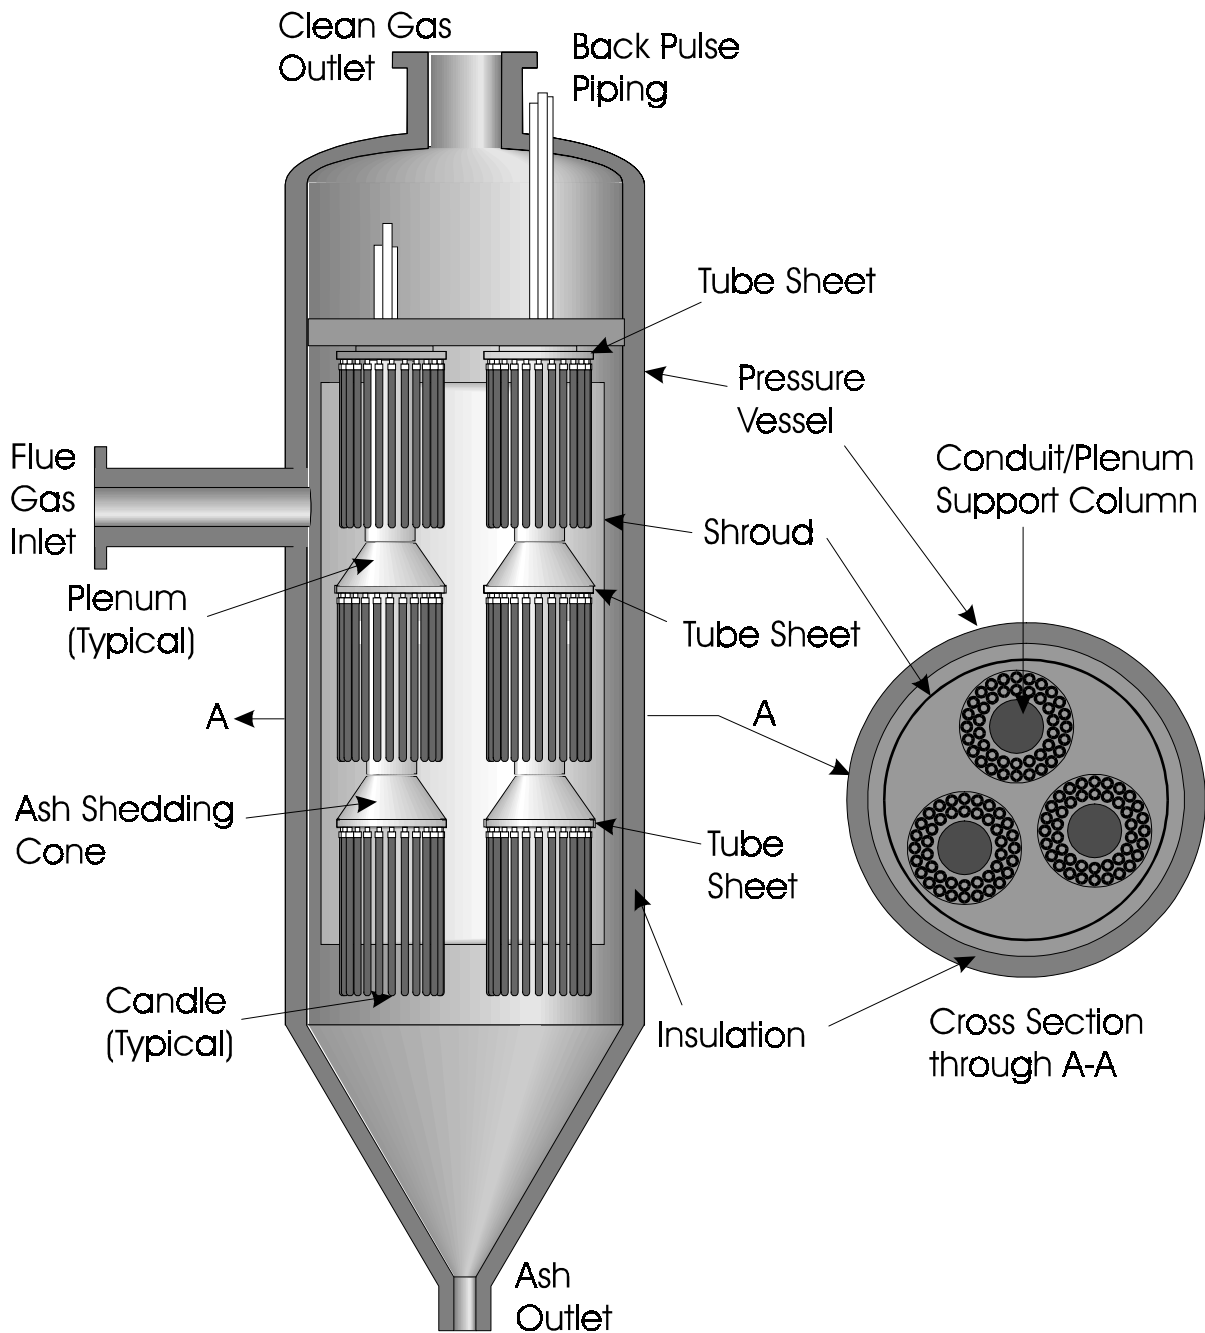
Figure 3-1. General features of the APF at the Tidd Demonstration Plant.

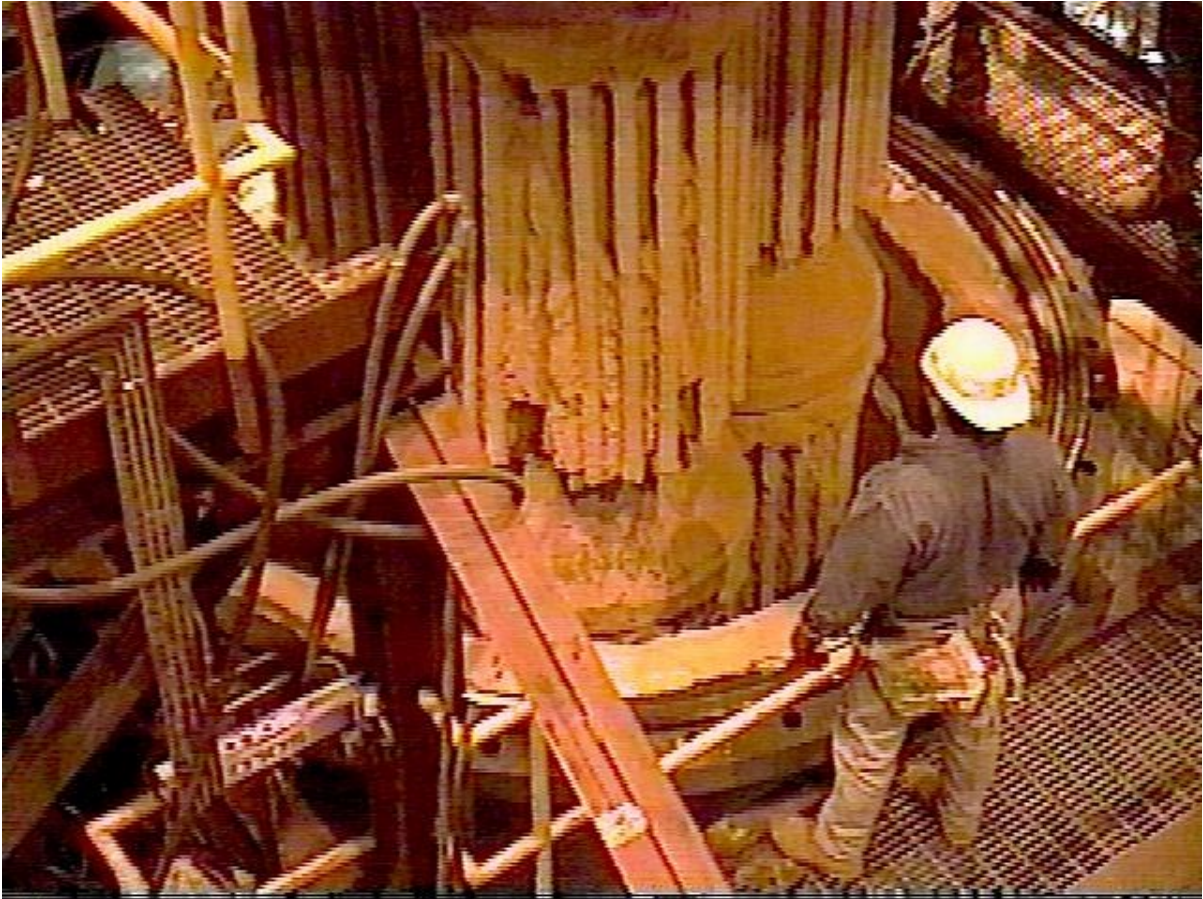
When the filter assembly was opened on September 30, 1993, extensive deposits of ash were found on candle surfaces, bridged between candles, and on non-filtering surfaces (ash sheds, plenum support conduits, and on the underside of the tube sheet). Deposits found on these non-filtering surfaces were formed by the gradual deposition of particles as a result of turbulent diffusion. Some of these passive deposits were up to six inches thick, with high

Figure 3-2. Severe ash bridging was evident as the top two plenums were lifted into view.

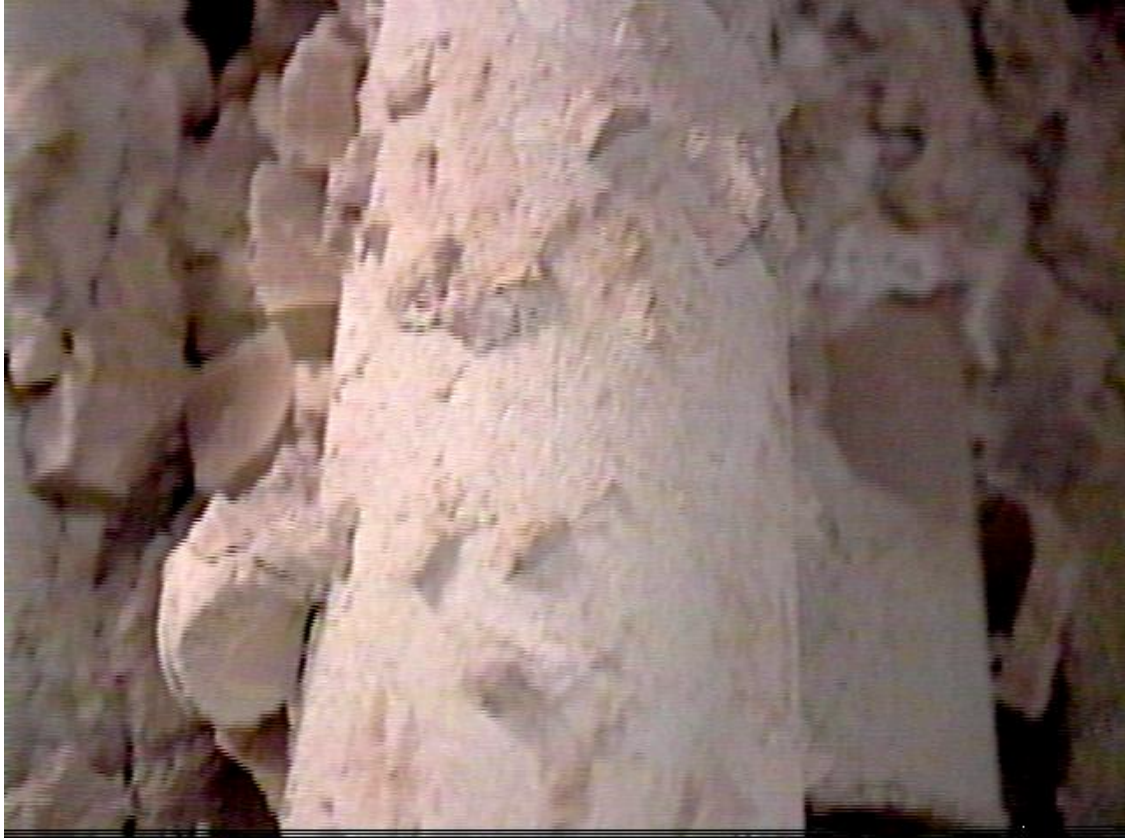
tensile strength. Many of the candle filter elements were covered by filter cakes up to one inch thick. Like the passively deposited agglomerates of ash, these filter cakes also had high tensile strength. Figures 3-2 through 3-5 provide representative views of the condition of the APF as observed on this site visit. Figure 3-6 shows one of the thick, strong filter cake specimens collected while on site.

Figure 3-3. Thick, patchy cakes were present throughout the filter vessel.

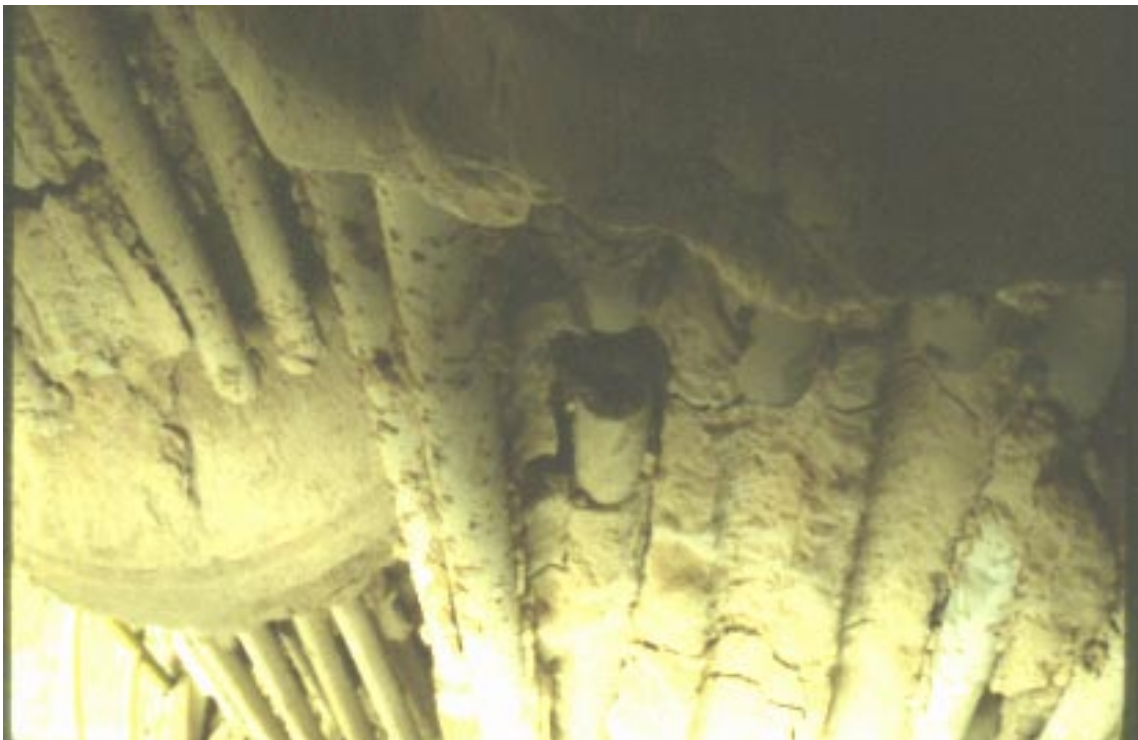
Figure 3-4. Ash almost completely enveloped many of the candle filter elements.

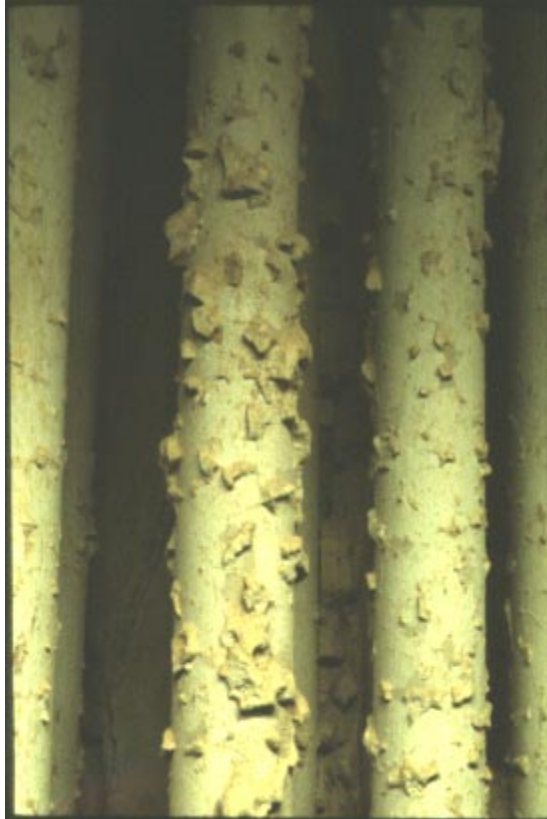
Figure 3-5. The appearance of these candles is believed to be the result of patchy cleaning and the loss of cake during cooling down of the filter vessel.

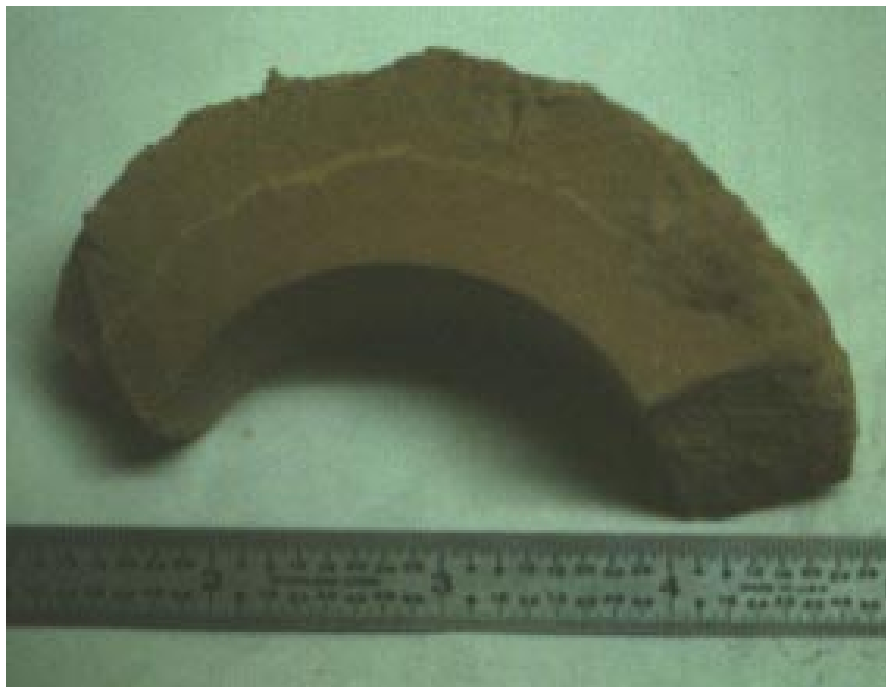
Figure 3-6. A number of laboratory analyses were performed on this thick filter cake deposit (ID # 4012). The deposition layers formed during filtration are clearly visible in this specimen.
