**Characterization and Failure Analysis of Ceramic Filters Utilized**

**Emission Control During Coal Gasification**

**Final Technical Report**

**Mechanical Engineering/Prairie View A&M University**

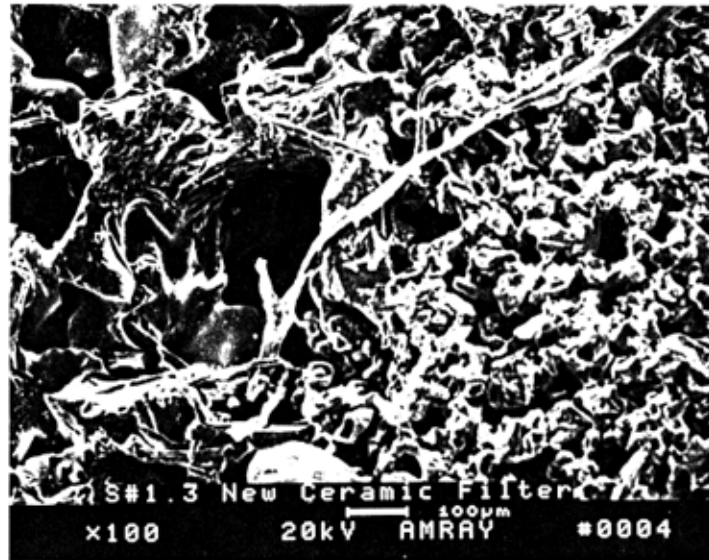
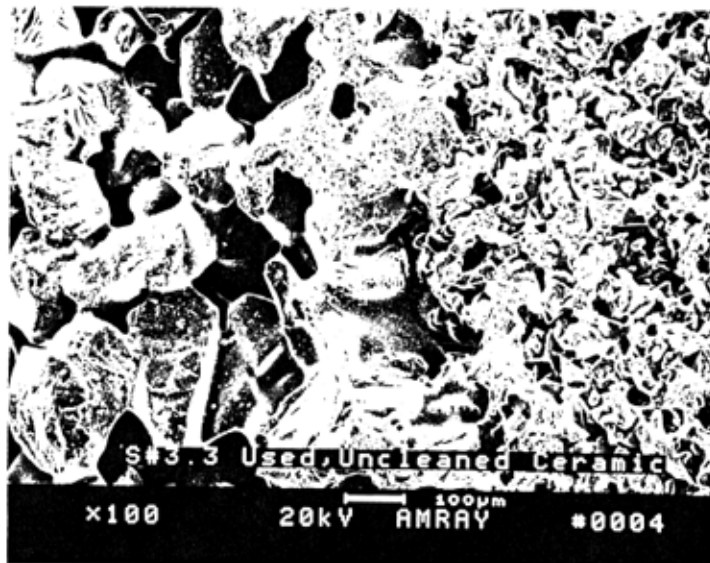
Figure 2-2-1 SEM micrographs of unused, used and ultrasonically cleaned filters

The micro-features and surface topography of unused, used, and used but ultrasonically cleaned ceramic filter samples were primarily analyzed by SEM. The results of the SEM showed that the unused ceramic filters have porous microstructural features, and the dimensions of the pores are about several ten micrometers with no fractured or broken surface. As for the used filter, the SEM pictures revealed broken and fractured surfaces in the inner and the outer layer due to thermal stress induced by cold back pulse cleaning and structural stress caused by thermal volume expansion. Also, traces of particulate and ashes were found in both layers of the used filter samples.

The micrographs of used (with or without ultrasonically cleaning), and unused filter samples are presented in **Figure 2.2.1**. The pictures show that the micro-structure of the filter can be divided into three regions. The first is the outer layer with a fine microstructure feature which correspond to aluminosilicate membrane of ceramic filter. The inner layer with coarse grains represents the support matrix (clay-bonded silicon carbide) of the ceramic filter. The third one is the interfacial region between the first and second layer. In this region, the microstructural characteristic transforms from one to another, i.e., from fine to coarse. Although there is no abrupt transition in the interfacial microstructure, the differences of microstructure features in the inner and outer region are easily to be differentiated. The outer layer has a porous cotton-like microstructural features, and the dimensions of the pores are about several ten micrometers. In the inner layer, with a porous microstructure too, the grains with several ten micrometers in size are bonded by clay and the pores are generally formed at the boundaries between the grains.

SEM Micrographs of: (a) unused; (b) used; (c) used and ultrasonically cleaned ceramic filters, illustrating the double layer structures.

For the used ceramic filter, the volume expansion generated by the changes in microstructure of the grains might induce stress fields inside in the filter matrix, which would further promote the nucleation and propagation of the micro-cracks at some inclusions and defects sites leading to the fatigue fracture failure of the ceramic filter. the inconsistency in changes of crystal constants and structure between inner and outer layer would cause delimitation of the ceramic filter structure. The unused filter usually have a fine coherence between inner and outer layer, while the used filters show that some particles have been dropped off the interfacial region. In addition, the growth of grain and volume expansion of the used filters may lead to the reduction of volume ratio of the pores, and as a result, decrease the permeability of the ceramic filters.

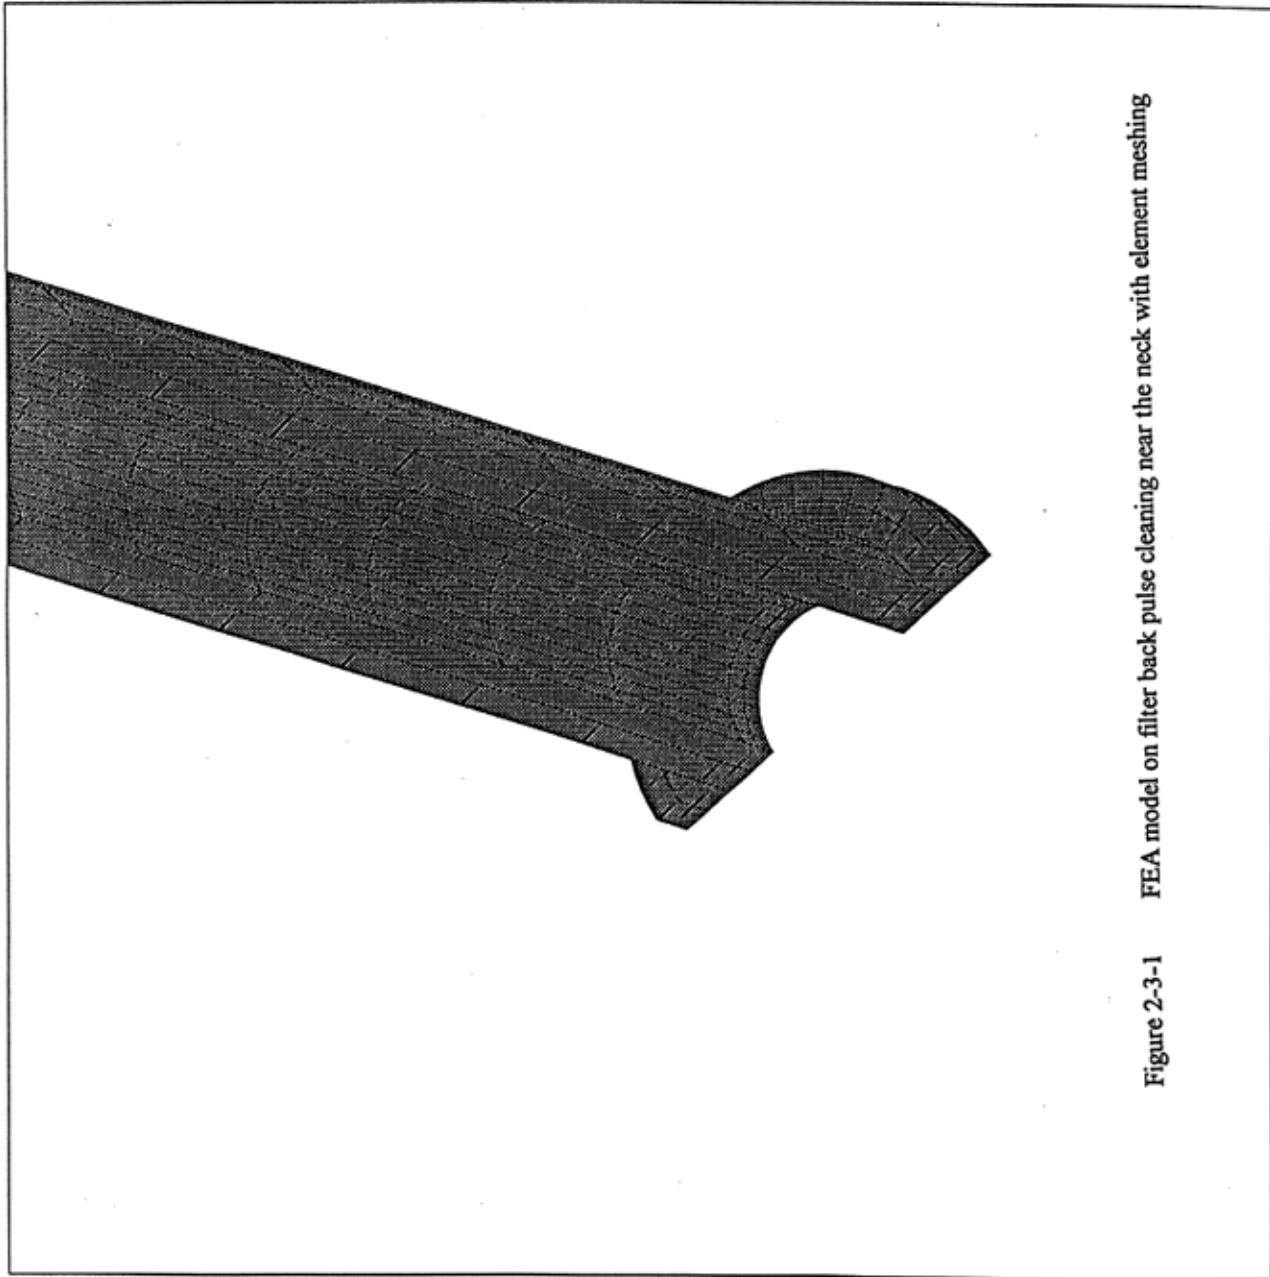
Figure 2-3-1 FEA model on filter back pulse cleaning near the neck with element meshing

The module was developed by dividing the computation zone into five volumes. This multizone approach was used in order to overcome the difficulties in meshing due to high slenderness ratio (length to diameter) of the filter. Discretization of the computational zone was done using two types of 3-D elements from the ANSYS element library. The bottom closed end of the filter was meshed with 3-D 10-node tetrahedral thermal solid. The rest of the cylinder was meshed with 20-node Thermal Solid Brick. In total for the entire computation domain 3598 elements were used. Connective boundary conditions were used for both outside and inside surface. The inside environmental temperature was assumed to be 40 degree C and the outside environment temperature was taken as 800 degree C, selected because it is close to the working temperature. 40 degree C at the inside was used to be close to the back pulse temperature.

Based on the thermal analysis performed on a single filter during back pulse cleaning process, it appears that there is a very sharp temperature gradient existing within filter inner surface. Even though the duration of the cold pulse is very short, less than one second, but the back pulse is operating with high frequency - every twenty minutes per cycle. The repetitive thermal shock attack to filter inner surface should be the cause leading to the micro-racks within the filter inner surface.
