Run #6: 1200°F with 7.83 vol% H₂S

APPENDIX VI: GRAPHS OF LONG- TERM DATA

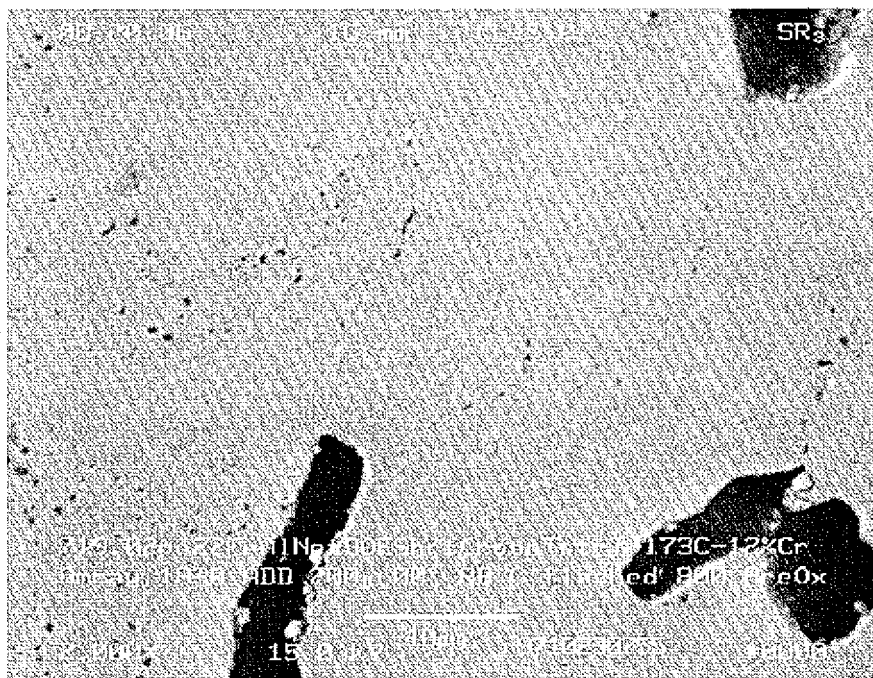
Figure 130: FAS, 800°C preoxidation, cross-section. 2000X (T-173-C-1)

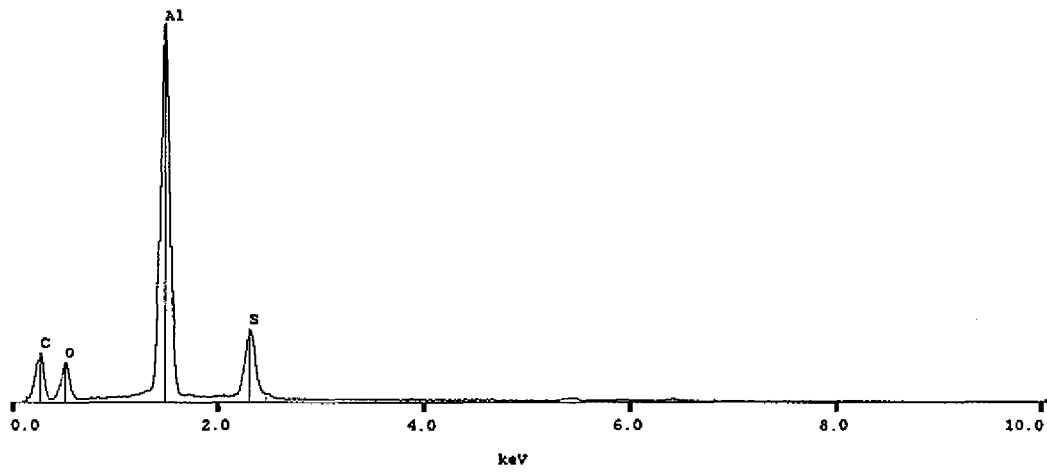
Figure 141: EDS spectrum of dark area of Figure 140. Alumina with sulfur.

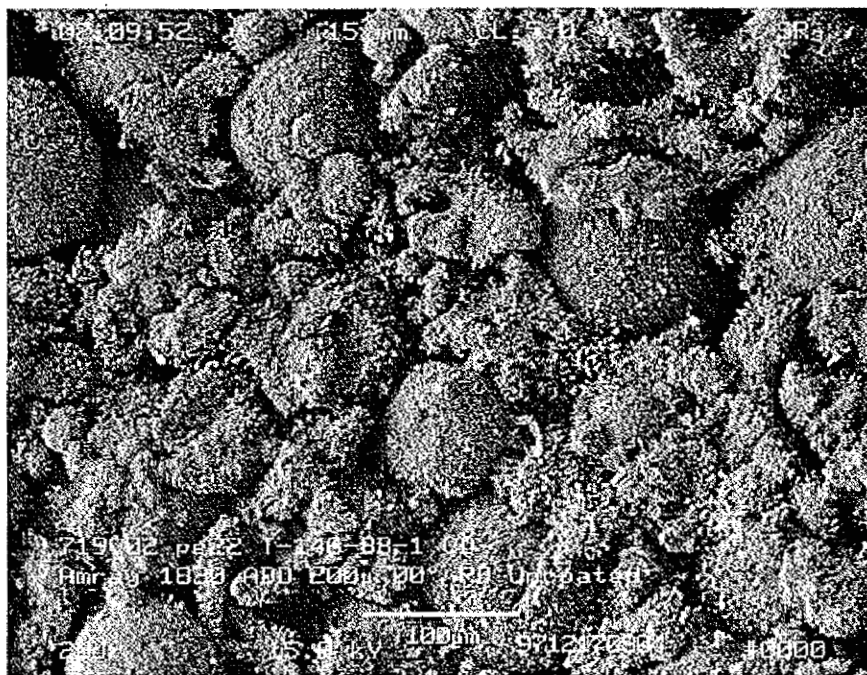
Figure 144: FAL, 800°C preoxidation, upstream surface of media. 200X (T-146-BB-1)

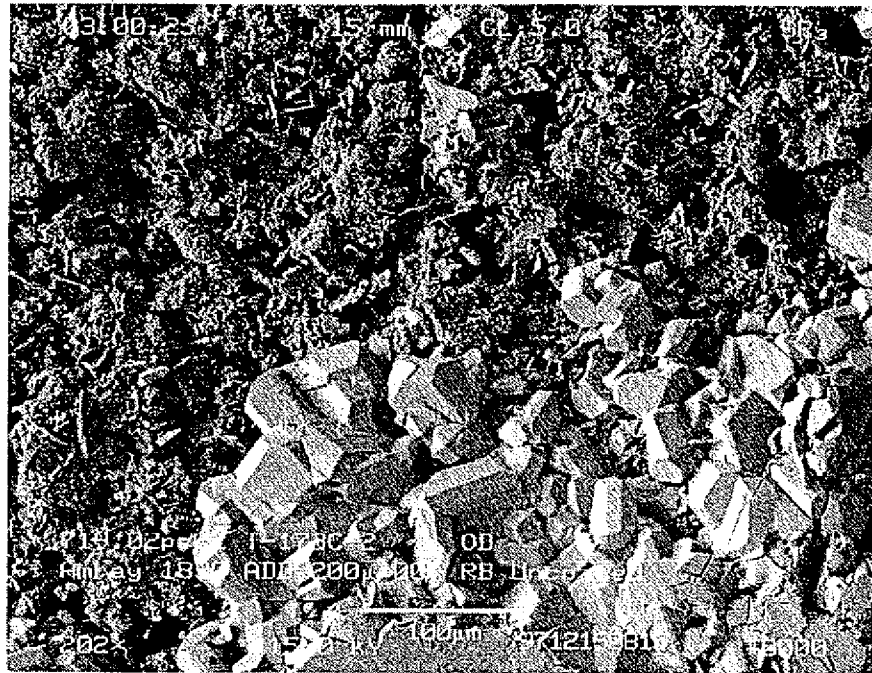
Figure 146: FAS, 1000°C preoxidation, upstream surface of media. Crystal is composed of aluminum and zirconium with oxygen (possible $\text{Al}_2\text{O}_3 - \text{ZrO}_2$), no sulfur. 200X (T-173-C-2)

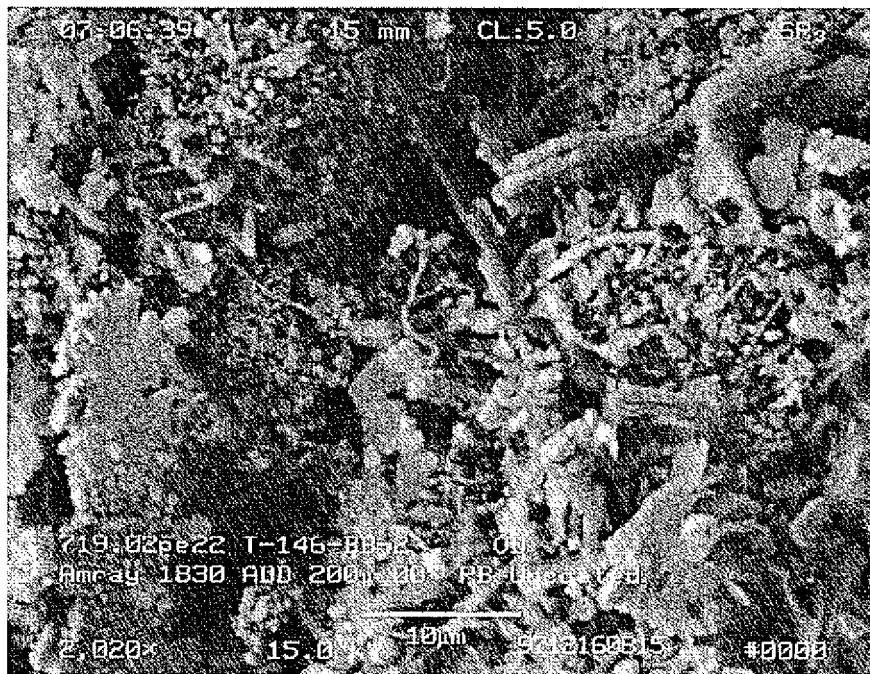
Figure 149: FAL 1000°C preoxidation, upstream surface of media. High sulfur detected using full screen spectrum. 2000X (T-146-BB-2)

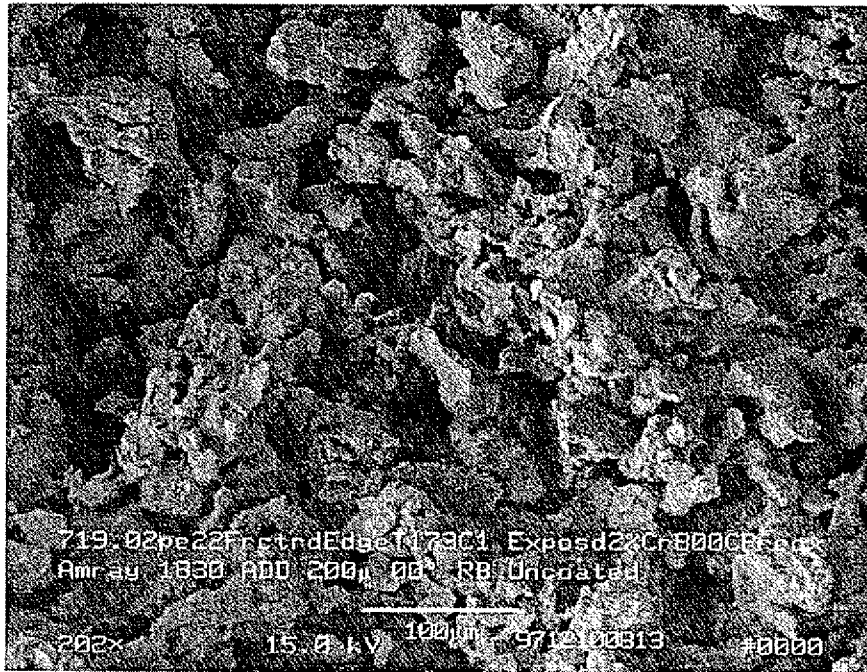
Figure 150: FAS, 800°C preoxidation, exposed, fractured surface. 200X (T-173-C-1)

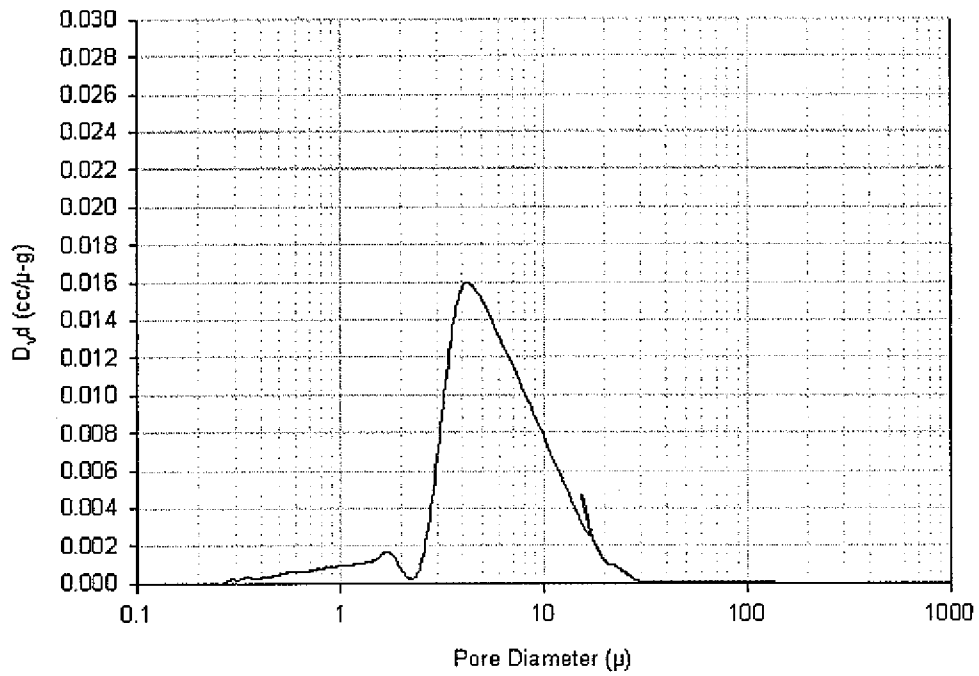
Figure 168: Porosimetry of as-sintered FAS media. Pore distribution centered at approximately 4.5 micron.

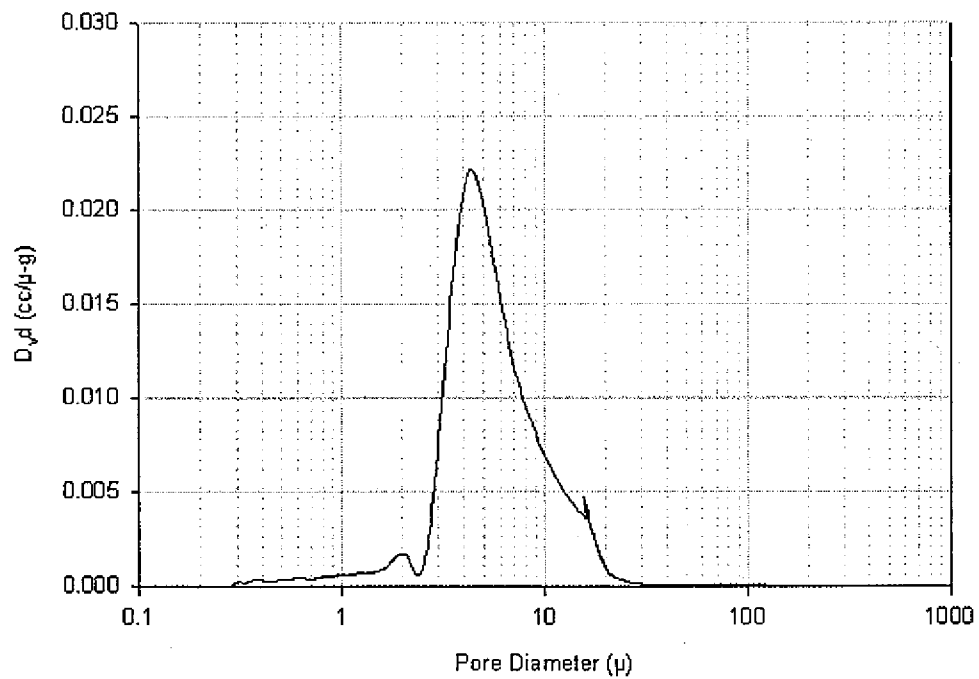
Figure 169: Porosimetry of preoxidized FAS media. Pore distribution centered at approximately 3.5 micron.

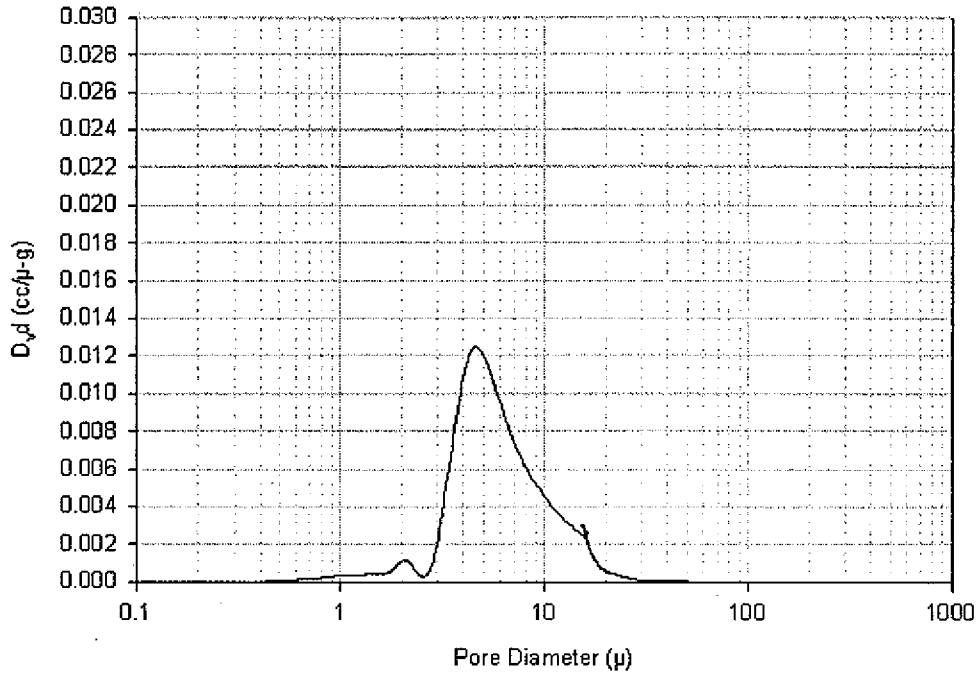
Figure 173: Porosimetry of as-sintered FAL media. Pore distribution centered at approximately 4.5 micron.

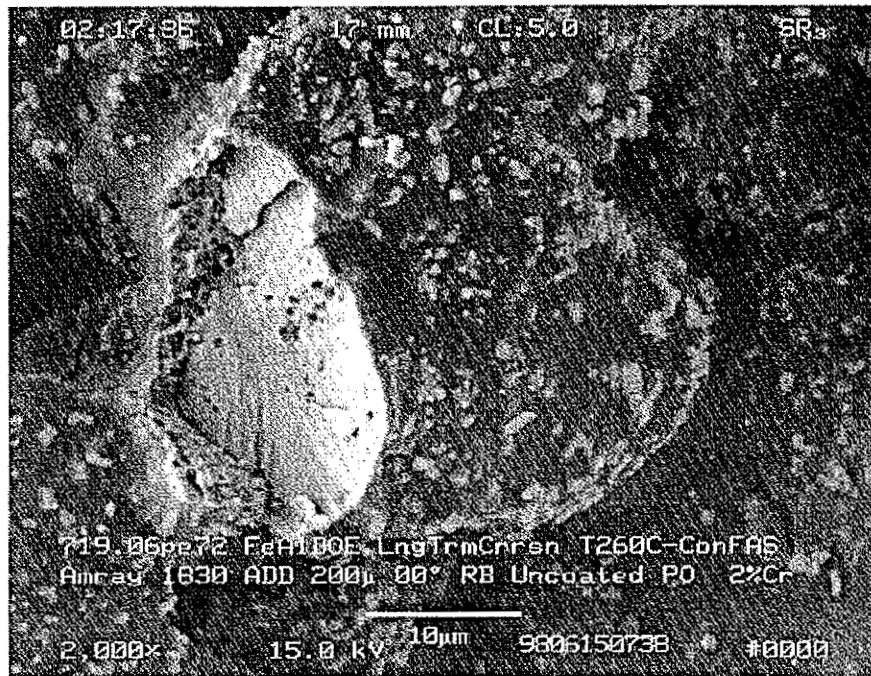
Figure 186: Fracture surface of FAS control sample. Preoxidized at 800°C. Brittle fracture of an iron aluminide sinter bond is shown. Sinter bond contains a small amount of porosity.

Figure 187: Full screen spectrum of Figure 186. Oxygen peak is from the formation of a continuous aluminum oxide layer.
