ANL-77-5

ARGONNE NATIONAL LABORATORY
9700 South Cass Avenue
Argonne, Illinois 60439

MATERIALS SCIENCE DIVISION
COAL TECHNOLOGY NINTH QUARTERLY REPORT,
OCTOBER—DECEMBER 1976

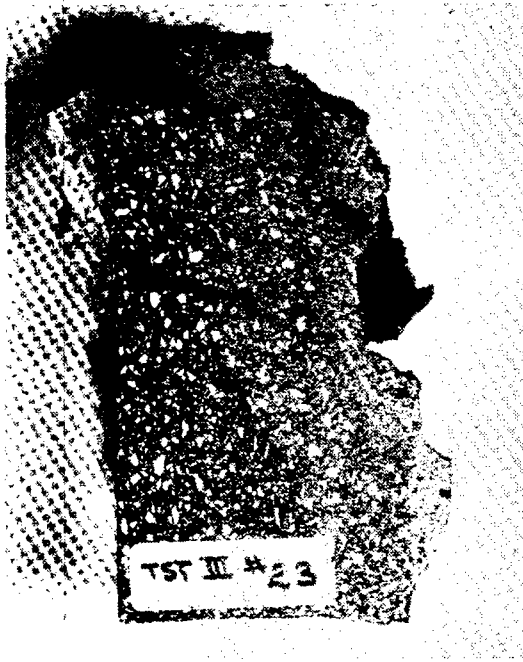
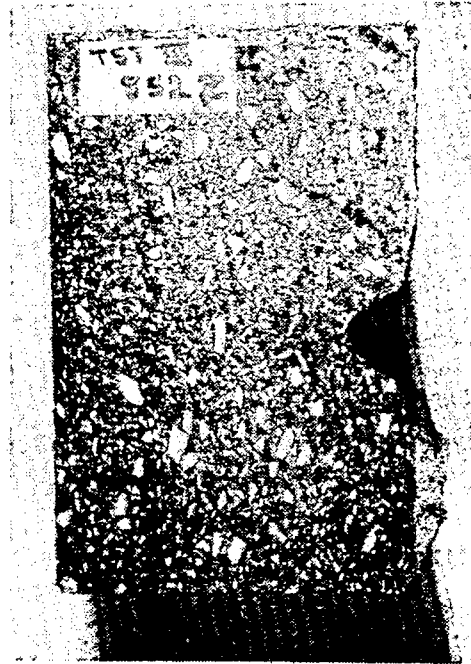
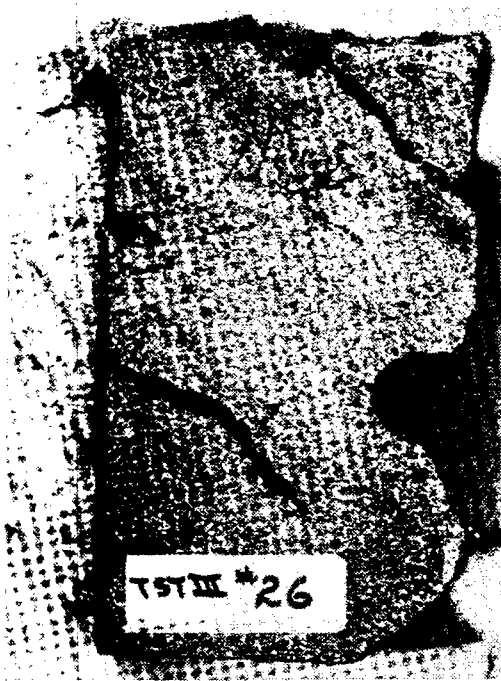
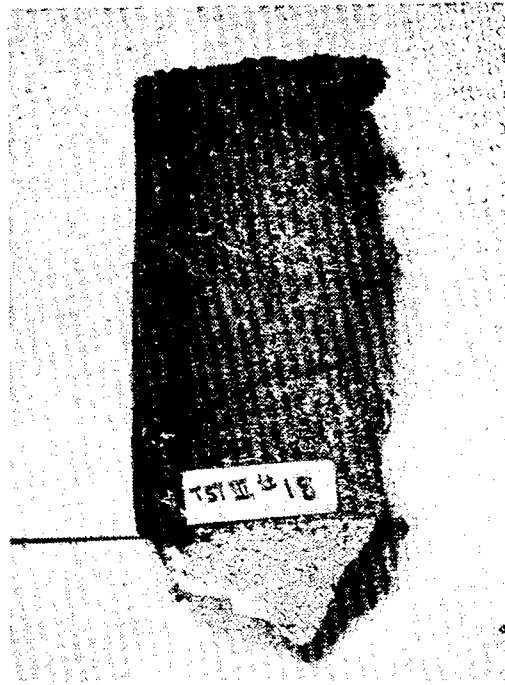
Fig. 2. Sintered $\text{Al}_2\text{O}_3\text{-Cr}_2\text{O}_3$ Bricks after Exposure to Slag. (a) 23, (b) 852, (c) 26, and (d) 18 (castable). Neg. No. MSD-63799.

Figures 1-4 show the 16 refractory bricks as they appeared after exposure to the slag. The bricks are identified in Table II, and their relative corrosion resistance is summarized.

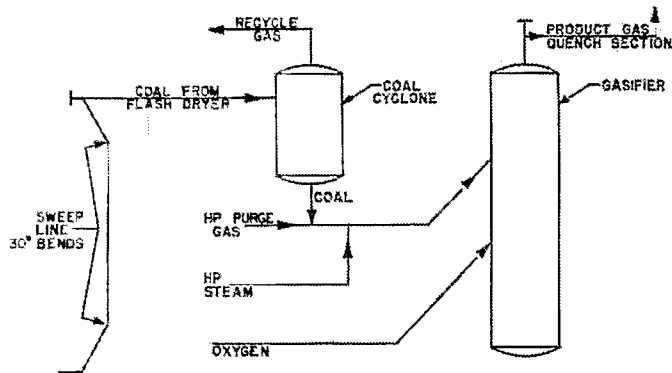
Fig. 5. Schematic Diagram of Bi-Gas Coal-conversion Process Showing Location of In-situ Erosion-measurement Systems. Neg. No. MSD-63393.

The field installations of the in-situ erosive-wear measurement system at the Bi-Gas coal-gasification facility were completed. Acoustic waveguides, described in a previous report,¹ were attached at three areas shown schematically in Fig. 5 as locations 2-4. All waveguides are attached to 250-mm A106B Schedule 120 carbon steel piping. The waveguides at location 1, which are not installed, will be on Type 316 stainless steel.

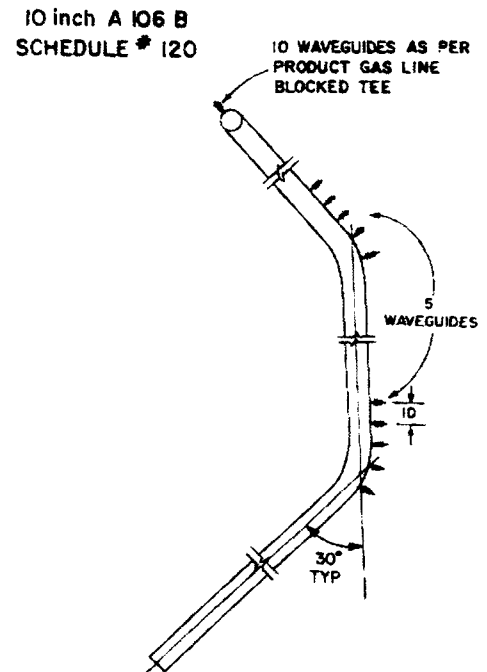
Fig. 9. Schematic Representation of Erosion-measurement Positions for Bi-Gas Coal-feed Transfer Line. Neg. No. MSD-62999.

installations completed except for transducer attachment. Numerical identification of the individual positions is indicated in Fig. 9. Table IV lists the measured base-line wall-thickness values for the sweep positions. No data were obtained at position 16 because the echo contained a significant noise level and the desired signal could not be discriminated.

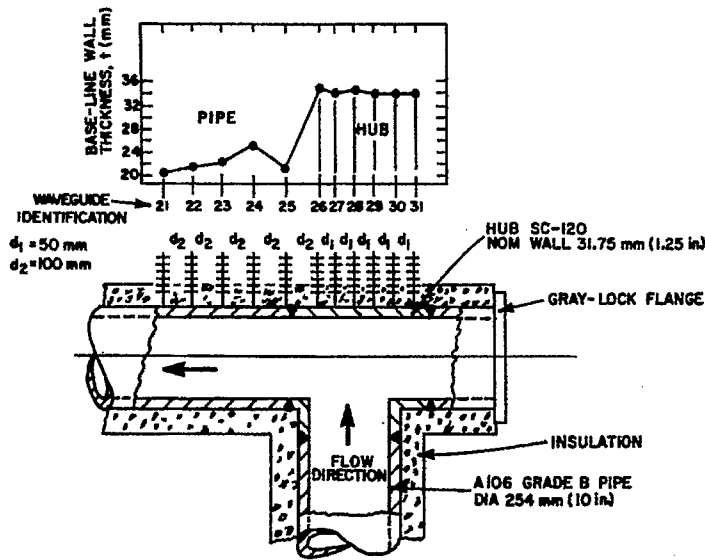
Fig. 10. Schematic Diagram Showing Monitoring Points on "Top Tee." Neg. No. MSD-63831.

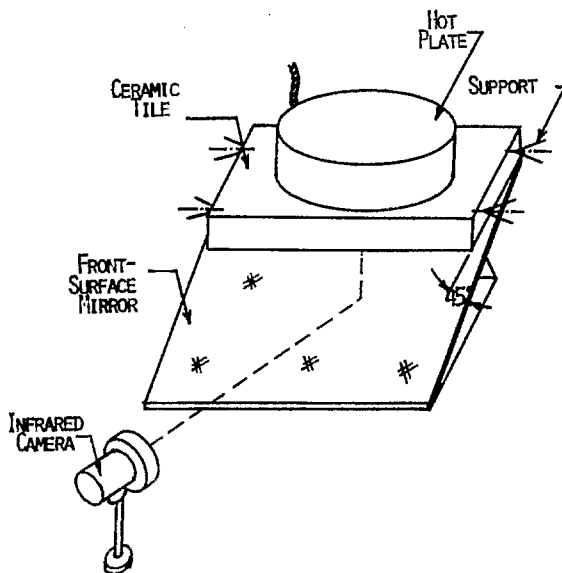
Fig. 13. Schematic of Laboratory Test Arrangement Used to Study Thermal Patterns of Defects. Neg. No. MSD-63830.

During this quarter, the study of using infrared images for quantitative prediction of defects in refractory linings was continued. In the present experiments, a GREENLITE 28 refractory tile* was arbitrarily chosen as the test sample; the setup is shown in Fig. 13. A hot plate was

used as the heat source. To minimize lateral heat dissipation in the sample, a nichrome wire was impregnated into a narrow groove cut around the front surface of the tile. Currents through the wire were adjusted to ensure an isothermal surface condition when the bottom of the tile was heated and the system reached steady state. To minimize reflection caused by the ambient irradiation, the front surface of the tile was painted black using 3M Nextel Velvet coating.

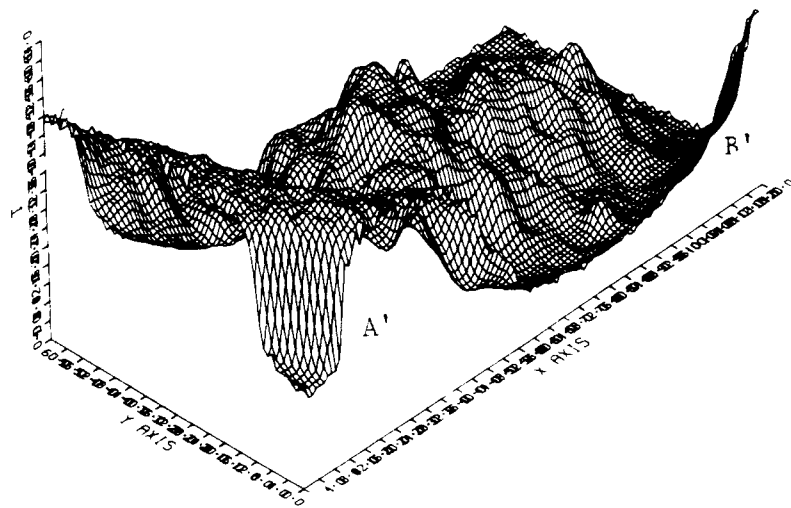
Fig. 15. Analog-to-digital Conversion of Thermal Pattern of Sample with Enlarged Cavity Defect. (a) Initial steady-state black and white image and (b) isometric display of resultant digitized image. Neg. Nos. MSD-63864-1 and MSD-63866.

As noted earlier, the first picture (Fig. 14) was used to establish ground-level energies. To study the net effect due to material defects, the data in Figs. 15 and 16 must be "cleaned" by subtracting out the ground-level energies. This operation also removes from the view field the misleading signals, which, in the present case, are caused by those hot spots that result from the nichrome heater. This cleaned data set is entered into the computer memory and used for analysis.

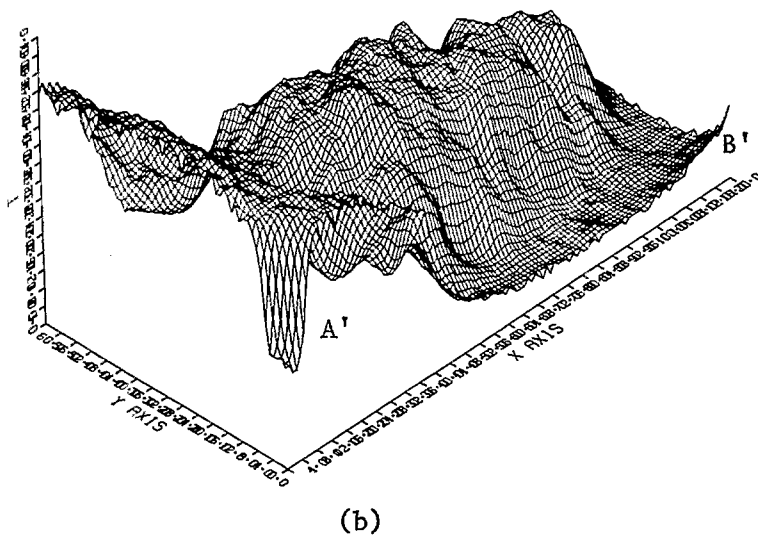
Fig. 16. Analog-to-digital Conversion of Thermal Pattern of Sample with Enlarged Cavity Defect. (a) Initial steady-state black and white image and (b) isometric display of resultant digitized image. Neg. Nos. MSD-63866-1 and MSD-63864.

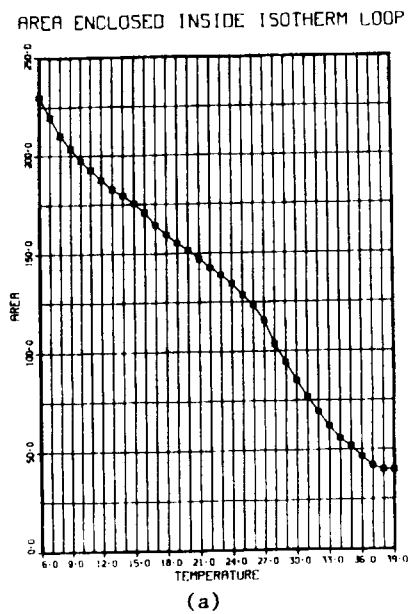
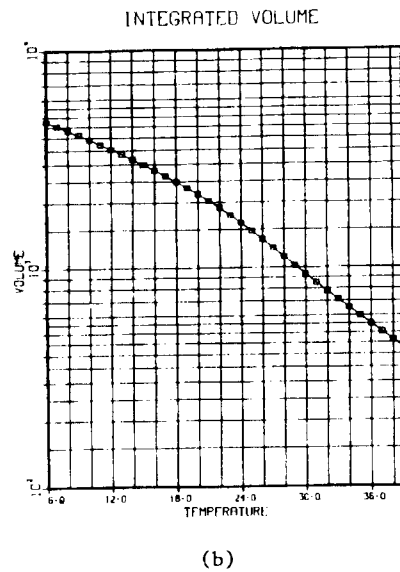
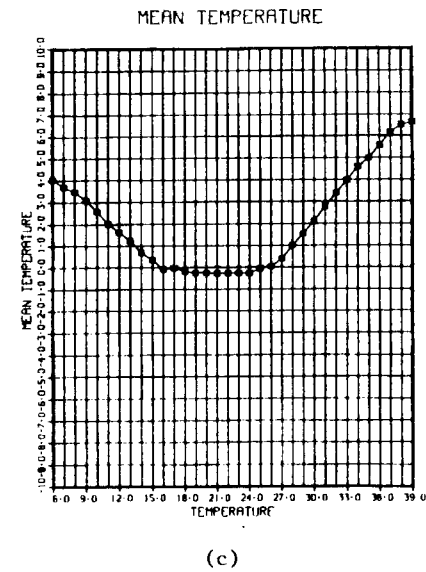
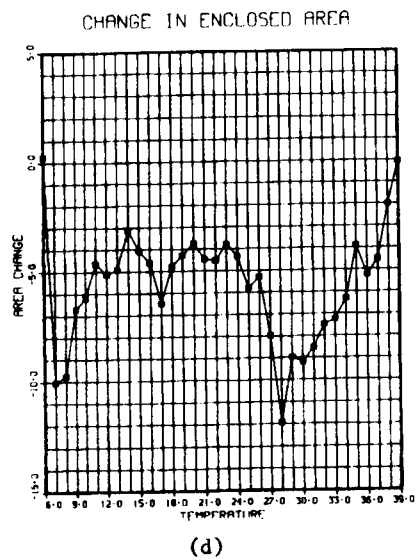
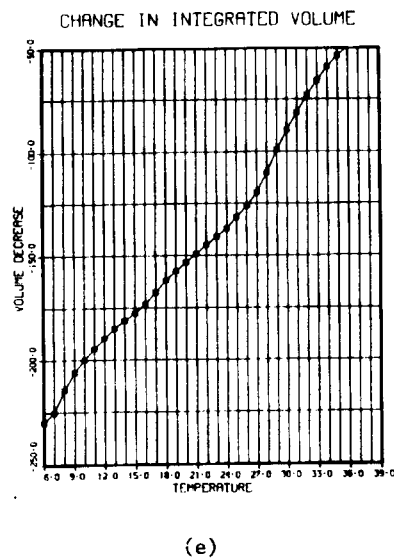
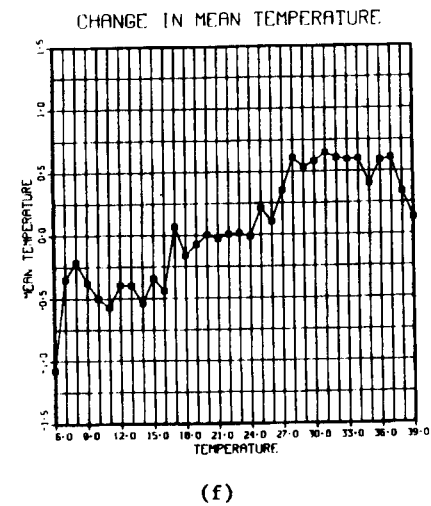
Fig. 17. Results Obtained from Fig. 15 for Selected Parameters Using Present System for Data Analysis (Cavity Defect). Neg. Nos. MSD-63905 through MSD-63910.

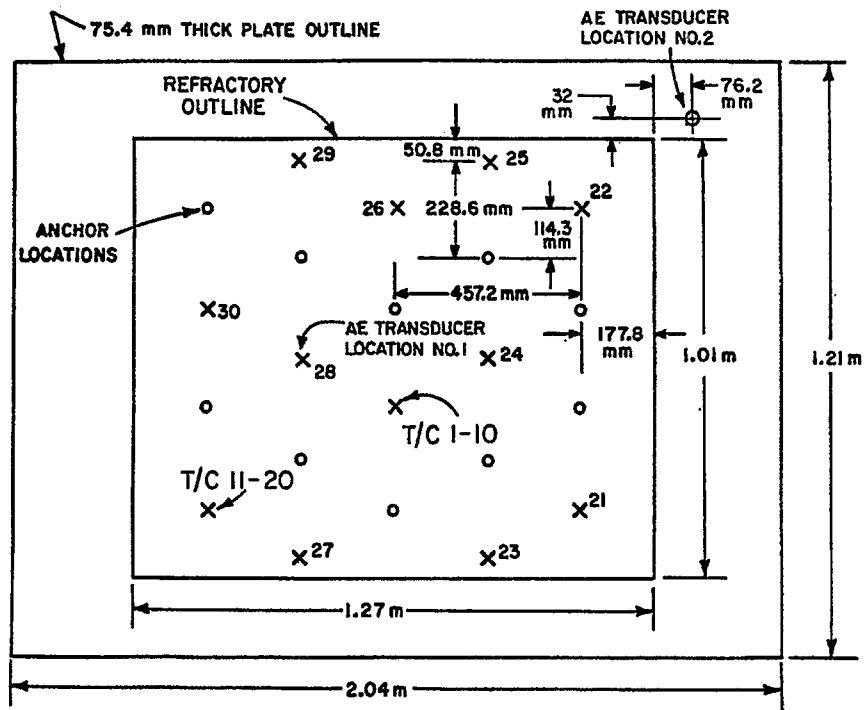
Fig. 19. Plan View of Full-scale Refractory Test Panel.
Neg. No. MSD-63823.

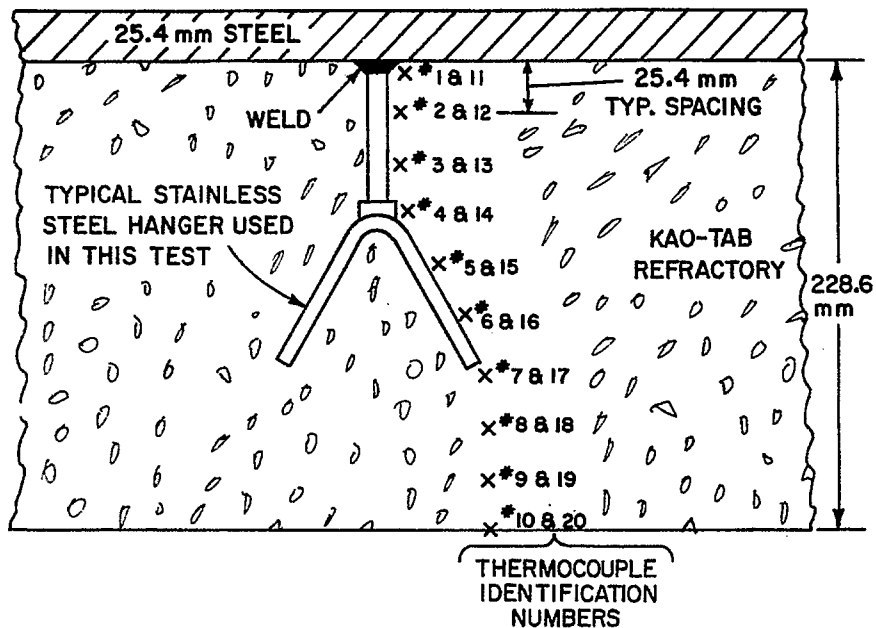
Fig. 20. Cross-section of Full-scale Refractory Test Panel
Showing Hanger and Throughwall Position of Thermocouples.
Neg. No. MSD-63826.

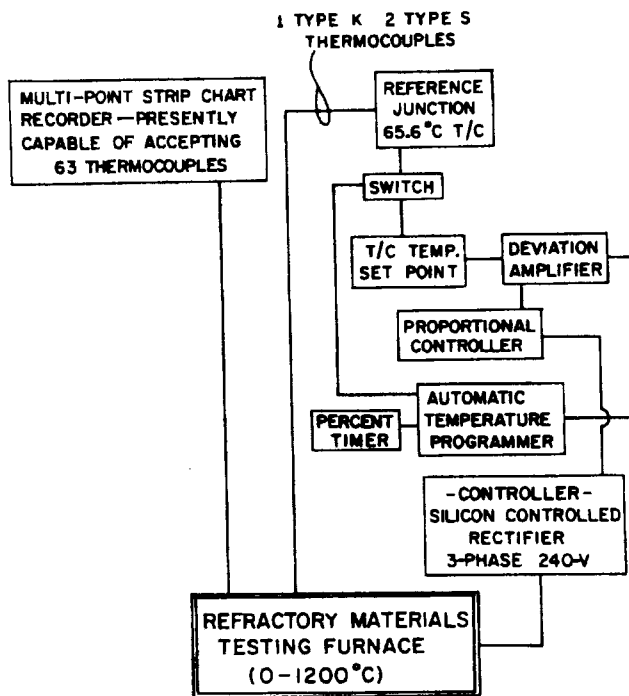
Fig. 21. Schematic of Automatic Control System for Thermal Curing of Full-scale Refractory Test Panels. Neg. No. MSD-63821.

The test-panel heat-up cycle was regulated by an automatic temperature controller system, shown schematically in Fig. 21.

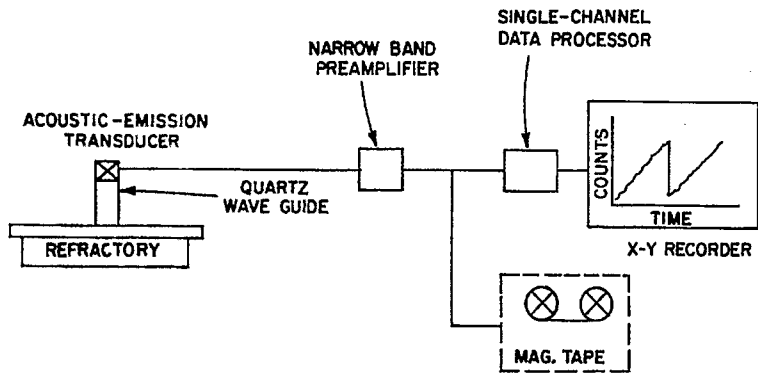
Fig. 22. Schematic of Acoustic-emission Data-acquisition System. Neg. No. MSD-63820.

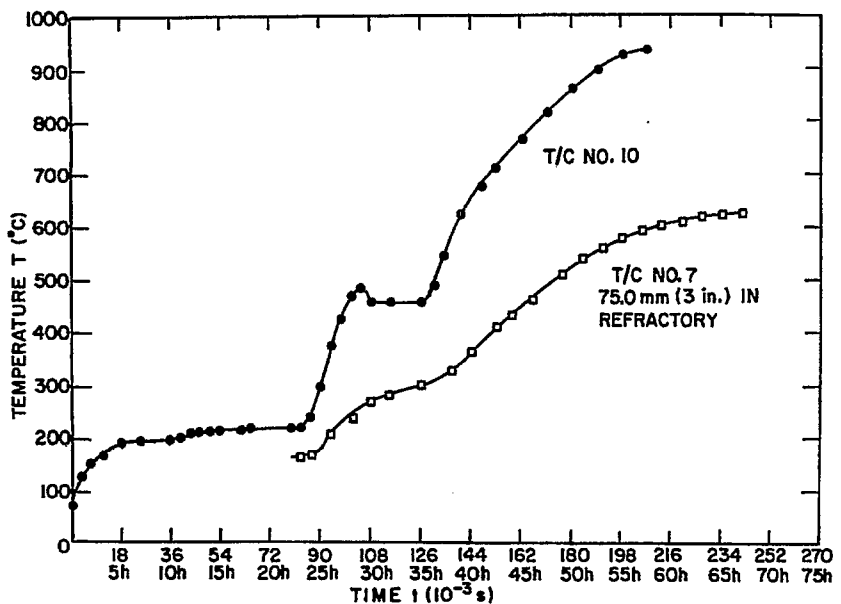
Fig. 23. Time-temperature Diagram for Thermocouple Positions 10 and 7 for Curing Cycle. Neg. No. MSD-63828.

- A. A 5.76×10^4 s hold between 190 and 220°C
- B. Heat up at 1.28×10^{-2} $^\circ\text{C/s}$ to 450°C
- C. Hold for 3.96×10^4 s at 450°C
- D. Heat up to 930°C at 1.75×10^{-2} $^\circ\text{C/s}$ for 1.08×10^4 s, 5.8×10^{-3} $^\circ\text{C/s}$ for 3.24×10^4 s, and 4.17×10^{-3} $^\circ\text{C/s}$ for 2.16×10^4 s
- E. Hold at 930°C for 5.04×10^4 s.

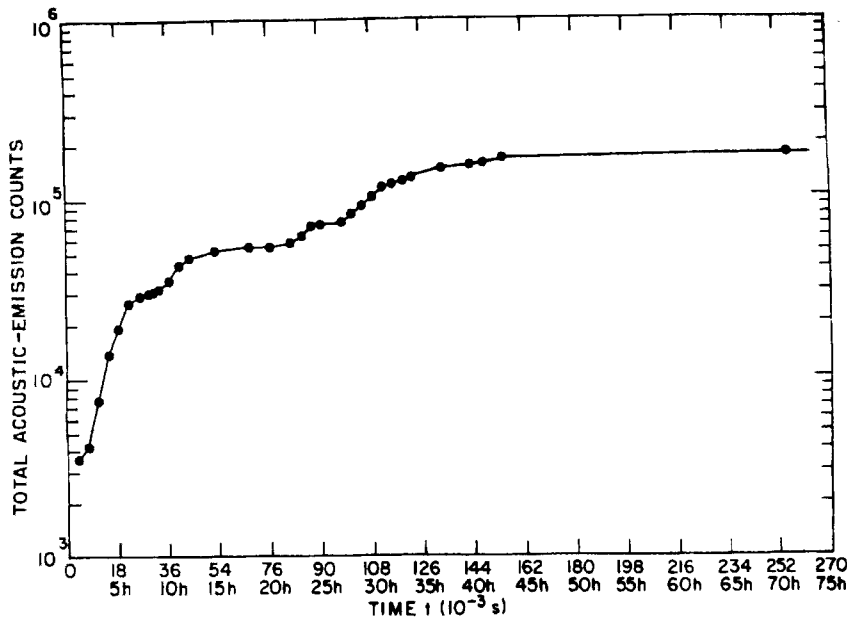
Fig. 24. Total Acoustic-emission Counts as a Function of Time for Acoustic Transducer Location 1. Neg. No. MSD-63833.

Similar results were obtained at acoustic-emission location 2, although the absolute value of the total count was somewhat less than at location 1. This experiment gives rise to the following question relative to the source

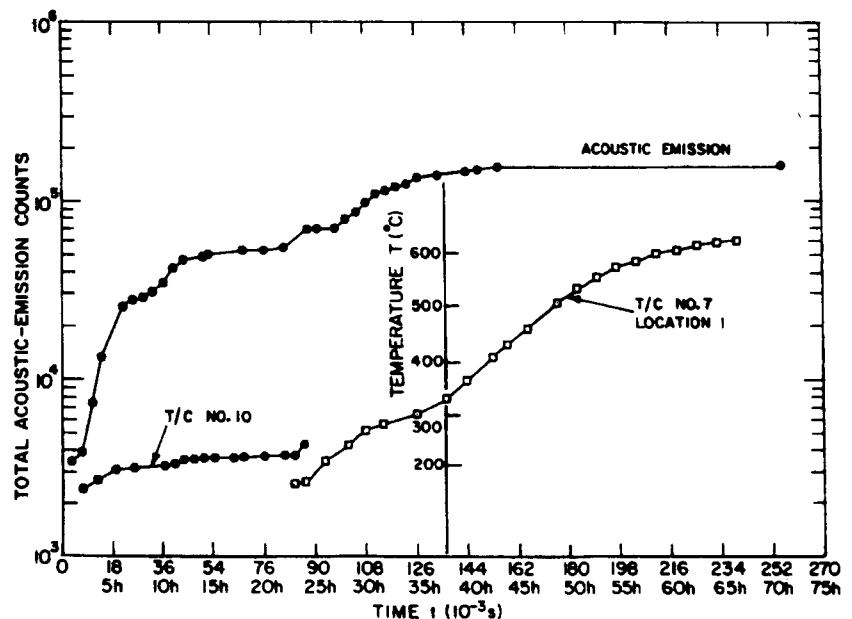
Fig. 25. Comparison of Time-Temperature Plot with Total Counts-Time Plot. Neg. No. MSD-63877.

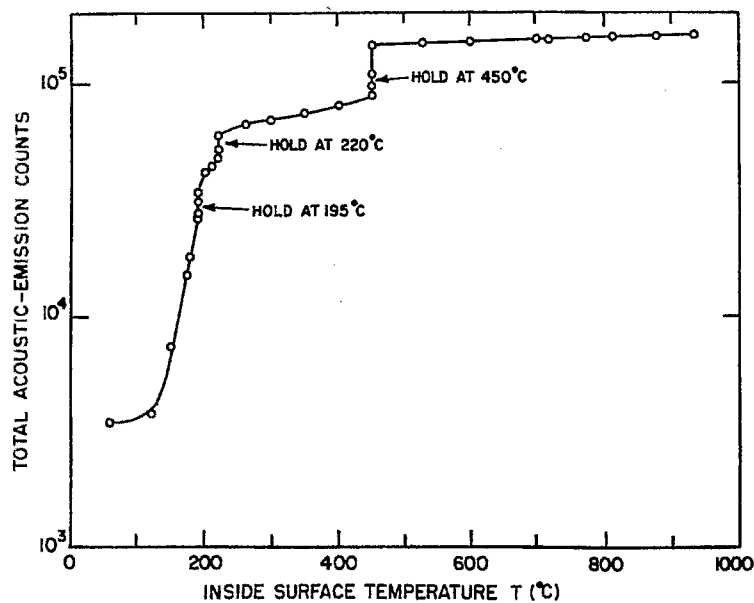
Fig. 26. Total Counts vs Temperature for Refractory Curing Cycle. Neg. No. MSD-63819.

of the emission: are the emissions caused by (a) expansion of the steel plate or (b) the difference in the thermal expansion between the refractory and steel (which results in rubbing)? In future work, if possible, a unique frequency window for the refractory cracking emissions will be determined. The present results are promising, however, and future curing will be at a much slower temperature rate to determine whether the cracking is less severe.

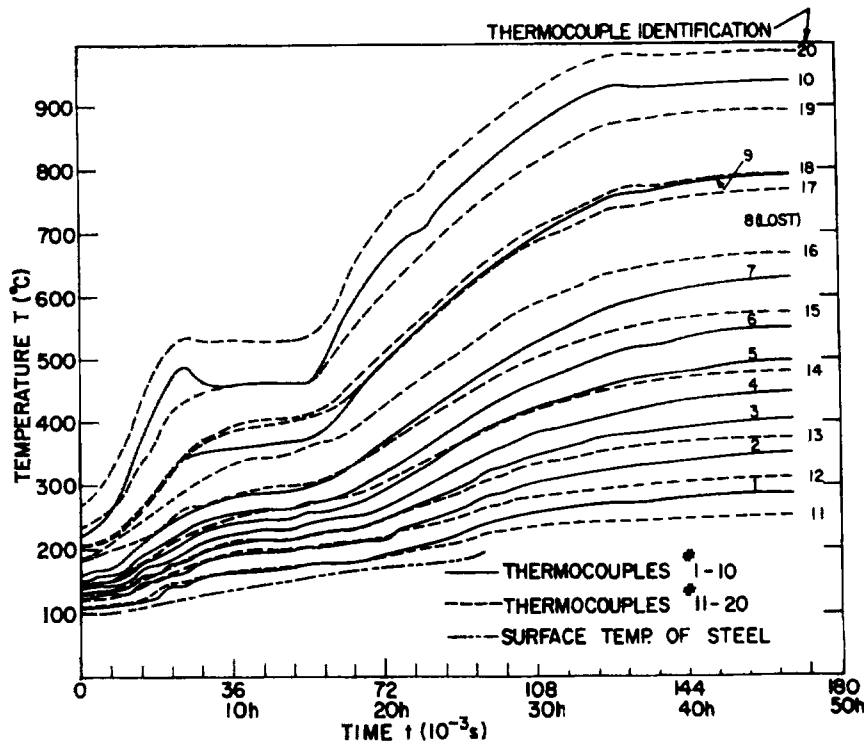
Fig. 27. Time-Temperature Plots for All Thermocouples at the Two Throughwall Locations. External surface temperature is also shown. Neg. No. MSD-63822.

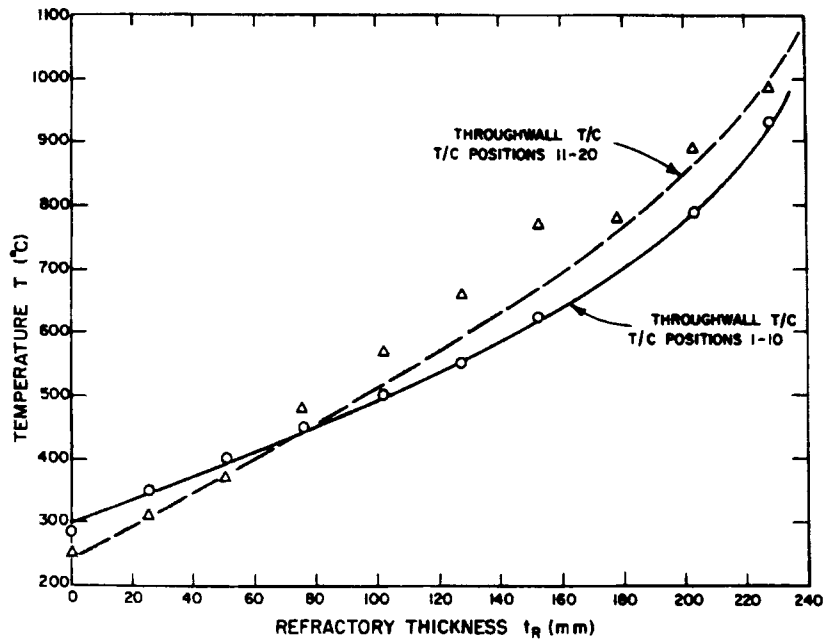
Fig. 28. Temperature Distribution through the Refractory Wall for Steady-state Conditions (930°C). Neg. No. MSD-63829.

The slope of the first 180 mm is $\sim 2.05^\circ\text{C}/\text{mm}$. The slope of the second portion is $\sim 4.8^\circ\text{C}/\text{mm}$. This difference is perhaps attributable to the fact that the monolithic refractory layer was actually cast as a two-component liner. The first 178 mm were poured with KAOTAB, which has a thermal conductivity of $51.7 \text{ W}/(\text{m}^2 - ^\circ\text{K})$, and the top 50 mm were poured with KAOTUFF, which has a thermal conductivity of $42.6 \text{ W}/(\text{m}^2 - ^\circ\text{K})$.

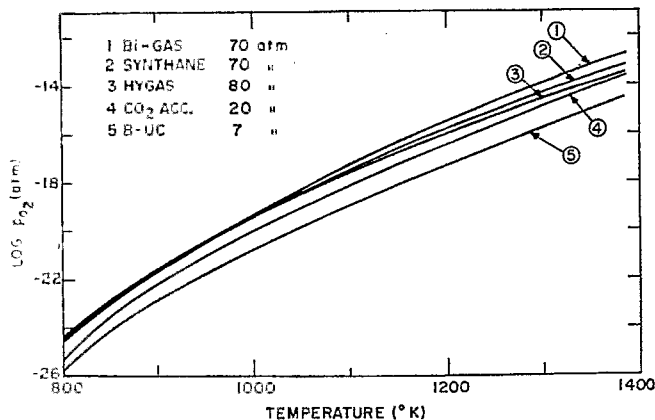
Fig. 29. Variation of Oxygen Partial Pressure as a Function of Temperature Calculated for Different Coal-gasification Processes. Conversion factor: 1 atm = 0.101356 MPa. Neg. No. ANL-306-76-179.

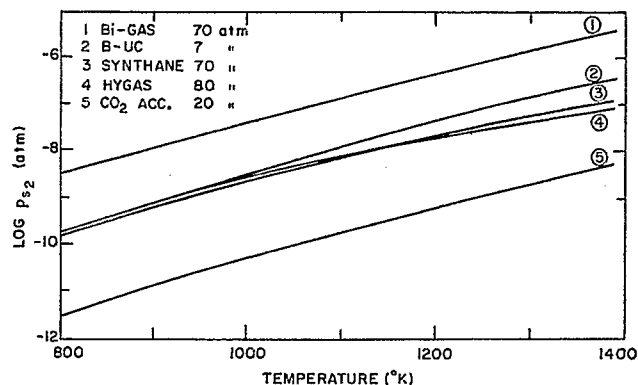
Fig. 30. Variation of Sulfur Partial Pressure as a Function of Temperature Calculated for Different Coal-gasification Processes. Conversion factor: 1 atm = 0.101356 MPa. Neg. No. ANL-306-76-180.

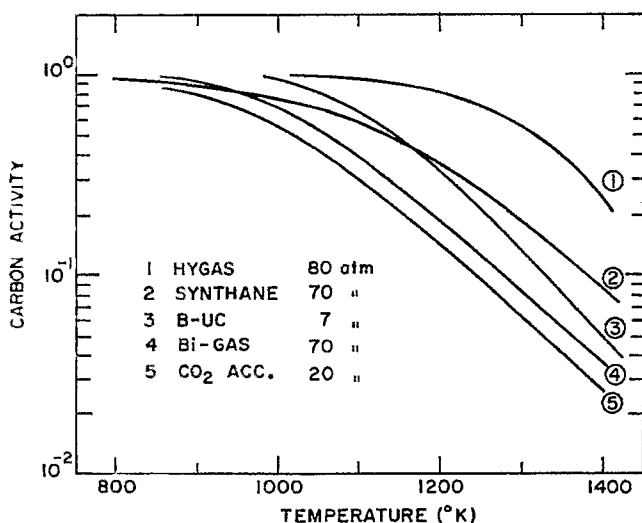
Fig. 31. Variation of Carbon Activity as a Function of Temperature Calculated for Different Coal-gasification Processes. Conversion factor: 1 atm = 0.101356 MPa. Neg. No. ANL-306-76-181.

processes are factors of ~ 30 higher and lower, respectively. Figure 31 shows the calculated values for the carbon activity as a function of temperature for the five processes. The results indicate that in all the processes, the carbon activity values increase rapidly as the temperature decreases from 1400 to 1000 K. To lend perspective to this diagram, one can consider Type 304 stainless steel, which, upon exposure to the CO_2 -Acceptor process environment, will undergo negligible carburization at 1400 K but will carburize to ~ 1.5 wt% carbon at 1100 K, on the basis of the available carbon activity-concentration

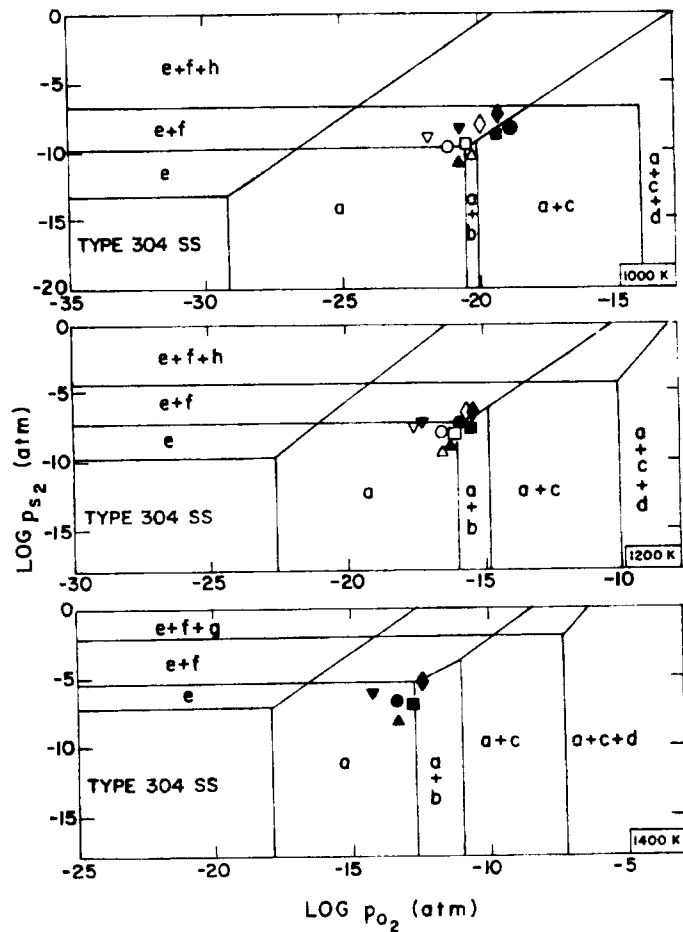
Fig. 32. Oxygen-Sulfur Thermochemical Diagram for Type 304 Stainless Steel at 1000, 1200, and 1400 K. The gas environments calculated for the pilot-plant processes are indicated by different symbols. Neg. No. ANL-306-76-183.

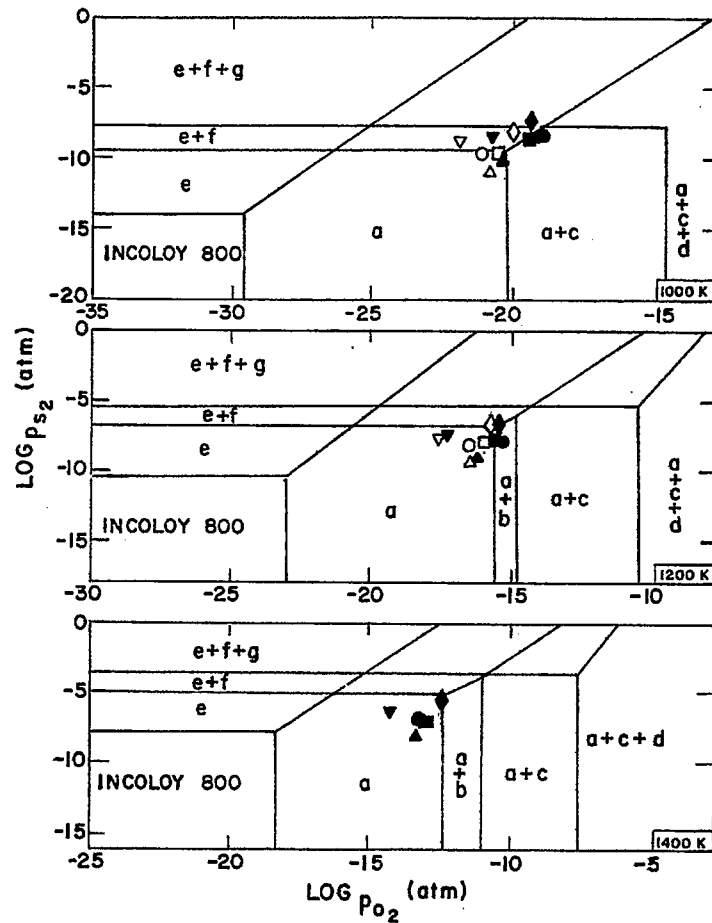
Fig. 33. Oxygen-Sulfur Thermochemical Diagram for Incoloy 800 at 1000, 1200, and 1400 K. The gas environments calculated for the pilot-plant processes are indicated by different symbols. Neg. No. ANL-306-76-182.

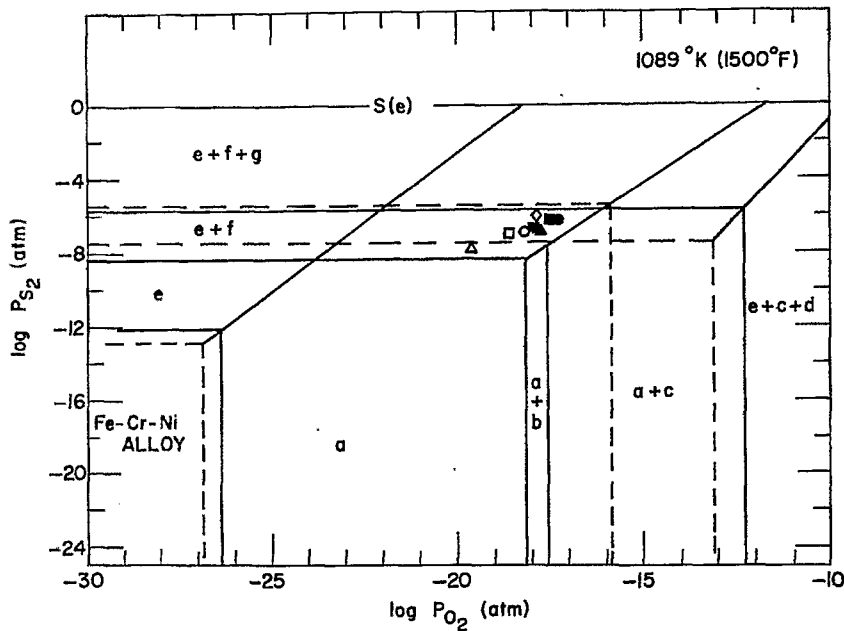
Fig. 35. Thermodynamic Stability of Different Phases in U. S. Steel Alloy (Fe-18.5 wt% Cr-18 wt% Ni) and Inconel 671 (50 wt% Ni-48 wt% Cr-2 wt% Fe) at 1089 K (1500°F). The gas environments proposed in the experimental program are indicated by open (10% CH₄) and closed (30% CH₄) symbols. Neg. No. MSD-63757.

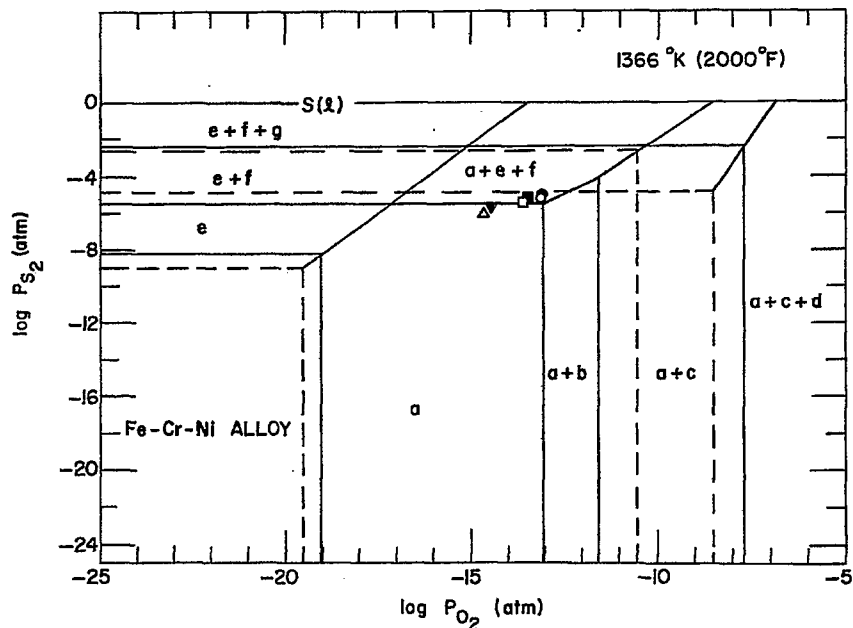
Fig. 36. Thermodynamic Stability of Different Phases in U. S. Steel Alloy (Fe-18.5 wt% Cr-18 wt% Ni) and Inconel 671 (50 wt% Ni-48 wt% Cr-2 wt% Fe) at 1366 K (2000°F). The gas environments proposed in the experimental program are indicated by open (10% CH₄) and closed (30% CH₄) symbols. Neg. No. MSD-63758.

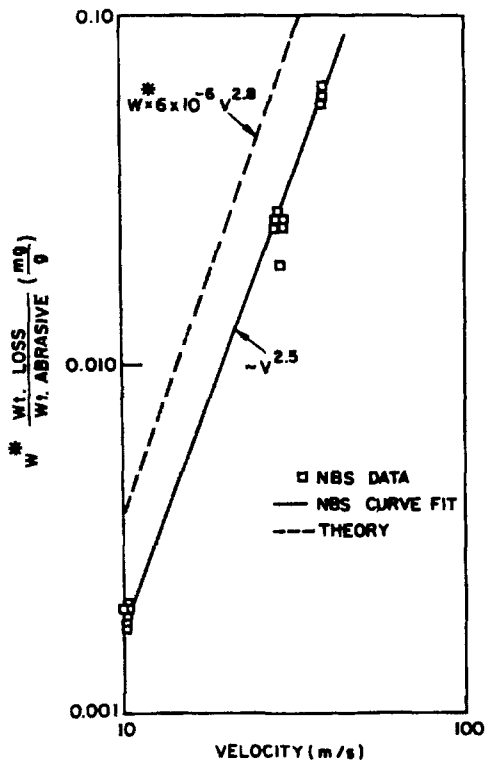
Fig. 45. Erosive Wear as a Function of Velocity for Type 310 Stainless Steel. Neg. No. MSD-63815.

A more direct comparison of the theory¹⁵ with experiment is possible using data generated by the National Bureau of Standards (NBS).³⁰ Their experiments were conducted with 90° impingement angles and at the lower speeds characteristic of coal-gasification systems. The NBS studies on a number of alloys indicate that at room temperature erosion is proportional to velocity in the range of $V^{2.5}$ to V^3 , which is in agreement with the velocity dependence predicted by the theory. Experimental data³⁰ on erosive wear of Type 310 stainless steel at room temperature by 150- μ m (100 mesh) SiC particles are shown in Fig. 45 along with the corresponding theoretical curve obtained from

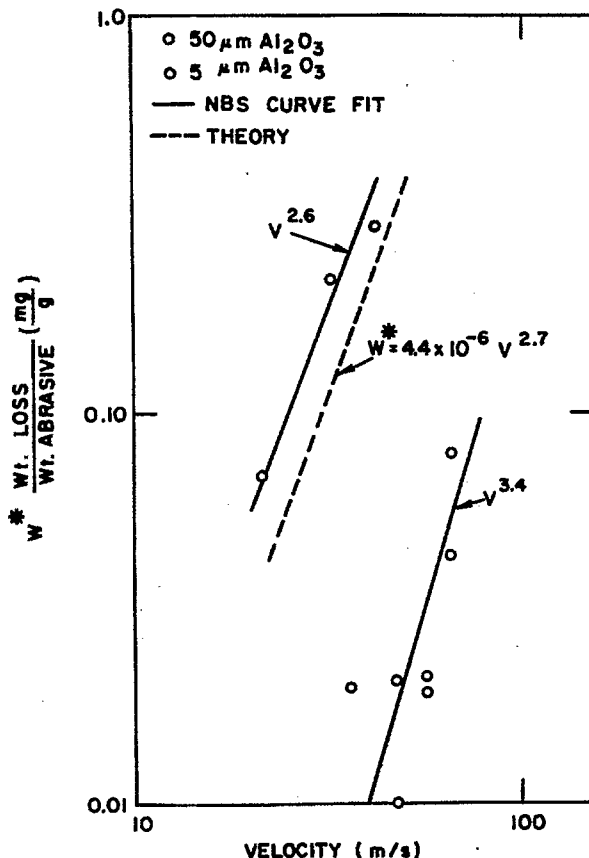
Fig. 46. Erosive Wear as a Function of Velocity for Type 304 Stainless Steel. Neg. No. MSD-63814.

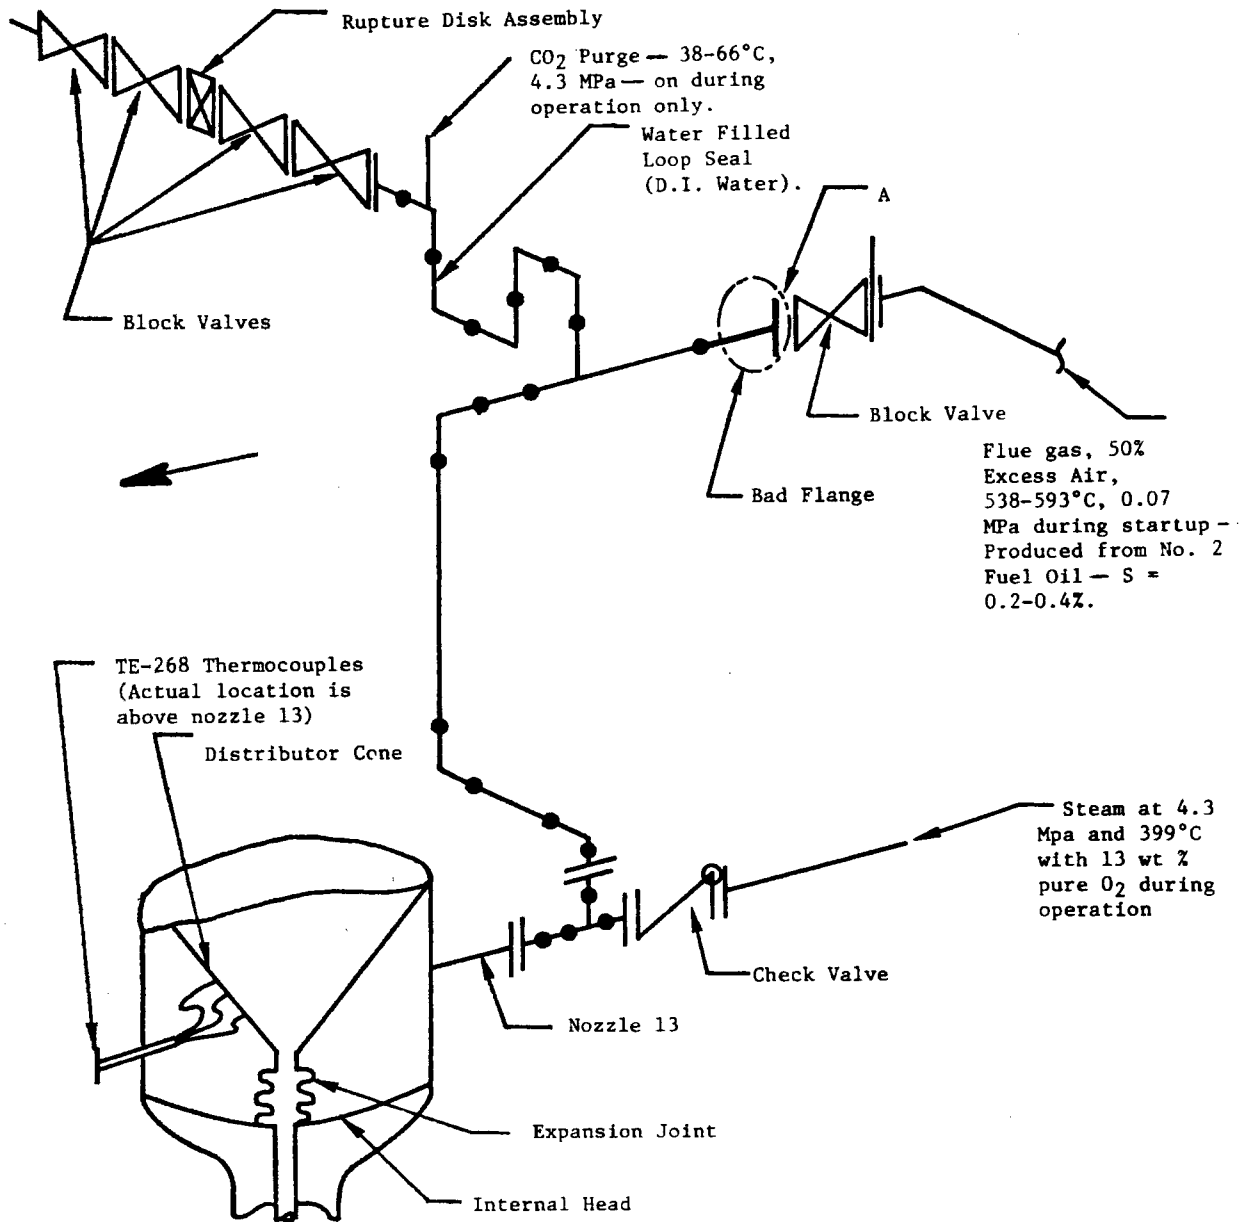
Fig. 47. Isometric Drawing of the Preheat Line. The cracked flange "A" is shown at the top center. The distributor cone is shown at the lower left. Butt welds are indicated by dots. Neg. No. MSD-63862.

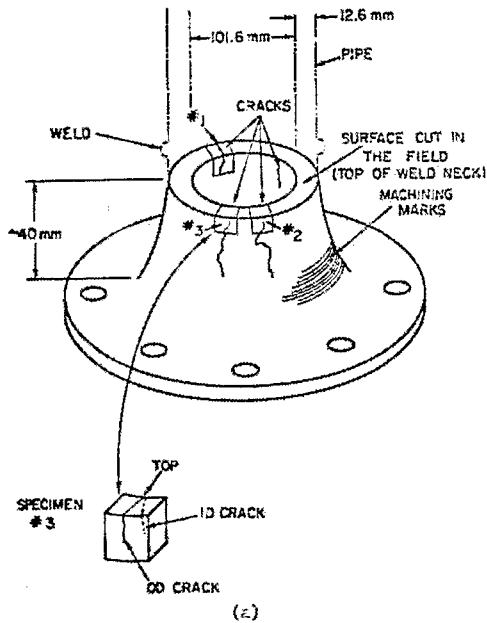
Fig. 48. Isometric Drawing and Photograph of the Weld-neck Flange. The three cracks examined are indicated. Neg. No. MSD-63861.

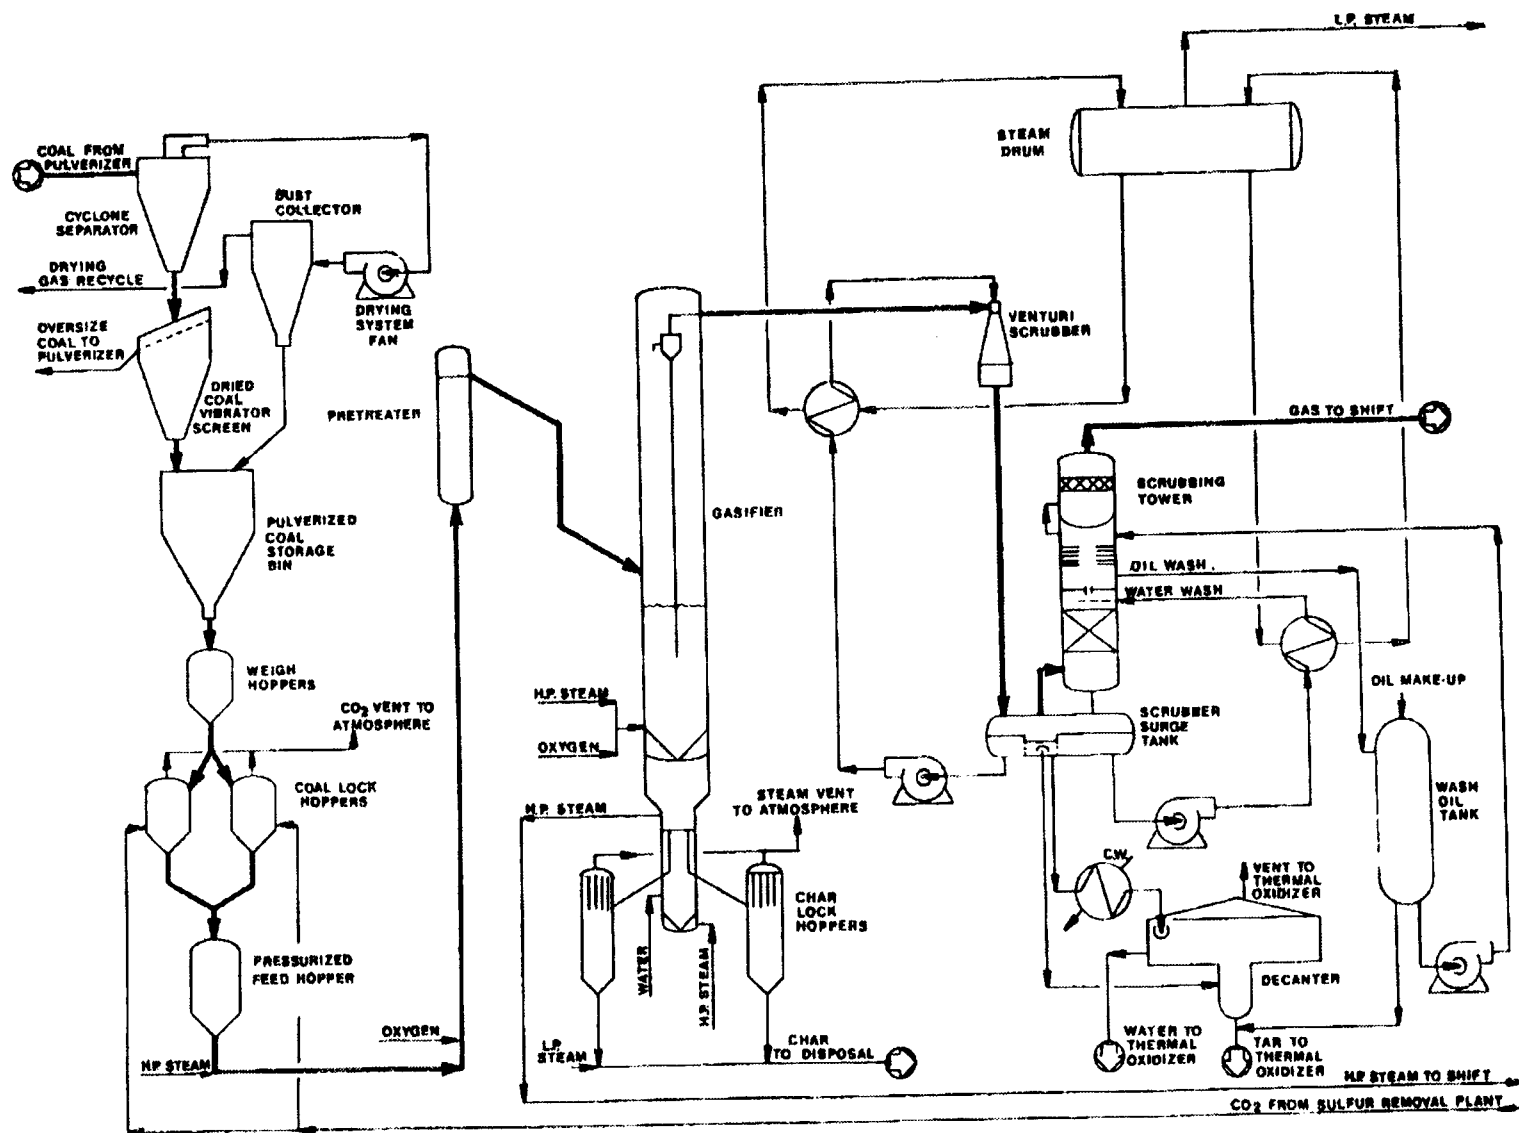
Fig. 49. Synthane Coal-gasification Pilot-plant Process. Neg. No. MSD-63863.

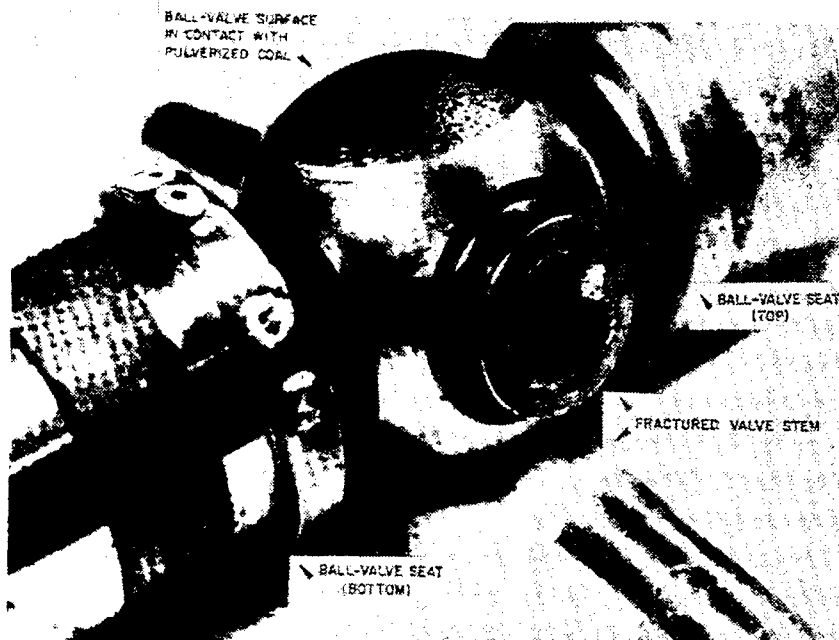
Fig. 50. Ball Valve, Fractured Valve Stem, and Top and Bottom Ball-valve Seats. Neg. No. MSD-63859.

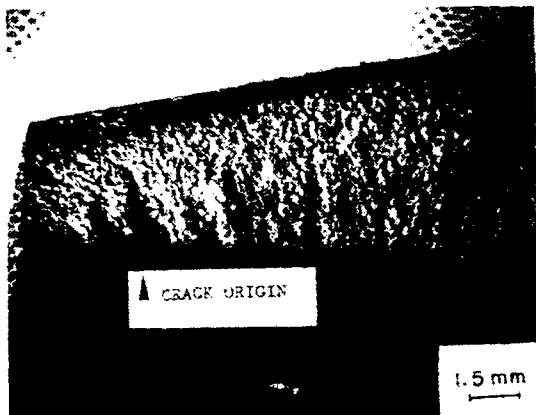
Fig. 51. Photograph and Schematic of Fracture Surface of Gate-valve Guide. Neg. No. MSD-63860.
