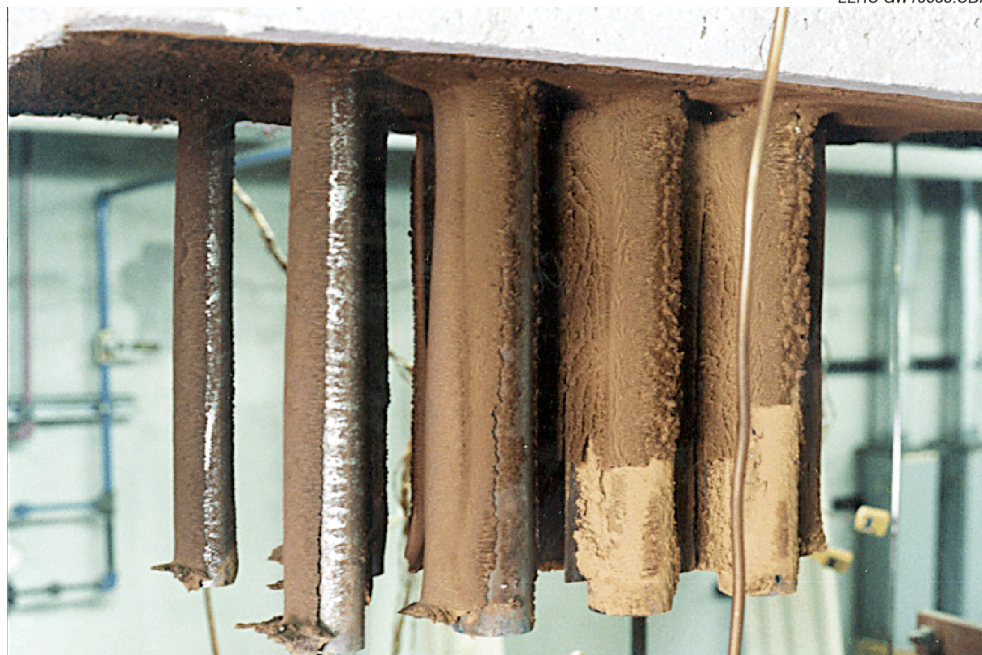
Figure 3-27. Photograph of ash deposits on the CAH tubes following the January test firing Illinois No. 6 bituminous coal.

removed intact from the tube surfaces. The total weight of the deposits collected from the CAH tubes and duct was 14 lb (6.4 kg). The total weight of the deposits collected from the CAH tubes was 4 lb (1.8 kg). On a mass per unit time basis, the ash deposition rate for this Illinois No. 6 coal-fired test would be 0.07 lb/hr (30.3 g/hr) of coal firing. Incorporating the surface area of the tube bank (6.28 ft² or 0.58 m²) results in a value of 0.01 lb/hr-ft² (52.2 g/hr-m²). On a coal-firing-rate basis, the CAH ash deposition rate would be 0.03 lb/MMBtu (13.3 g/10⁶ kJ). These calculated values are comparable to previous Illinois No. 6 tests.

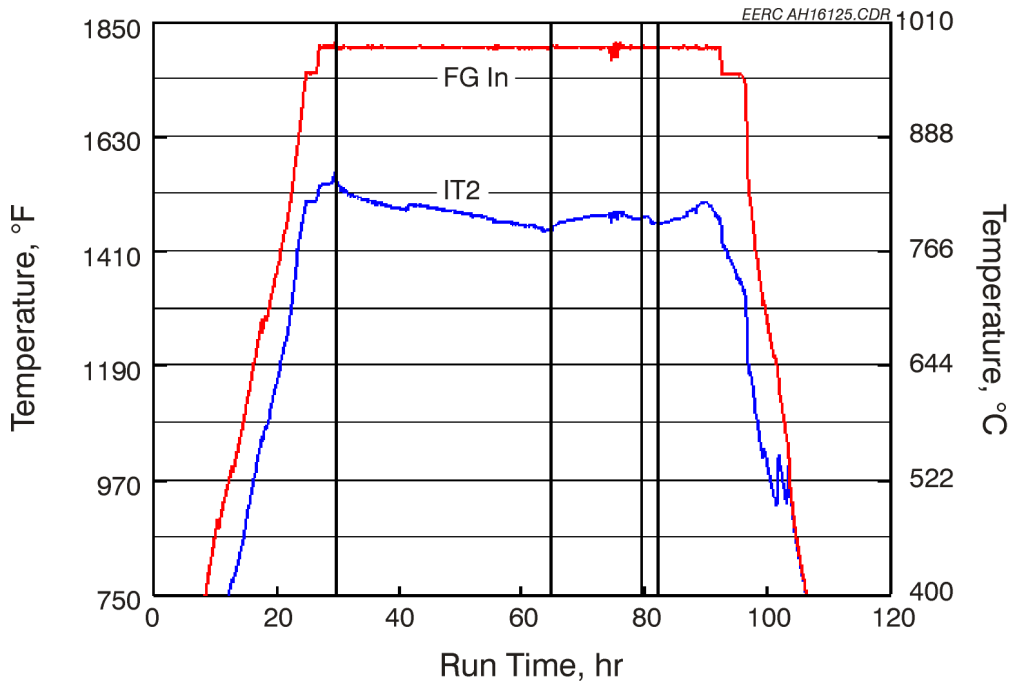
Figure 3-28. CAH tube surface and flue gas temperatures versus run time for the February test, SFS-RH7-0299.

Figures 3-28 through 3-30 summarize CAH tube bank surface and flue gas temperatures, process air temperatures, and process air flow rate data for the February test (SFS-RH7-0299). While natural gas was fired and the tubes were clean, heat recovery from the CAH tube bank was roughly 44,474 Btu/hr (46,921 kJ/hr). This result was observed for the following conditions:

When coal firing (Kentucky) began, surface temperatures initially decreased at a rate of nominally 5°F/hr (3°C/hr) over nearly 12 hours as ash deposits developed on the surface of the tubes. After nearly 40 hours of coal firing, there was no further decrease in tube surface temperature. It must be noted that process air flow rates were also decreasing (0.01 scfm/0.0003 m³/min) over these time frames in an attempt to maintain a relatively constant process air exit temperature. The minimum process air flow rate through the CAH tube bank was 104 scfm (2.9 m³/min). As ash deposits developed on the tube surfaces, heat recovery from the CAH tube bank decreased from roughly 46,500 Btu/hr (49,058 kJ/hr) to 27,000 Btu/hr (28,485 kJ/hr). The coal feed was terminated at this time because of the plugging problems in the slag screen. When coal feed resumed, heat recovery from the CAH tube bank was nominally 30,000 Btu/hr (31,650 kJ/hr). Heat recovery decreased to nominally 29,000 Btu/hr (30,595 kJ/hr) over the final 2.5 hours of coal firing prior to the termination of the coal feed. These data indicate that heat recovery from the CAH tube bank when the Kentucky bituminous coal was fired is significantly greater as compared to the Illinois No. 6 coal data. This result is most likely due to the smaller quantity of ash in the Kentucky fuel and the differences in ash properties.

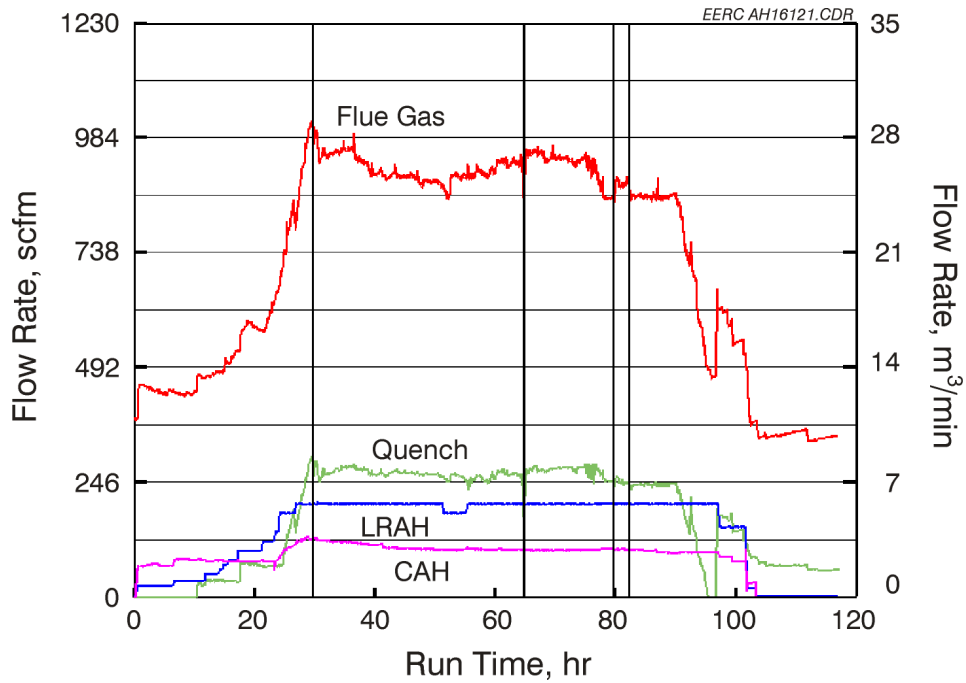
Figure 3-30. CAH process air, RAH process air, quench gas, and flue gas flow rates versus run time for the February test, SFS-RH7-0299.

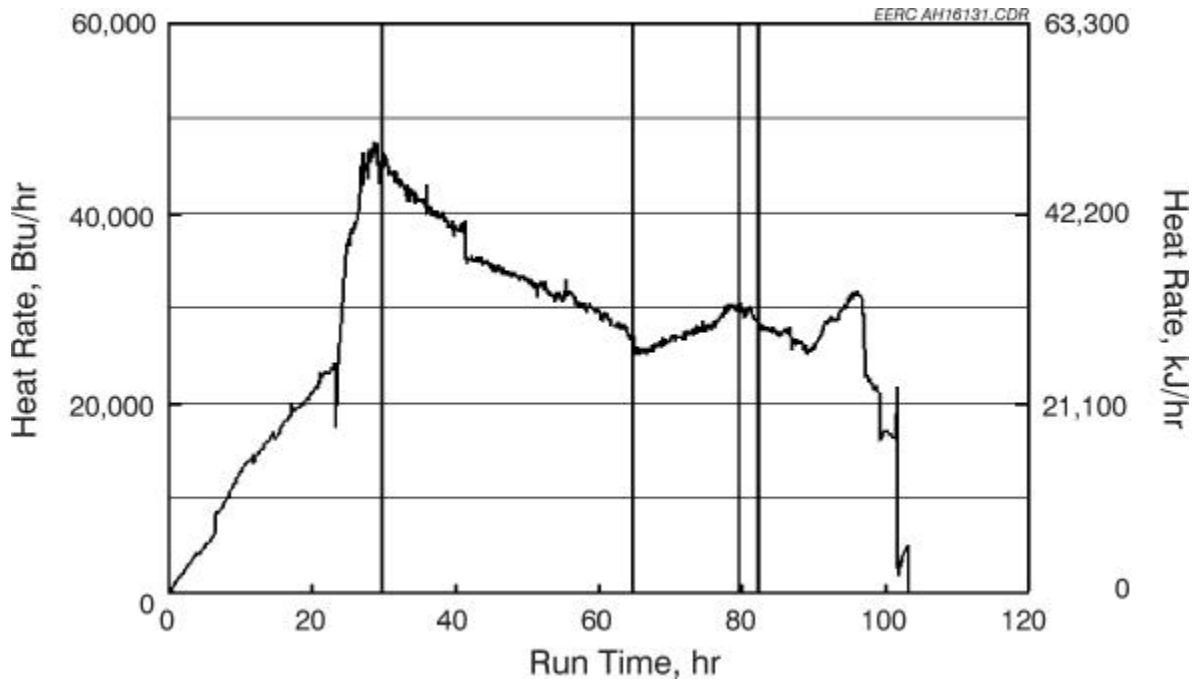
Figure 3-31. CAH heat recovery versus run time for the February test, SFS-RH7-0299.

Figure 3-31 presents heat recovery in the CAH as a function of run time for the February test.

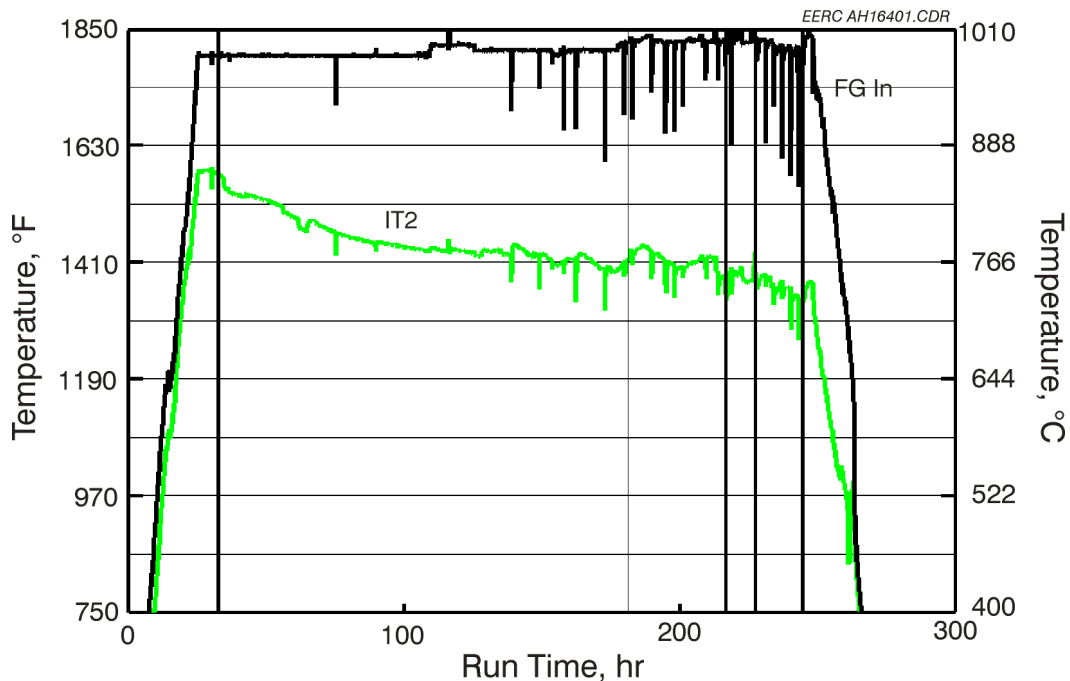
Figure 3-33. CAH tube surface and flue gas temperatures versus run time for the April test, SFS-RH8-0399.

Figures 3-33 through 3-35 summarize CAH tube bank surface and flue gas temperatures, process air temperatures, and process air flow rate data for the April test (SFS-RH8-0399). While natural gas was fired and the tubes were clean, heat recovery from the CAH tube bank was roughly 40,000 Btu/hr (42,200 kJ/hr). This result was observed for the following conditions:

When coal firing (eastern Kentucky) began, surface temperatures initially decreased at a rate of nominally 5°F/hr (3°C/hr) over nearly 10 hours as ash deposits developed on the surface of the tubes. After 40 hours of coal firing, the rate of decrease was 0.7°F/hr (0.4°C/hr). No

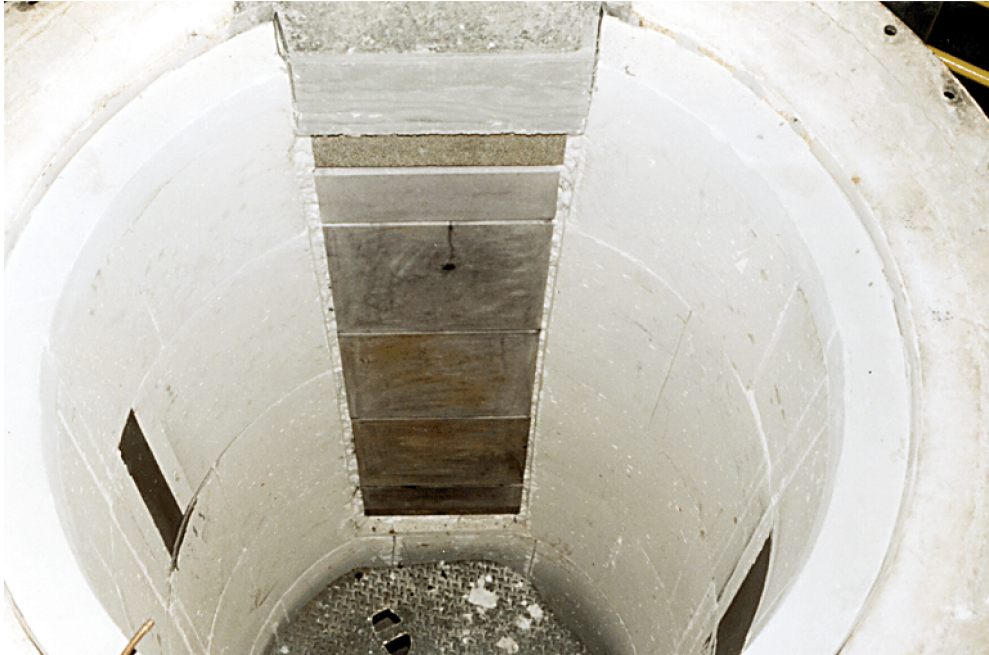
Figure 3-38. Photograph of new ceramic tiles installed on the RAH panel inside of the slagging furnace in January 1999.

The RAH panel ceramic tiles were thoroughly inspected upon initial installation and following each week of operation. The initial inspection revealed the presence of minor cracks in two of the five ceramic tiles. Cracks were not visible in either of the top or bottom support blocks. Figure 3-38 is a photograph of the new ceramic tiles installed on the RAH panel inside of the slagging furnace prior to the January 1999 test. The cracks visible at the time were hairline cracks in the large upper and lower tiles. The large upper tile had five visible cracks originating from the left edge and one crack originating from the top edge. Cracks originating from the left edge were about 0.75 in. (1.9 cm) in length and are not visible in the photograph. The vertical crack is visible in the photograph as a result of the application of a blue die. In addition, rough surface pitting of the tile is evident at the end of the vertical crack in the upper center of the tile. The large lower tile had one crack originating on the left edge and a few rough surface pits along the right edge near the middle of the tile. Neither the crack nor the surface pits in the large lower tile are visible in the photograph.

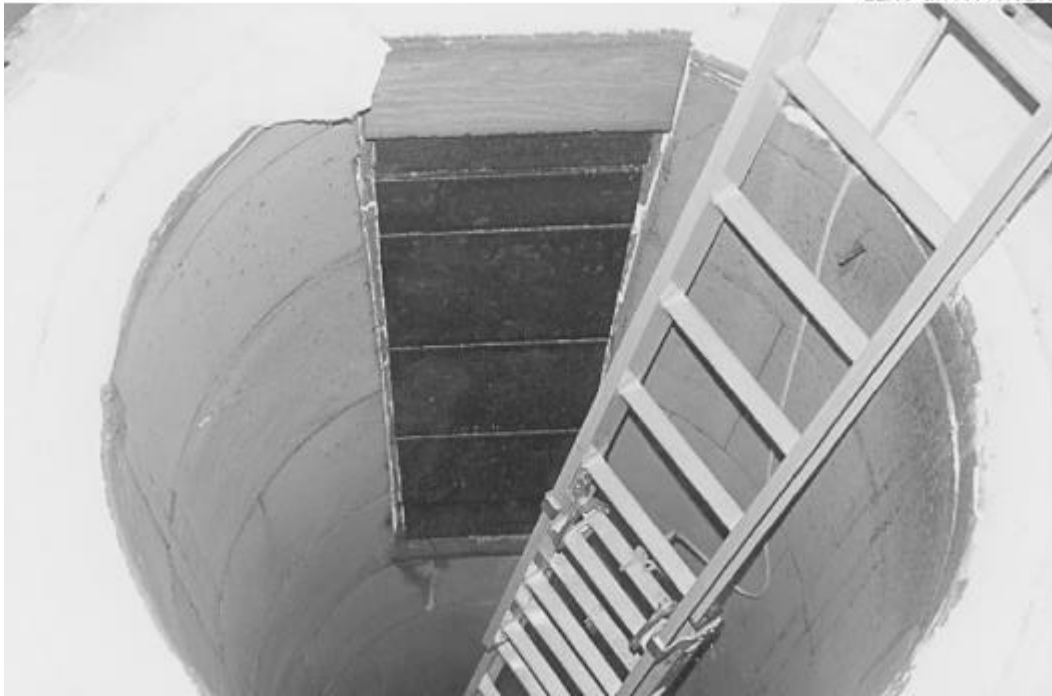
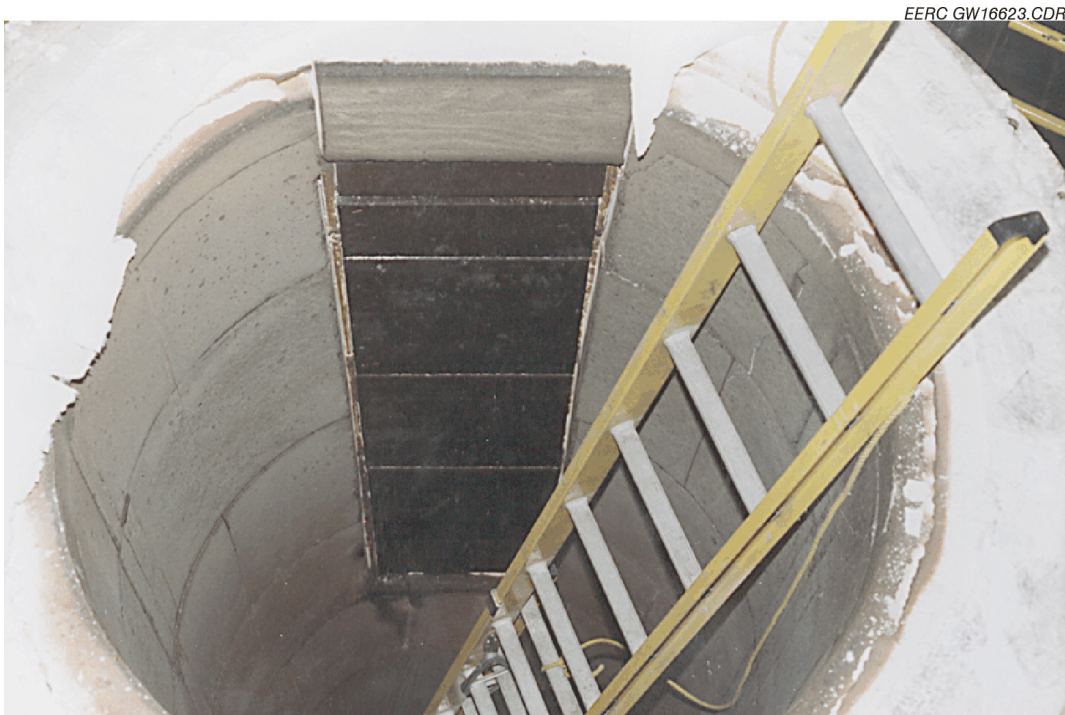
Figure 3-39. Photographs of the RAH panel inside of the slagging furnace following the January (top) and February (bottom) tests.

Figure 3-39 presents photographs of the furnace interior after the January (top) and February (bottom) tests. Both photographs illustrate the excellent condition of the high-density furnace refractory as well as the darkening of the refractory with exposure to slag as a result of coal firing. Exposure of the RAH ceramic tiles to slag during coal firing in January darkened the

tiles as a result of the residual slag layer on the surface. No additional tile color change is evident following the February test. Although not obvious in the photos, the slag layer on the tiles is thin and appears to be uniform with no evidence of any extensive slag buildup. While there was some slag present in the seams between the tiles, there was no evidence of any fusion between adjacent tiles. Therefore, the 4-hour period of natural gas firing prior to SFS cooldown appears to be adequate to prevent buildup of excess slag on the surface of the tiles or in the seams between tiles for the Illinois No. 6 and Kentucky bituminous coals. Also, any quantity of slag present in the seams between tiles appears to crack as a result of cooldown and tile movement.

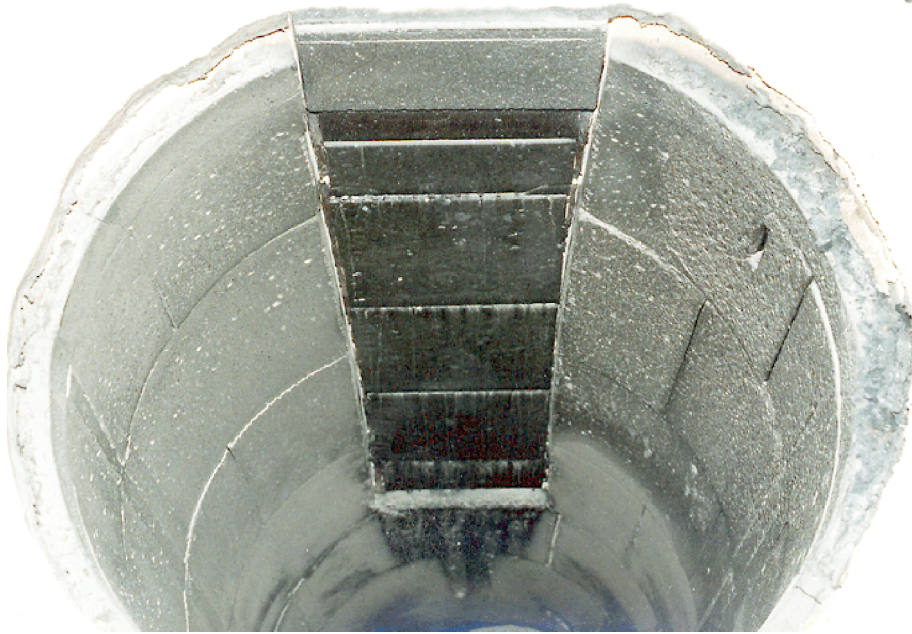
Figure 3-40. Photograph of the RAH panel inside of the slagging furnace following the April test.

Figure 3-40 presents a photograph of the furnace interior after the April test and illustrates the good condition of the high-density furnace refractory as well as the darkening of the refractory with exposure to slag. With each week of coal firing, the high-density furnace refractory gets darker. The high-density refractory immediately below the RAH panel is showing signs of deterioration as a result of slag dripping off the bottom RAH support brick onto the refractory.

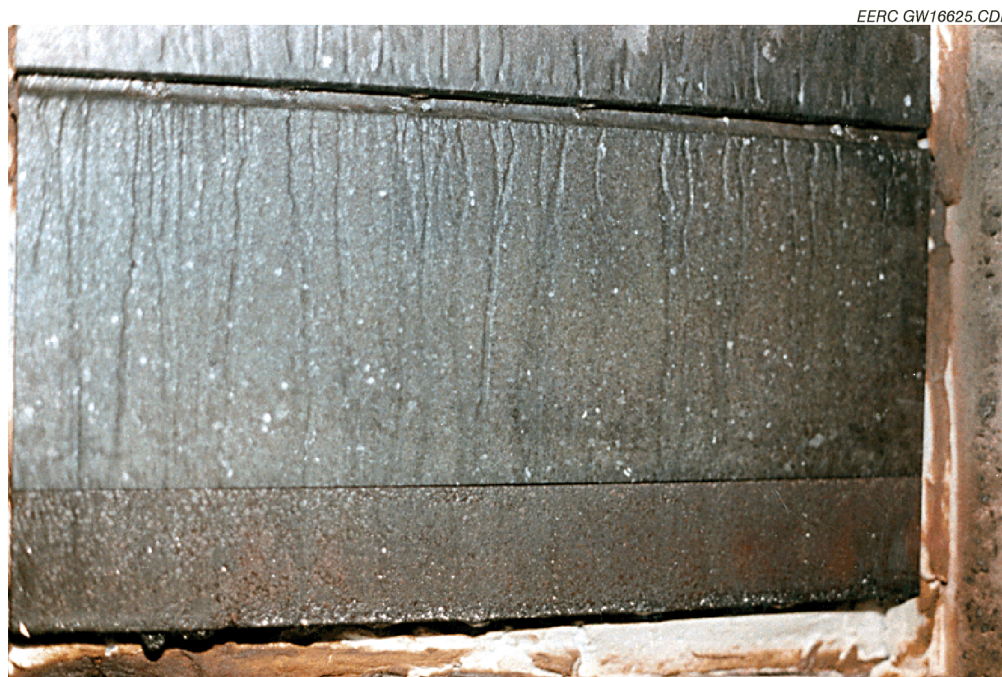
Figure 3-43. Photograph of the RAH lower support brick, small lower tile, and the lower edge of the large lower tile following the February test.

Heatup/cooldown cycles are believed to be the primary cause of RAH panel ceramic tile/brick cracking and the propagation of cracks formed during tile fabrication, with slag contributing to erosion/corrosion of surfaces and imparting stresses on the ceramic tile as it finds its way into seams between tiles. Figure 3-43 is a photograph of the lower support brick, small lower tile, and the lower edge of the large lower tile following the February test. Figure 3-44 presents a photograph of the RAH panel from inside of the furnace following the April test. Both photographs show where the flow of slag has caused erosion/corrosion of the tile surfaces. This observation is consistent with those made concerning the original RAH tiles installed in December 1997 and removed subsequent to failure in August 1998. In addition, the photographs illustrate the small quantity of slag found in the seams between the tiles.

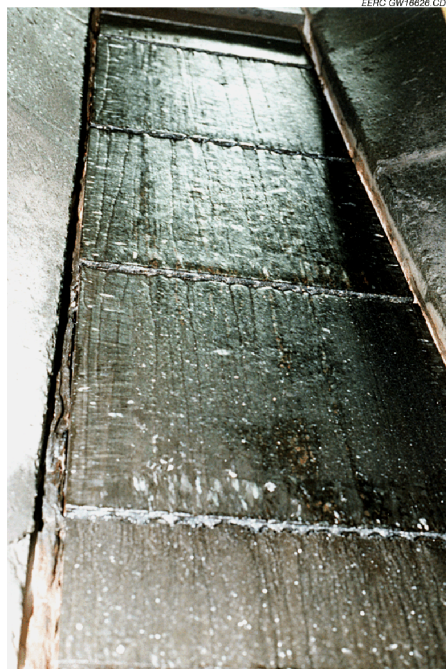
Figure 3-44. Photograph of the RAH panel from inside of the furnace following the April test.

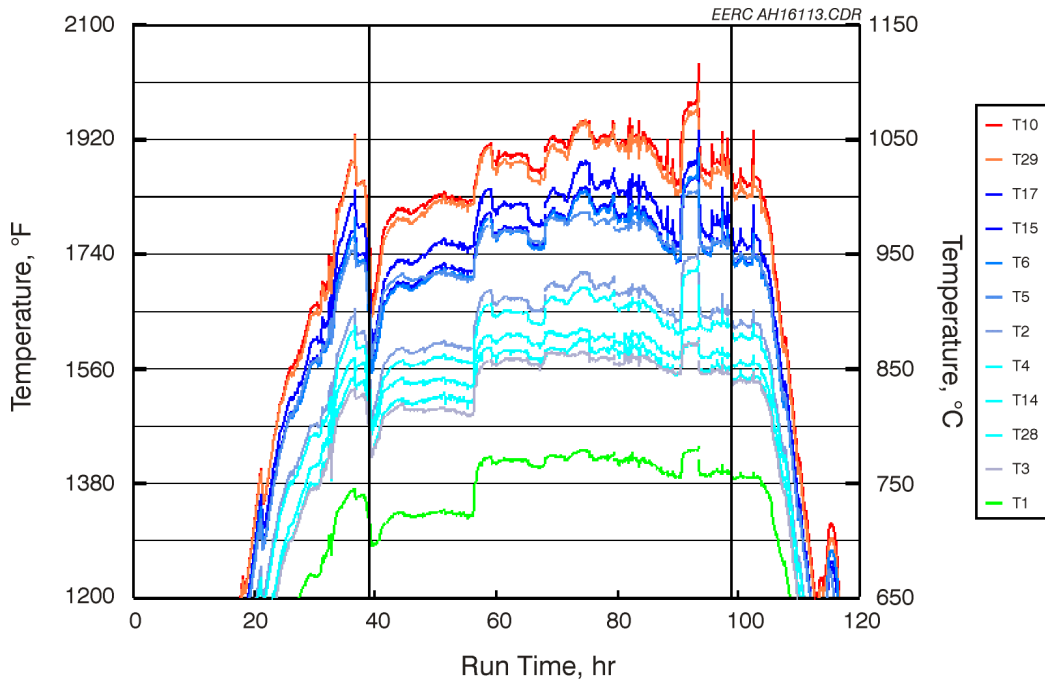
Figure 3-46. RAH tube surface temperatures versus run time for the January test, SFS-RH6-0199.

Figures 3-45 through 3-47 summarize the RAH ceramic tile temperatures, tube surface temperatures, and process air temperatures for the January test (SFS-RH6-0199). The process air flow rate data for the RAH panel were summarized in Figure 3-24. Figure 3-48 illustrates the

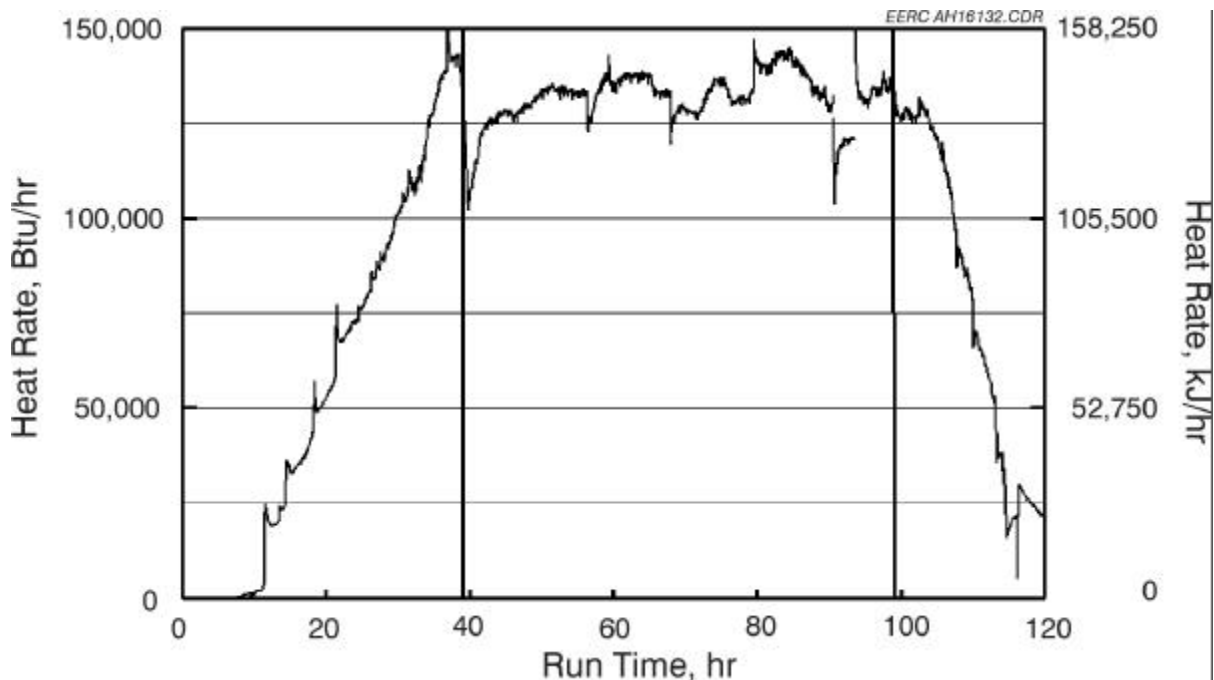
Figure 3-49. RAH heat recovery versus run time for the January test, SFS-RH6-0199.

Heat recovery data from the RAH panel are presented in Figure 3-49 for the January test. At process air flow rates of 150, 180, and 200 scfm (4.2, 5.1, and 5.7 m³/min), the heat recovered from the RAH panel during coal firing was 120,000 Btu/hr (126,600 kJ/hr), 125,960 to 136,540 Btu/hr (132,888 to 144,050 kJ/hr), and 128,850 to 144,230 Btu/hr (135,937 to 152,163 kJ/hr), respectively. For process air flow rates of 180 and 200 scfm (5.1 and 5.7 m³/min),

the heat recovery ranges are a function of minor adjustments to the coal feed rate, combustion air flow rates, and main burner swirl setting. The main burner firing rate was nominally 2.1 to 2.25 MMBtu/hr (2.2 to 2.3×10^6 kJ/hr).

A comparison of the RAH panel data for the January Illinois No. 6 bituminous coal-fired test and the previous tests firing the same fuel indicates that there has been a significant improvement in the heat recovery rate. During previous test periods, the heat recovery rate in the RAH panel was $<120,000$ Btu/hr ($<126,600$ kJ/hr). However, in January, the heat recovery rate was generally $>120,000$ Btu/hr ($>126,600$ kJ/hr). The higher heat recovery rate observed in January was potentially a function of many factors: 1) the SRAH panel was no longer in place, 2) a minimal main burner swirl setting resulted in a more uniform temperature over the length of the furnace, 3) the total furnace firing rate was somewhat higher in January than tests completed in late 1997 and early 1998, and 4) the new condition of the high-density refractory may have resulted in a slight reduction in furnace heat loss. Another possible contributing factor may have been the position of the inlet and outlet process air thermocouples. These thermocouples were reinstalled in January when the RAH panel was reassembled. Although every effort was made to place the thermocouples in exactly the same position they had previously occupied, it is possible that the measurement location was altered slightly. Further testing and data review would be necessary to develop an explanation for the higher RAH heat recovery observed in January.

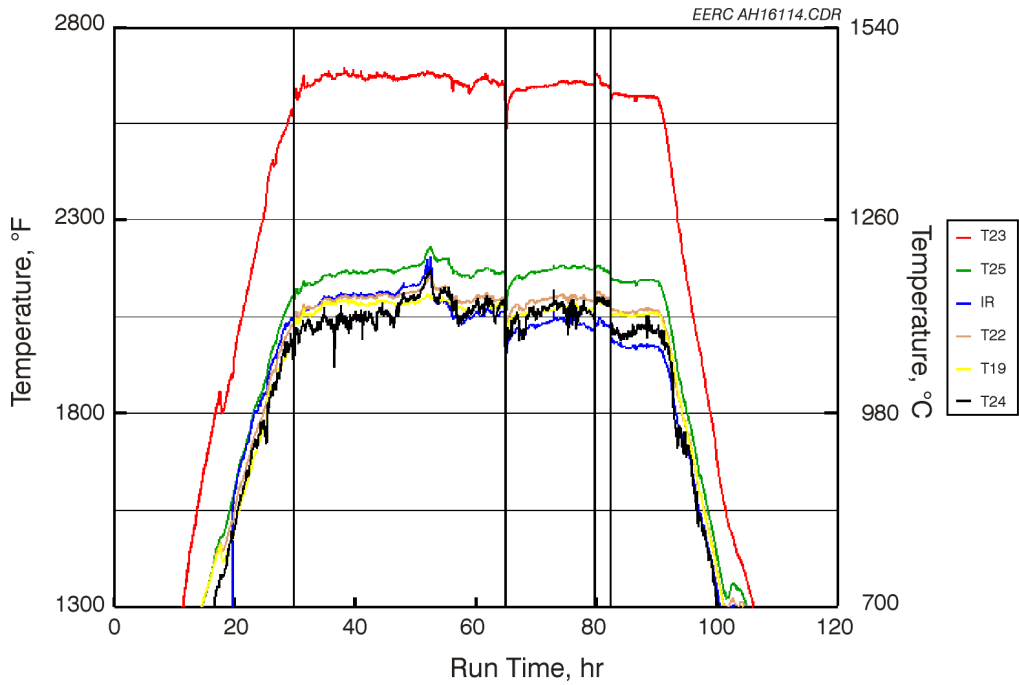
Figure 3-50. RAH ceramic tile temperatures versus run time for the February test, SFS-RH7-0299.

Figures 3-50 through 3-52 summarize the RAH ceramic tile temperatures, tube surface temperatures, and process air temperatures for the February test (SFS-RH7-0299). The process air flow rate data for the RAH panel were summarized in Figure 3-30. Once the SFS had

stabilized thermally (Run Hours 35 through 65 and 80 through 82), the indicated ceramic tile surface temperatures (cavity side) ranged from nominally 2070° to 2170°F (1133° to 1188°C), on the basis of measurements made at the center of each of the three large tiles. Higher tile surface temperatures (furnace-side), 2640° to 2690°F (1449° to 1477°C), were measured near the center of the large middle tile. Tile surface temperatures during the February test were comparable to those observed in January.

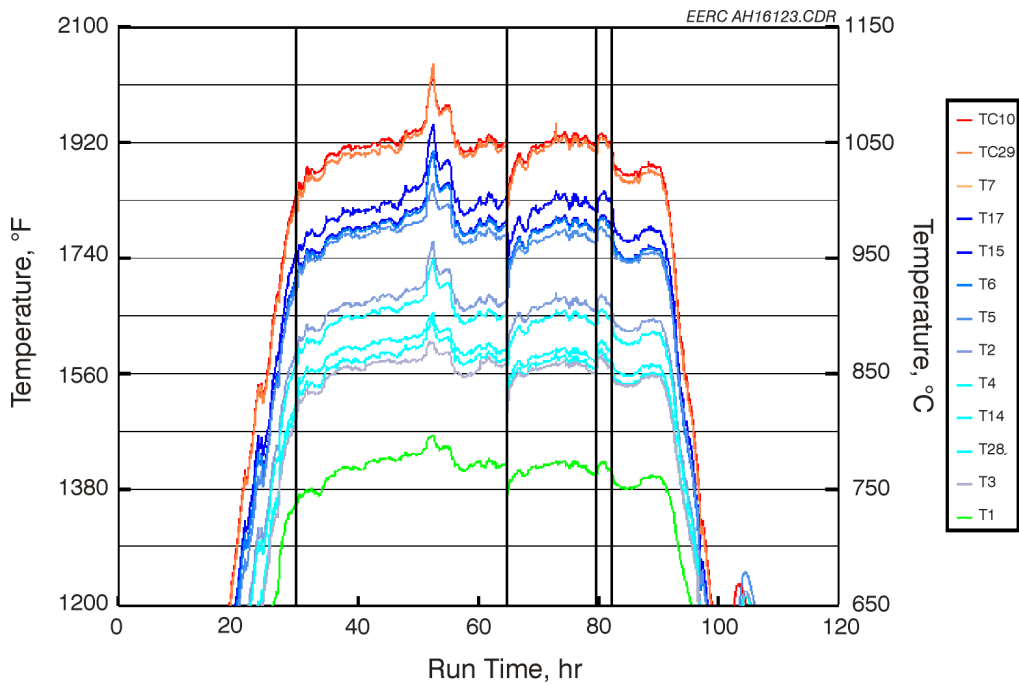
Figure 3-51. RAH tube surface temperatures versus run time for the February test, SFS-RH7-0299.

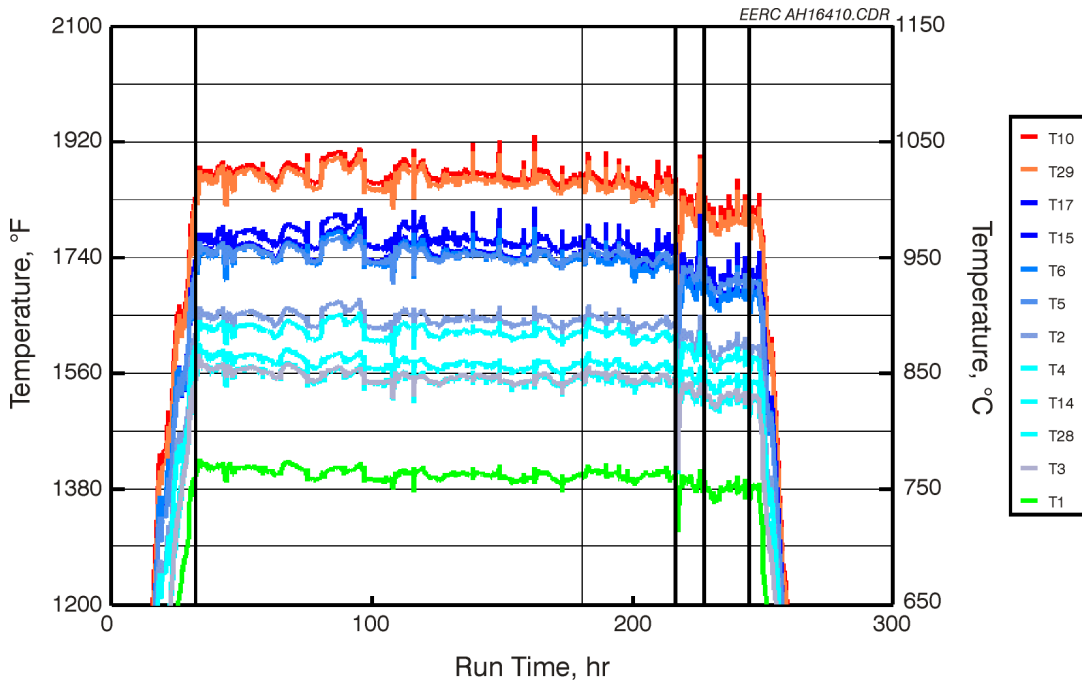
Figure 3-55. RAH tube surface temperatures versus run time for the April test, SFS-RH8-0399.
