3.3 TC06 INSPECTION REPORT

3.3.1 Introduction

3.3.2 TC06A Inspection

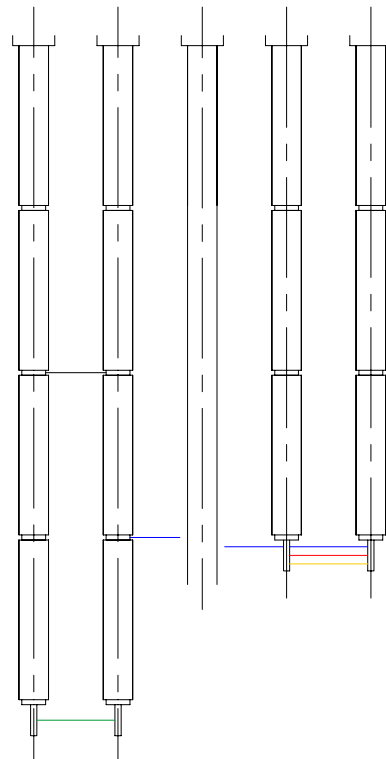
Figure 3.3-1 TC06A Tubesheet Layout

Element Layout	Layout 20 (Figure 3.3-1)
Filtration Area	261.3 ft ²
Back-pulse Pressure	200 to 400 psig Above Reactor Pressure (Approximate)
Back-pulse Timer	Set to 5 min (Varied Between 5 and 20 min)
Back-pulse High-Pressure Trigger Point	250 to 275 inH ₂ O
Back-pulse Valve-Open Time	0.2 sec
Inlet Gas Temperature	750 to 800°F (Approximate)
Face Velocity	3 to 4 ft/min (Approximate)
Baseline DP	80 to 140 inH ₂ O (Approximate)
Peak DP	140 to 270 inH ₂ O
Inlet Loading (SRI Sampling)	7,000 to 18,800 ppmw
Outlet Loading (SRI Sampling)	0.10 ppmw (During Normal Operation) and 22.9 ppmw (When Leaking Due to Filter Element Failure)
Coal/Sorbent	PRB/Dolomite

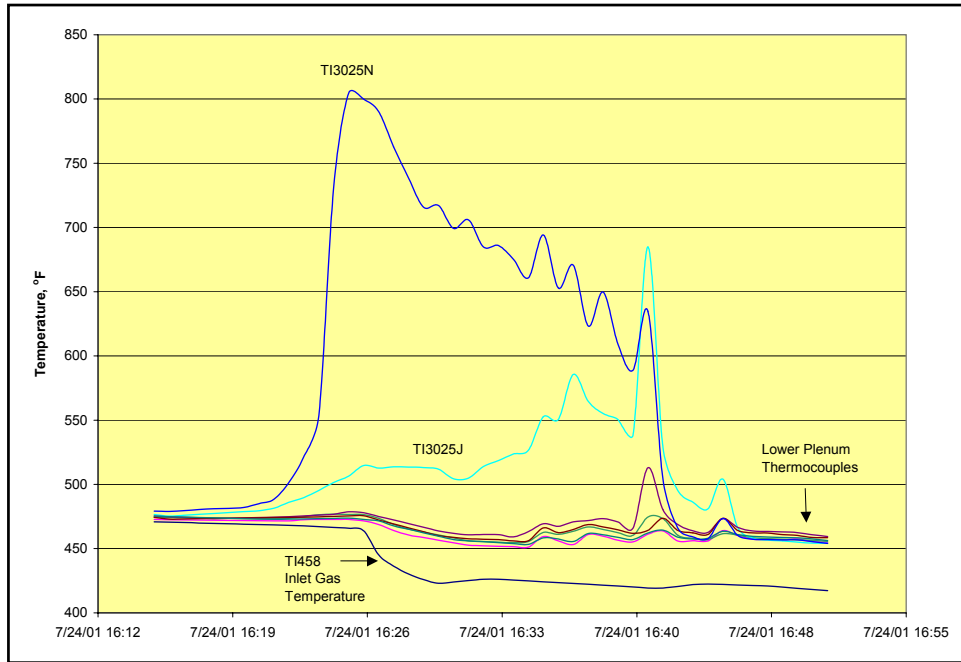
Figure 3.3-2 Temperature Excursion on the Lower Plenum

As mentioned in the Section 3.2, TC06A was ended due to a filter leak. On July 24, 2001, the main air compressor was tuned while online; however, the coal feed was stopped. Originally, it was believed that oxygen would not ignite the g-ash at low temperature. The temperature in the PCD during this time was below 500°F. Around 16:20 on July 24, 2001, the temperature measured by thermocouple TI3025N (B-53) began to increase rapidly after the air compressor tuning began (See [Figure 3.3-2](#)). [Figure 3.3-2](#) shows that the temperature measured by this

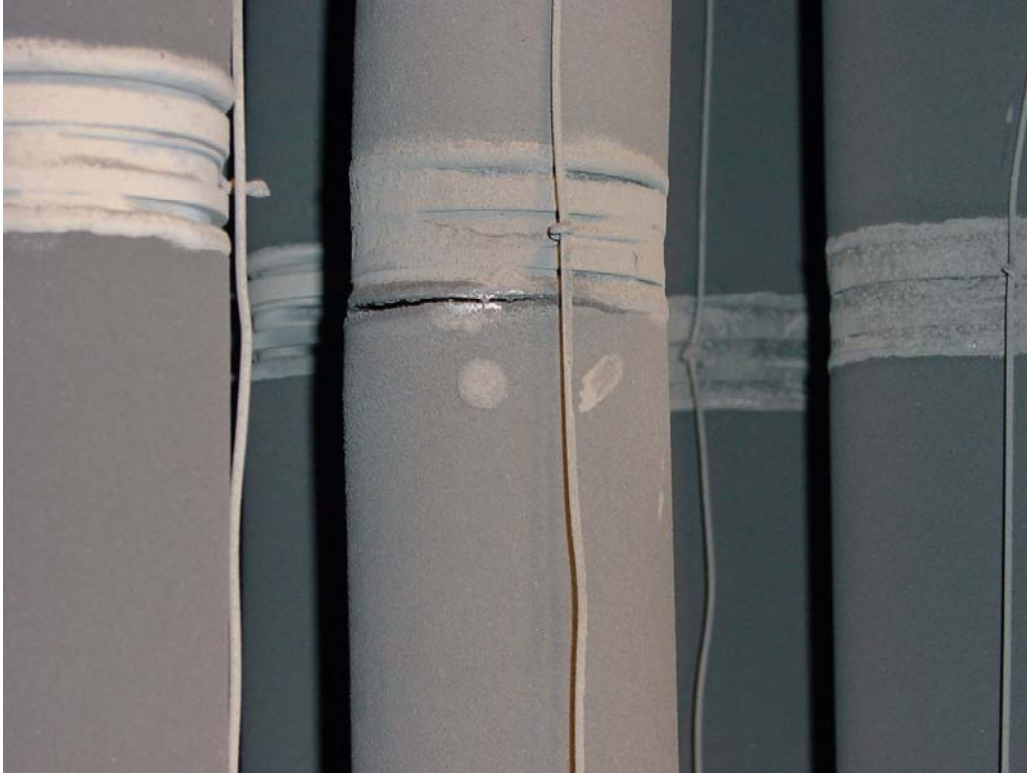
Figure 3.3-4 Failed Fe₃Al Filter (B-32)

On July 27, 2001, the PCD plenum was removed for inspection. Upon inspection a crack was found near the weld between the top and middle sections of Pall Fe₃Al Element 21076, location B-32 (See Figure 3.3-4). This filter was located in the area where the temperature spike was detected by thermocouples TI3025N and TI3025J. When the support brackets were removed from the bottom of this element and the ones around it, as required for its removal, it became apparent that several elements were bowed (See Figure 3.3-5). The support brackets were then removed from all elements on the bottom plenum to determine how many elements were bowed. Five bowed elements were found, all in the same area and all of the bowed elements were apparently exposed to the temperature spike (See Figure 3.3-6). These five elements were removed and replaced for TC06B. Since the extent of the suspected g-ash bridging and subsequent damage to the filters was not known, 15 filters were removed during this outage. The locations of the elements that were removed are shown in Figure 3.3-6.

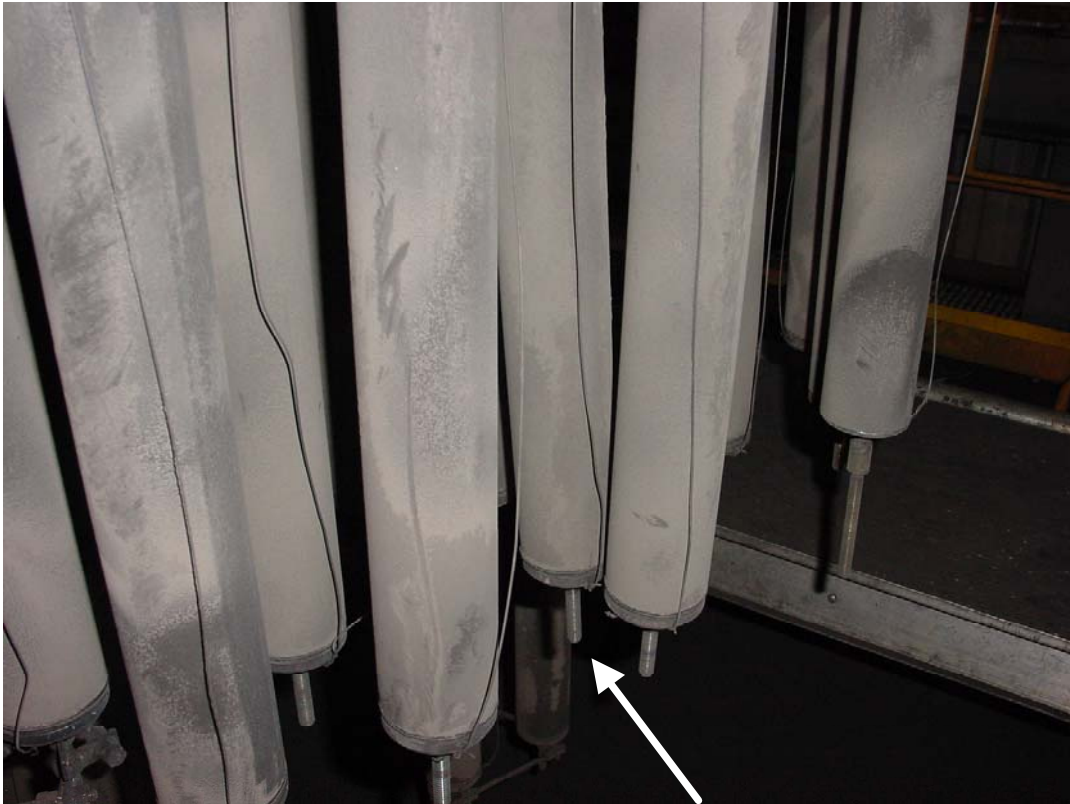
Figure 3.3-5 Bowed Fe₃Al Filters on Lower Plenum

After removal, the elements were cleaned by water washing and then inspected. On inspection, a dramatic color pattern was seen. The elements were light colored on one side and bowed toward that side (See Figures 3.3-7 and -8). The light color resulted from combustion of bridged g-ash on the surface of the elements; therefore, these regions reached the highest temperature during the thermal transient. The bowing of the Fe₃Al elements and the failure of the element at location B-32 can be understood from the thermal expansion of this material measured in the SRI lab. Thermal expansion up to 2,100°F, measured during heating up from room temperature and then cooling down, is shown in Figure 3.3-9. In this plot, the change in length divided by original length (that is, the unit thermal expansion) is plotted on the y-axis and temperature on the x-axis. The slope of this curve is the familiar coefficient of thermal expansion. At approximately 1,800°F, the curve measured during heating begins to “roll over.” This behavior in thermal expansion is usually an indication of a change in the material such as a phase change. In fact, the Al-Fe phase diagram indicates that a phase change occurs at approximately 1,800°F, the exact temperature depending on the composition. The thermal expansion curve obtained during cooling (Figure 3.3-9) is offset below the curve obtained during heatup. The implication of this is that after the material underwent the phase change at 1,800°F the length was permanently decreased. During the thermal transient of TC06A, one side of the elements (the light-colored side) got hot enough to go through the phase change and the length was permanently changed. The other side did not. Therefore, on cool down after thermal transient,

the elements tended to bow to accommodate the different lengths resulting from one side of the elements undergoing a phase change but not the other side. Since the bottom supports restrained the elements from bowing, one of them failed.

During this outage all of the bottom support brackets were removed to inspect the filters for bowing. Five of the 1.5-meter Fe₃Al filters bowed during TC06A as a result of the thermal incident. After the support brackets were removed no bowing was observed.

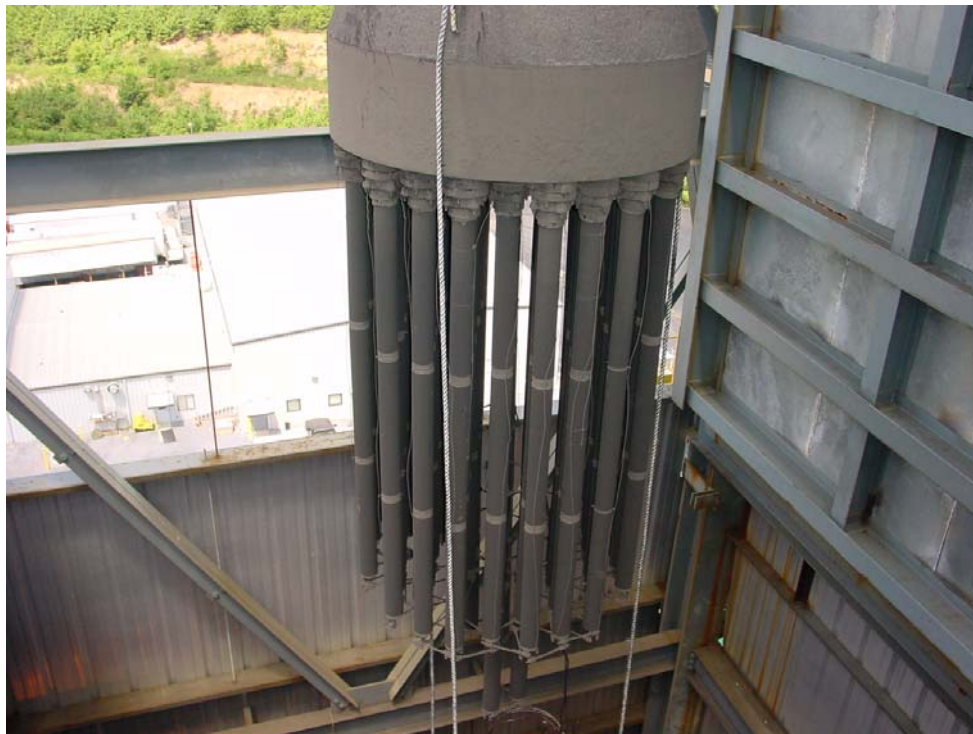
Figure 3.3-10 PCD Internal Removal (Lower Plenum)

G-ash bridging was believed to have contributed to the temperature excursion in the PCD; however, upon inspection g-ash bridging was not observed. [Figure 3.3-10](#) shows the bottom plenum being lifted out of the PCD vessel and into the maintenance bay. This figure shows that the filters were relatively clean compared to past gasification runs. During the temperature excursion the bridged material may have dislodged and fallen out or burned out. The material that was left on the filters had a relatively high ash content indicating partial combustion.

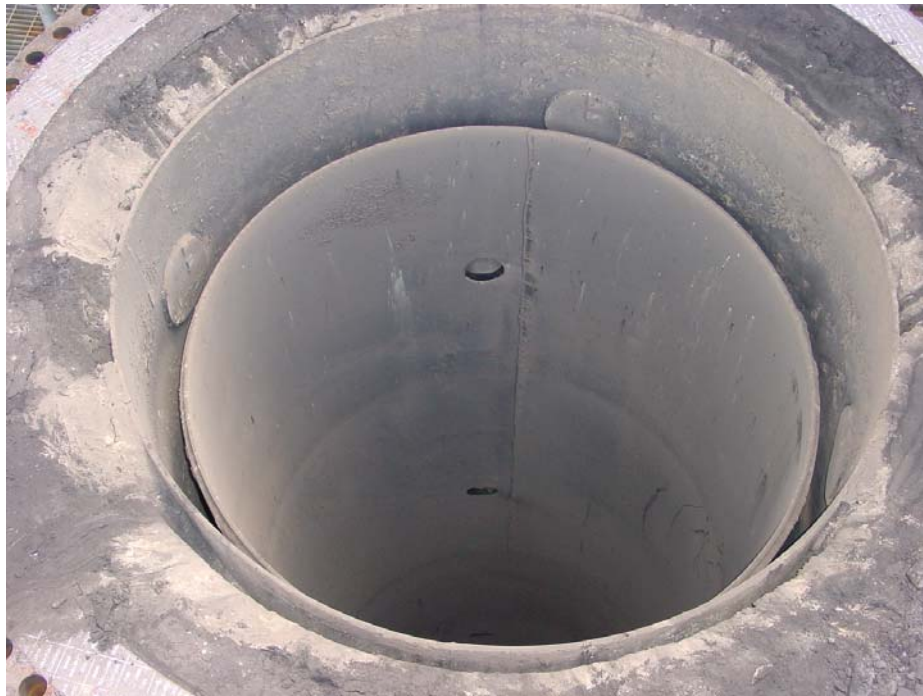
Figure 3.3-12 PCD Internal Shroud and Liner

accumulated g-ash on the top ash shed. [Figure 3.3-12](#) shows very little g-ash buildup on the inside wall of the shroud. Also, there was very little buildup on the liner sections. The clean side of the tubesheet appeared to be in good shape despite the filter failure. [Figure 3.3-13](#) shows that the insulation on the clean side of the tubesheet was relatively clean. [Figure 3.3-14](#) shows the condition of the insulation in the PCD head. The insulation reveals the g-ash penetration in that area was not significant. The shiny scale material detected in GCT3 and GCT4 was not found after this run. Before this run a coke breeze feeder system was installed to help prevent tar formation. The existing start-up burner on the Transport Reactor can raise the reactor temperature to around 1,000°F. In the past, coal has been fed after the reactor temperature exceeded 1,000°F. While the reactor was heating up to 1,600 from 1,000°F on coal, tars were produced because there was not enough energy to crack them. It is suspected that these tars condense during the back-pulse, leaving the shiny scale that has been noted. The coke breeze is fed to the reactor once the reactor reaches 1,000°F. When the reactor reaches 1,600°F coal is introduced to the reactor and the coke breeze system is shut down. The coke breeze feeder addition appears to have solved the tar formation problem.

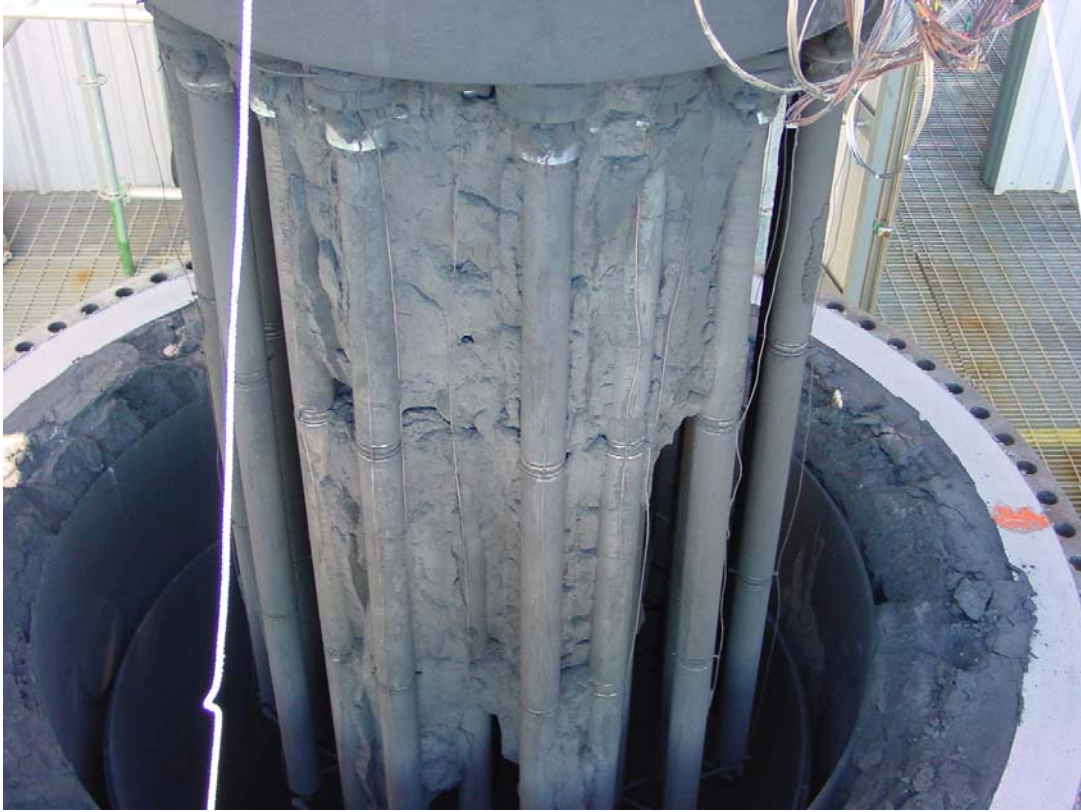
Figure 3.3-15 Removal of PCD Internals After TC06B

[Figure 3.3-15](#) shows the severity of the g-ash bridging as the plenum was lifted out of the PCD vessel. Once the plenum was set in the maintenance bay, inspection of the PCD internals continued. The g-ash bridging was isolated to the lower plenum. [Figure 3.3-16](#) is a filter layout that shows where the g-ash bridging was found on the lower plenum. The numbers around the layout designate how far down the length of the filter the g-ash penetrated. [Figure 3.3-17](#) shows the extent of the g-ash bridging in the area of TI3025J. On September 4, 2001, the temperature from this thermocouple began to deviate from the other thermocouples. This relationship between temperature deviation and g-ash bridging has been noticed, but no satisfactory explanation for the temperature deviation has been found.

- **Install a soot blower:** A soot blower would involve blowing high-pressure nitrogen through nozzles strategically placed immediately below the tubesheet to remove g-ash bridging. A feasibility test was conducted on the g-ash bridging material that was found on the lower plenum after shutdown. A soot blower lance was constructed with a 1/8-inch diameter nozzle that could be directed downward from the top of the g-ash bridge. The high-pressure air (100-psig service air) did not remove the g-ash bridging. It was found that the soot blower was effective in removing the deposit only within about 1 foot of the nozzle exit. Therefore, it was determined that once the g-ash bridging forms it will be difficult to remove with a soot blower. Based on these results it was suggested that the soot blower should be used to prevent the g-ash bridging from ever forming. In other words, a soot blower should be installed and cycled periodically (or continuously) to keep the material from consolidating. However, it was concluded that by preventing the formation of g-ash bridging, a learning opportunity would be missed since the g-ash bridging mechanism is not understood.

- **Remove all 2-meter filter elements:** One possible mechanism that has been suggested for the formation of the g-ash bridge was that the back-pulse gas intensity was not evenly distributed due to the 2-meter filter elements. All six 2-meter filter elements from TC06 will be replaced with 1.5-meter elements for TC07.

- Remove tie wire: Tie wire is currently used to secure the metal filter elements in the event of a filter failure. Originally, there were some concerns that a failed metal filter element would damage the screw cooler (FD0502). Since the filter elements are secured at the bottom by the support pins, the relative risk of filters failing and falling into the screw cooler is low; therefore, the tie wires will be removed for TC07. The thought behind removing the tie wire is to remove any object that would possibly facilitate g-ash bridging.

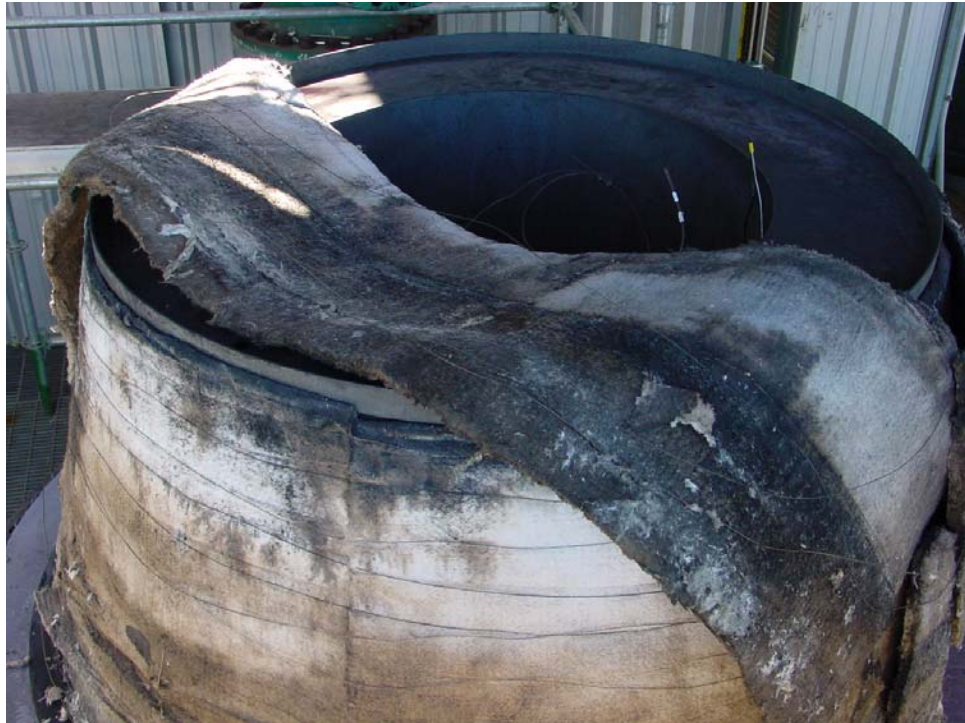
Figure 3.3-24 Tubesheet Insulation

The clean side of the tubesheet appeared to be in good condition. [Figure 3.3-24](#) shows that there was very little g-ash penetration to the insulation on the clean side of the tubesheet. [Figure 3.3-25](#) shows the condition of the insulation of the PCD head.

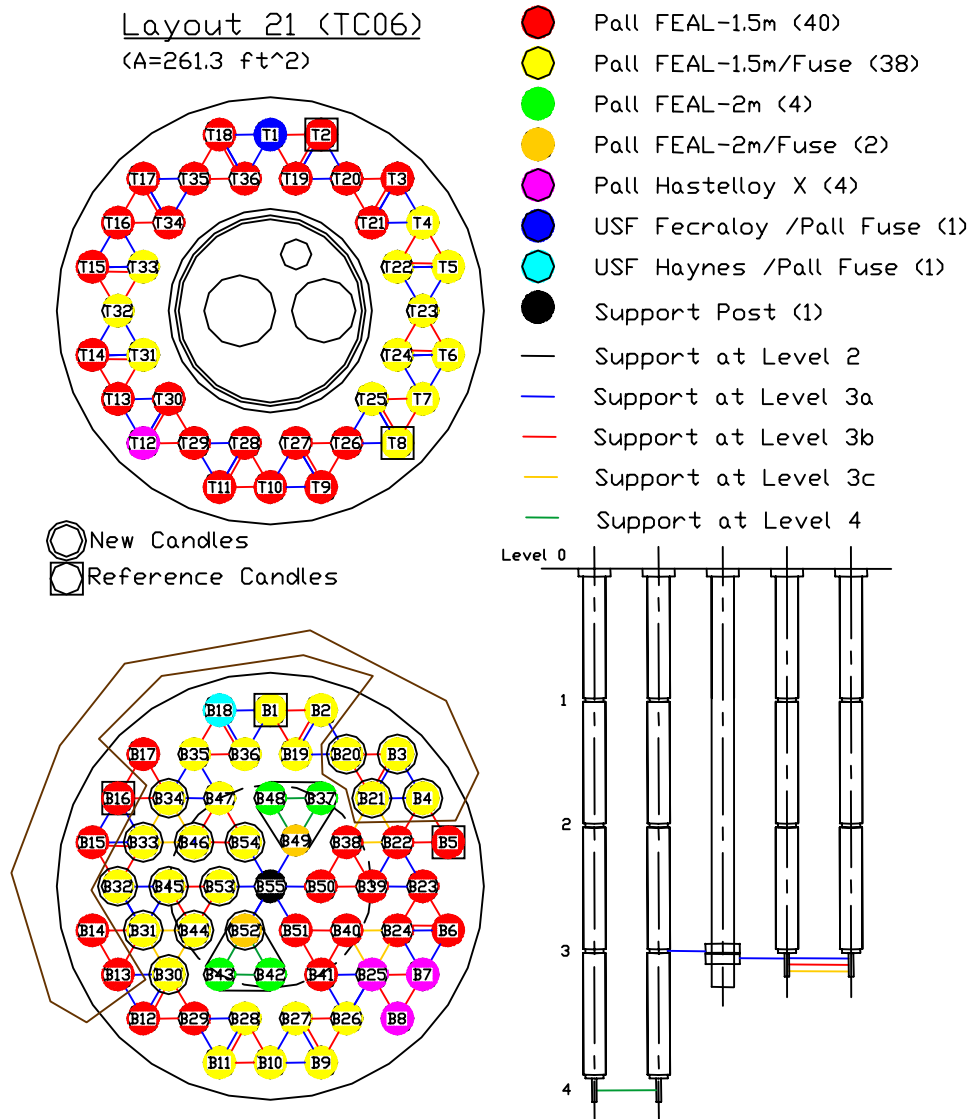
Figure 3.3-26 TC06B Filter Element Layout

Element Layout	Layout 21 (Figure 3.3-26)
Filtration Area	261.3 ft ²
Back-pulse Pressure	200 to 400 psig Above Reactor Pressure (Approximate)
Back-pulse Timer	Set to 5 min (Varied Between 5 and 20 min)
Back-pulse High-Pressure Trigger Point	250 – 275 inH ₂ O
Back-pulse Valve-Open Time	0.2 sec
Inlet Gas Temperature	670 to 750°F (Approximate)
Face Velocity	2.3 to 4 ft/min (Approximate)
Baseline DP	80 to 125 inH ₂ O (Approximate)
Peak DP	140 to 275 inH ₂ O
Inlet Loading (SRI Sampling)	9,300 to 17,000 ppmw
Outlet Loading (SRI Sampling)	< 0.1 ppmw
Coal/Sorbent	PRB/Dolomite

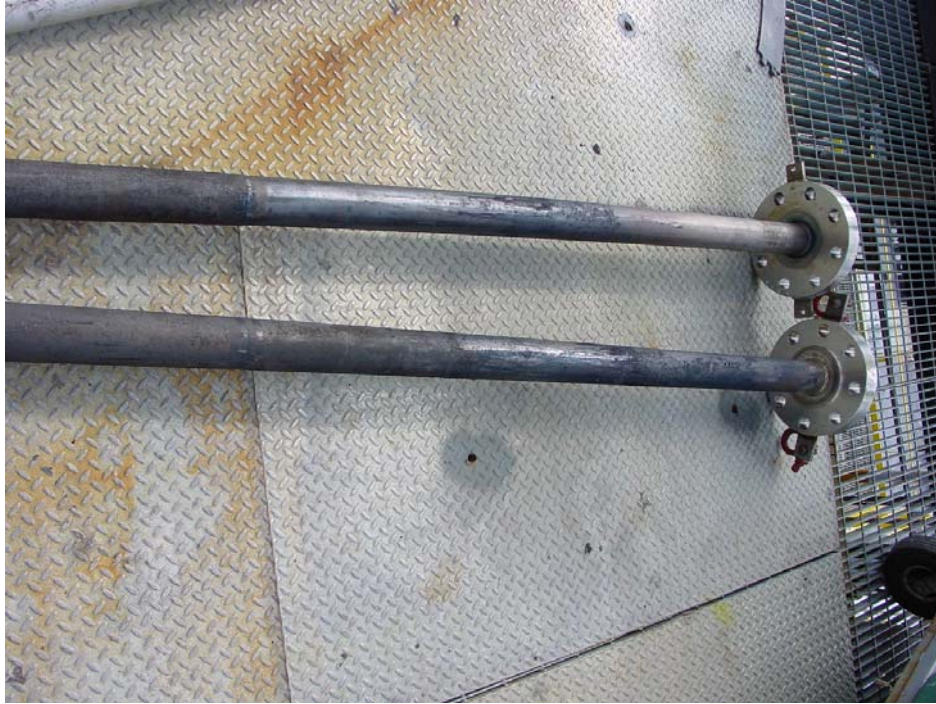
Figure 3.3-27 Back-Pulse Pipes After TC06B

The back-pulse pipes were removed and inspected during this outage. Inspection of the back-pulse pipes didn't reveal any significant damage. There was no significant tar buildup on the pulse pipes and the inner liner appeared to be in good condition. [Figure 3.3-27](#) shows the condition of the back-pulse pipes after TC06B.

During the outage it was noticed that the two 4-inch carbon steel pipe studs that the pulse pipes pass through on the PCD head were badly corroded. In the past, scale has been reported on top of the failsafes; therefore, the pipe studs were replaced with 310 stainless steel during this outage. The lengths of the new pipe studs were adjusted using field measurements to maintain the specified gaps between the ends of the pulse pipes and the venturi inlets.

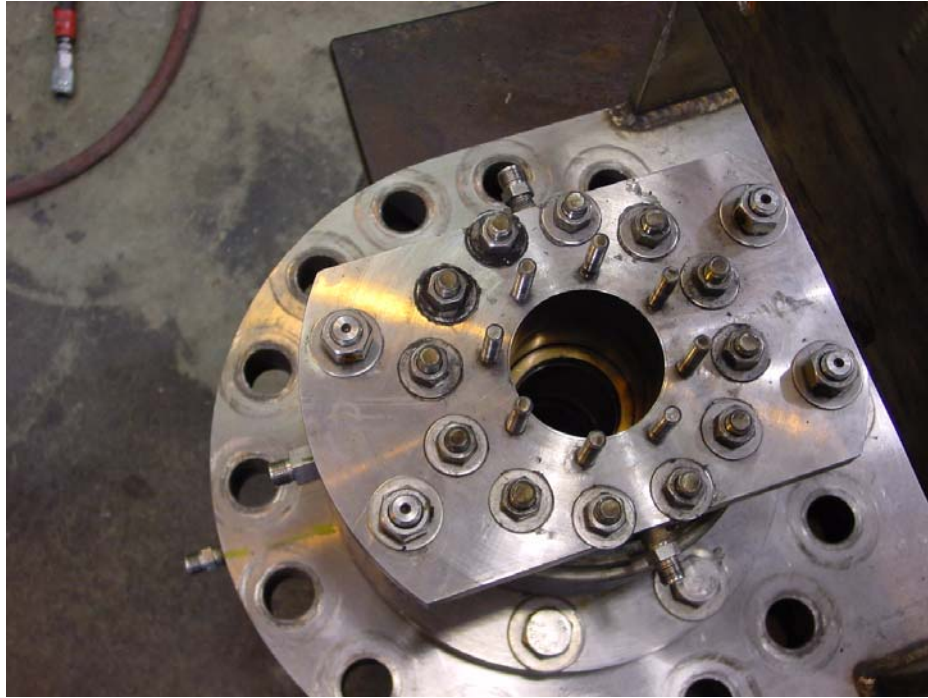
Figure 3.3-28 FD0502 Stuffing Box After TC06

The packing rings appeared to be in good condition. Also, the stuffing box was inspected and no damage was noted (See [Figure 3.3-28](#)). The wear sleeve and shaft appeared to be in good condition as well (See [Figures 3.3-29 and -30](#)).

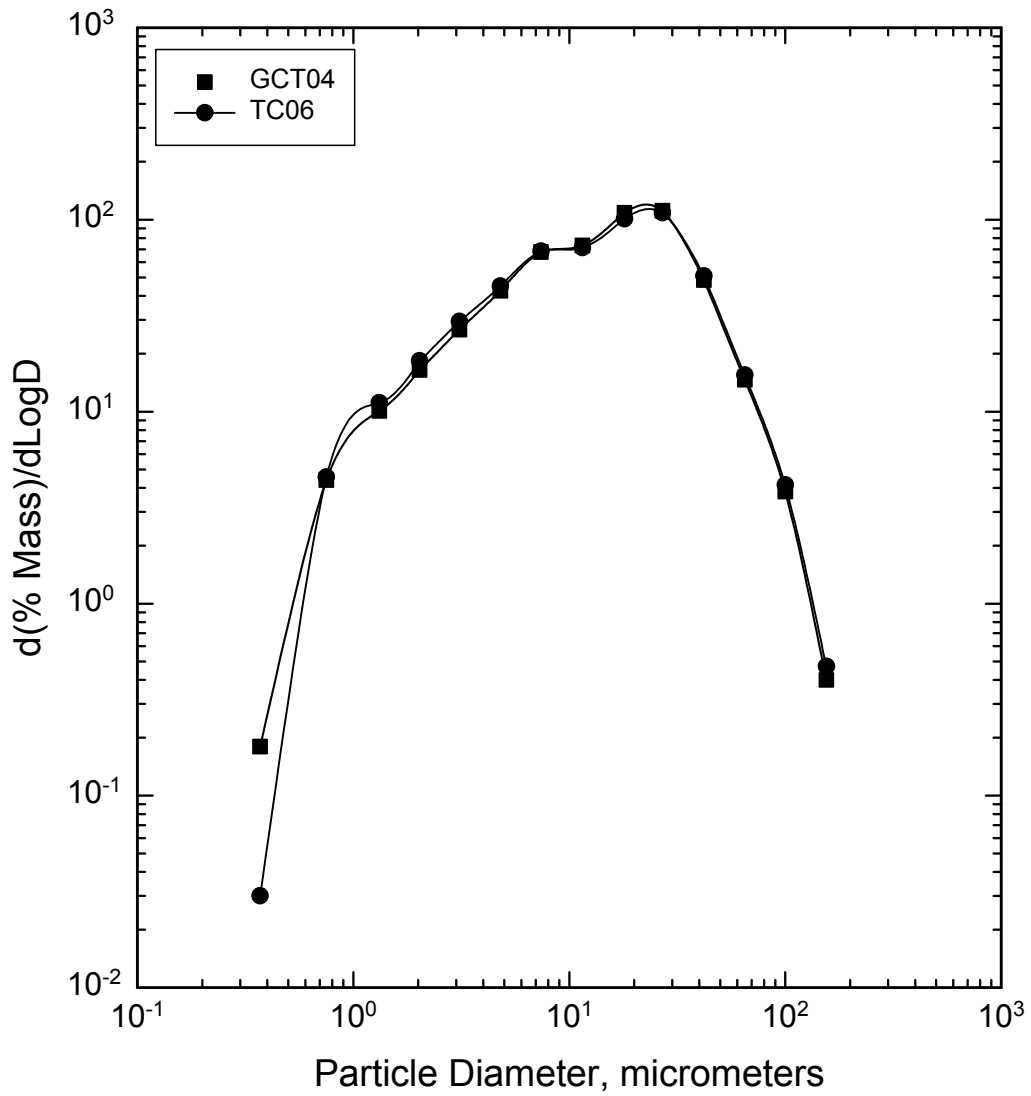
Figure 3.4-1 GCT4 and TC06 Coal G-ash Particle-Size Distributions

The average particle-size distribution of in situ dust samples entering the PCD during TC06 coal operation is shown in [Figure 3.4-1](#). Also shown on the figure is the average distribution from GCT4. The two distributions are nearly identical and show that no significant changes in particle size occurred between the two test programs. At least with PRB coal, Transport Reactor operation appears to have reached a stable, reproducible condition.

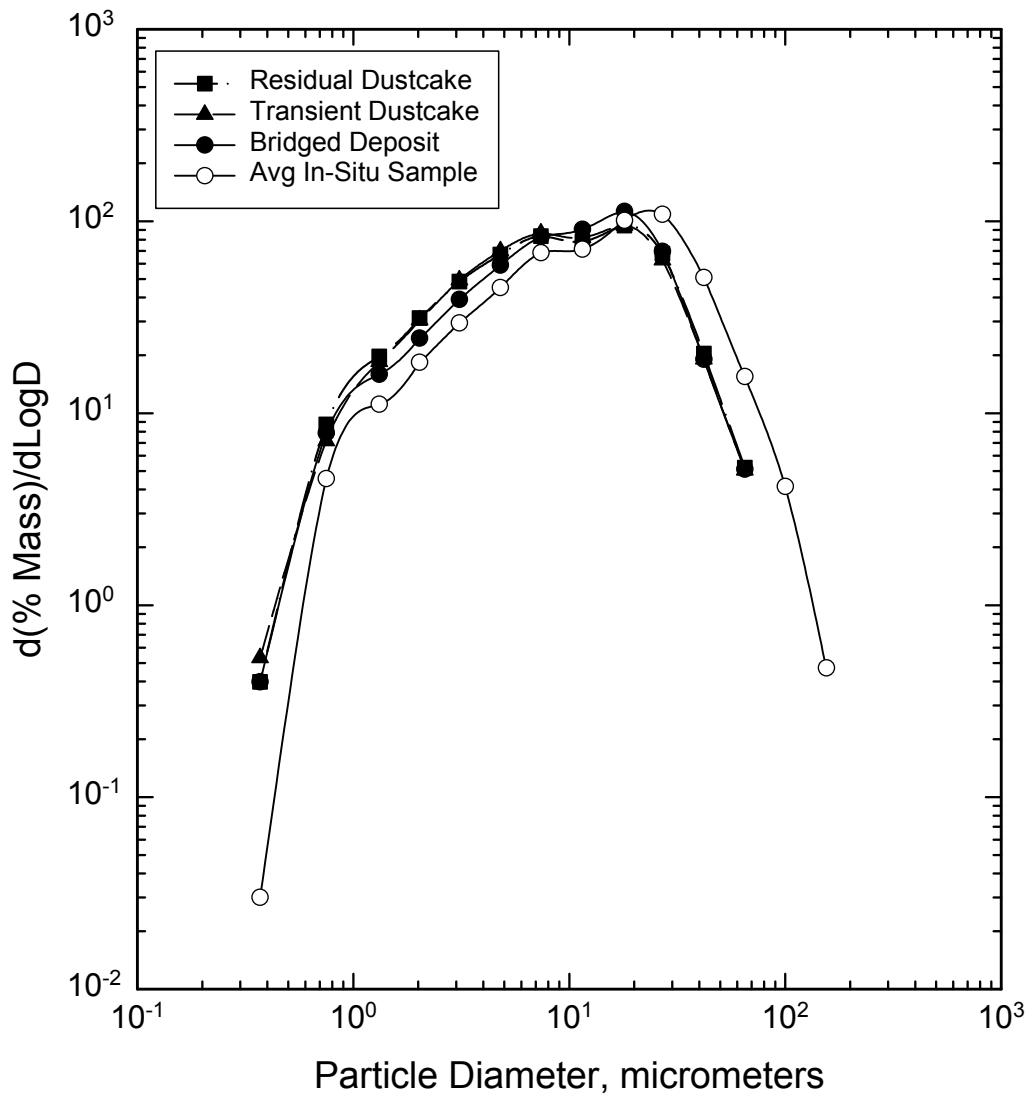
Figure 3.4-3 G-ash Particle-Size Distributions

The size distributions of samples removed from inside the PCD after shutdown are shown in [Figure 3.4-3](#). The solid symbols represent PCD dustcake samples while open symbols are the PCD inlet data discussed above. (The PCD dustcake samples shown here are only from TC06B because the dustcake samples of TC06A were damaged by the thermal transient at the end of the run.) The three dustcake samples (residual, transient, and bridged deposit) show almost exactly the same size distributions. This is different from previous test programs, which frequently indicated that the residual dustcake was finer than the transient dustcake or bridged deposits. The similarity of dustcakes may be attributable to the lack of tar formation during TC06, which resulted in residual dustcakes that were fluffy with low cohesivity. Unlike previous test programs, the TC06 residual dustcake was very thin and easily removed. Since the residual dustcake could be pulse cleaned more readily, there may have been less opportunity for fine-particle enrichment of a long-lived, residual dustcake that persisted throughout the run.

Comparison of the in situ and dustcake samples in [Figure 3.4-3](#) shows that the in situ distribution contained more large particles than were found in the dustcakes although the differences are minor. This difference could indicate some cyclonic separation of large particles by the tangential entry system, although evidence of this effect has been inconsistent over a number of test programs.

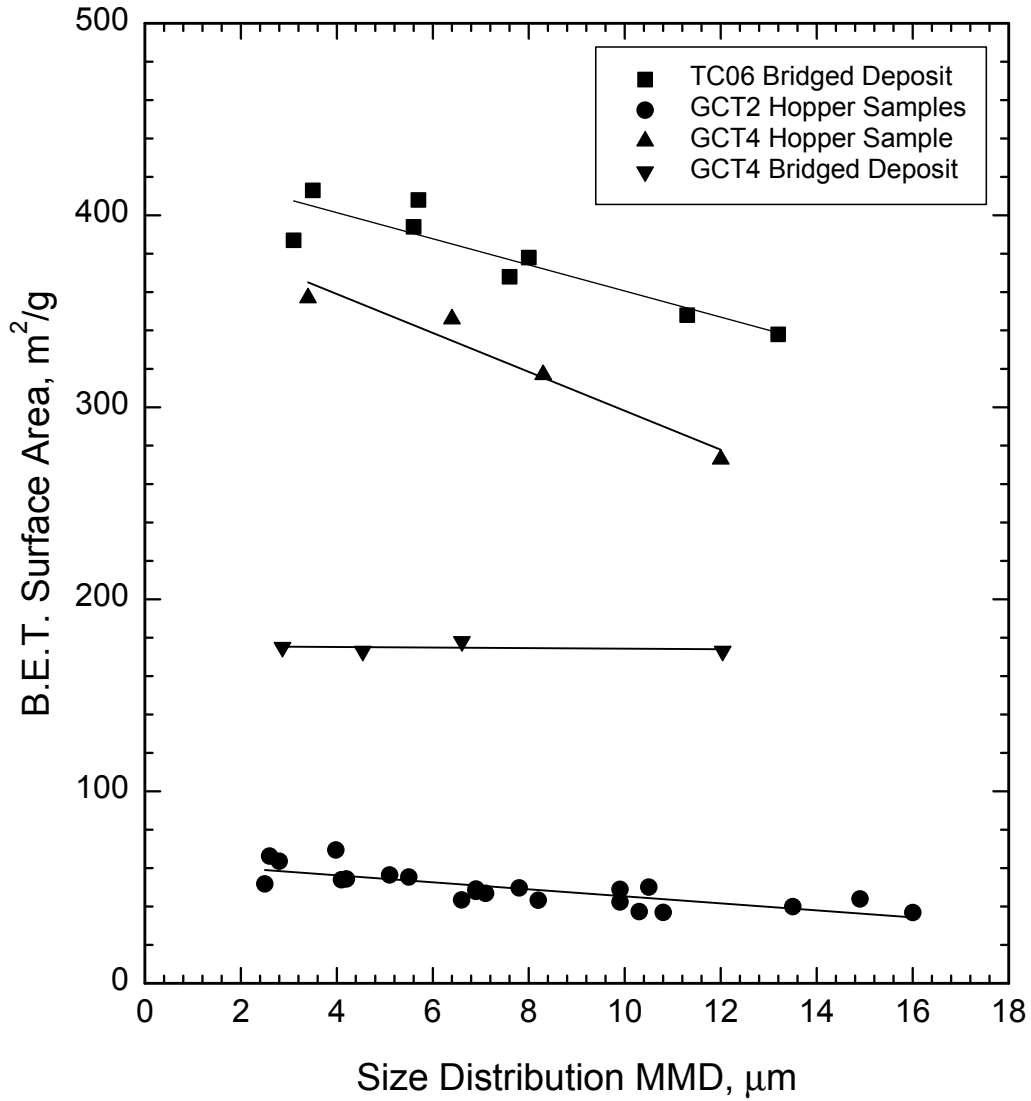
Figure 3.4-7 BET Surface Areas of G-ash Samples

In [Figure 3.4-7](#), specific surface areas measured on the RAPTOR samples are plotted as a function of the MMD of the sample. Also included on the graph are GCT2 and GCT4 data for comparison. In the GCT4 report, it was suggested that the large increase in surface area from GCT2 to GCT4 was caused by improved gasification and a resulting change in particle morphology. The relationships between surface area and MMD and between drag and MMD suggest that, at a given particle size, there is a definite effect of surface area on drag. However, the GCT4 hopper samples and bridged dustcake samples had similar drag characteristics despite the difference in surface area shown in [Figure 3.4-7](#). This difference in surface area was attributed to the deposition of tar in features too small to affect drag (submicron pores). The TC06 bridged deposit has both high surface area and high drag, despite what is presumed to be long exposure inside the PCD. This is another measure of the success of coke breeze startup in eliminating tar.
