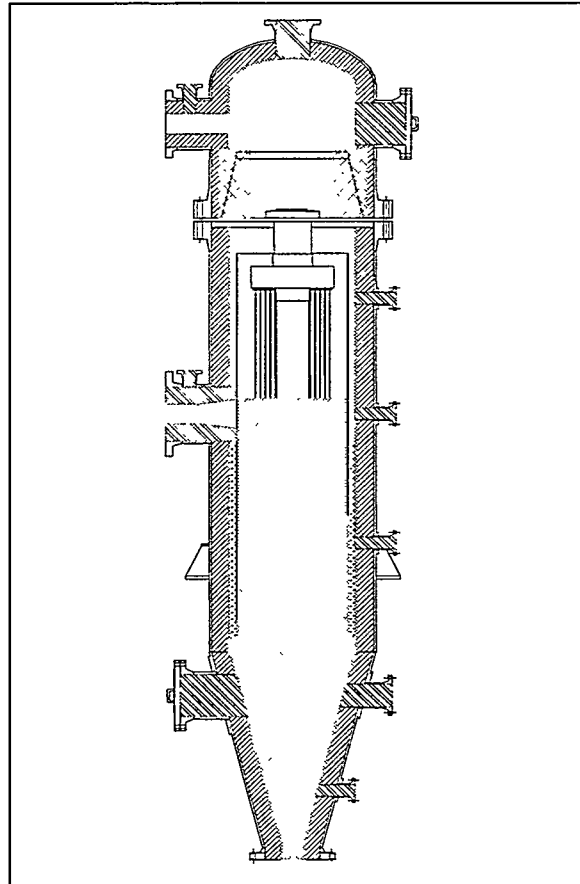
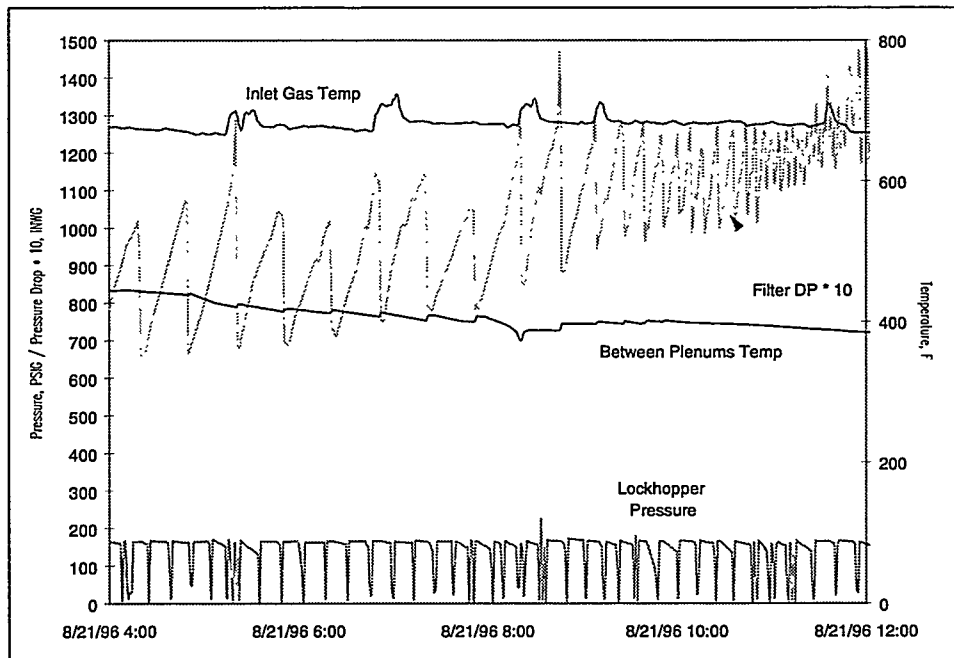
Figure 6.1.15-11 Beginning to Cover Upper Level With Ash

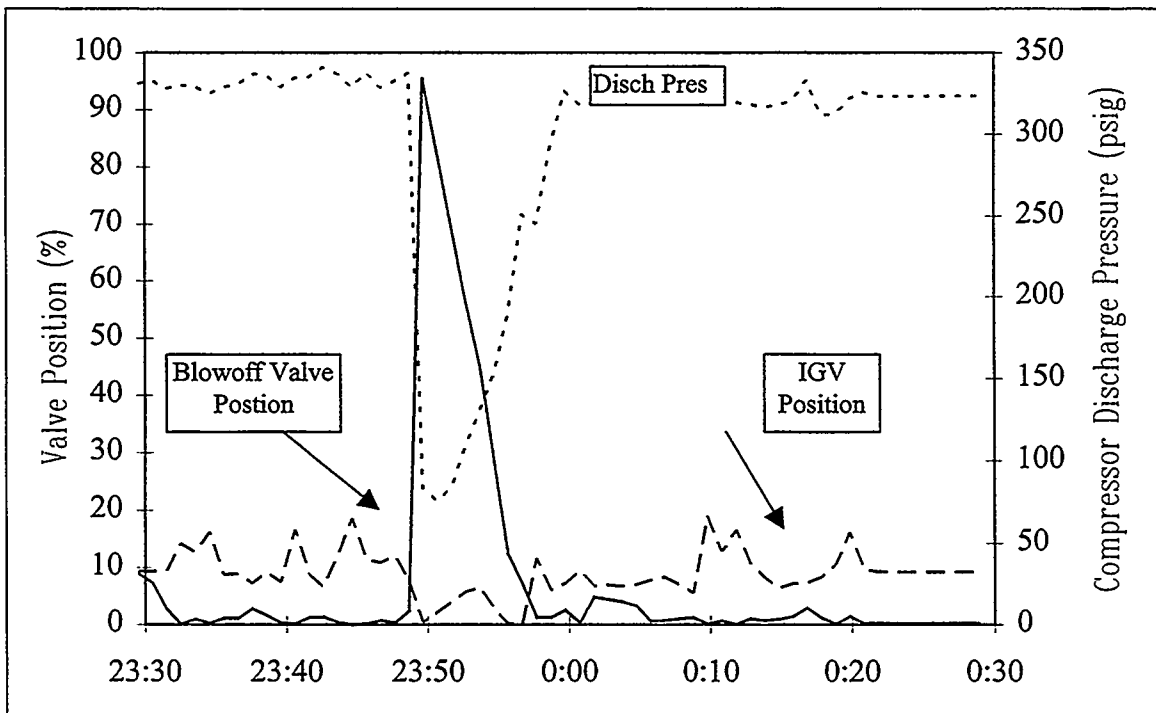
Figure 8.2.4-2 Main Air Compressor Operations November 15 to 16, 1996

However, late in the year during test run CCT2C and CCT3A the compressor experienced some additional control problems. On two consecutive nights during CCT2C, the compressor began to surge and then automatically unload and tripped several other systems. At this time, problems were also experienced with the transport air dryer which was causing some pressure swings (~60 psig) in the compressor downstream pressure. However, the compressor continued to have control problems during CCT3A after the dryer had been repaired. The problems (according to Atlas Copco) are believed to have been caused by the variations in atmospheric conditions operating with "winter air" while the compressor tuning parameters were set in the summer position for "summer air" (humidity ~90 percent and temperature ~90°F). To address this problem, an inlet temperature compensation will be installed during February 1997. Figure 8.2.4-2 is a graph of discharge pressure, inlet guide vane position, and blowoff valve position showing a compressor unload during CCT2C. The compressor ran for a total of 1,570 hours during 1996.

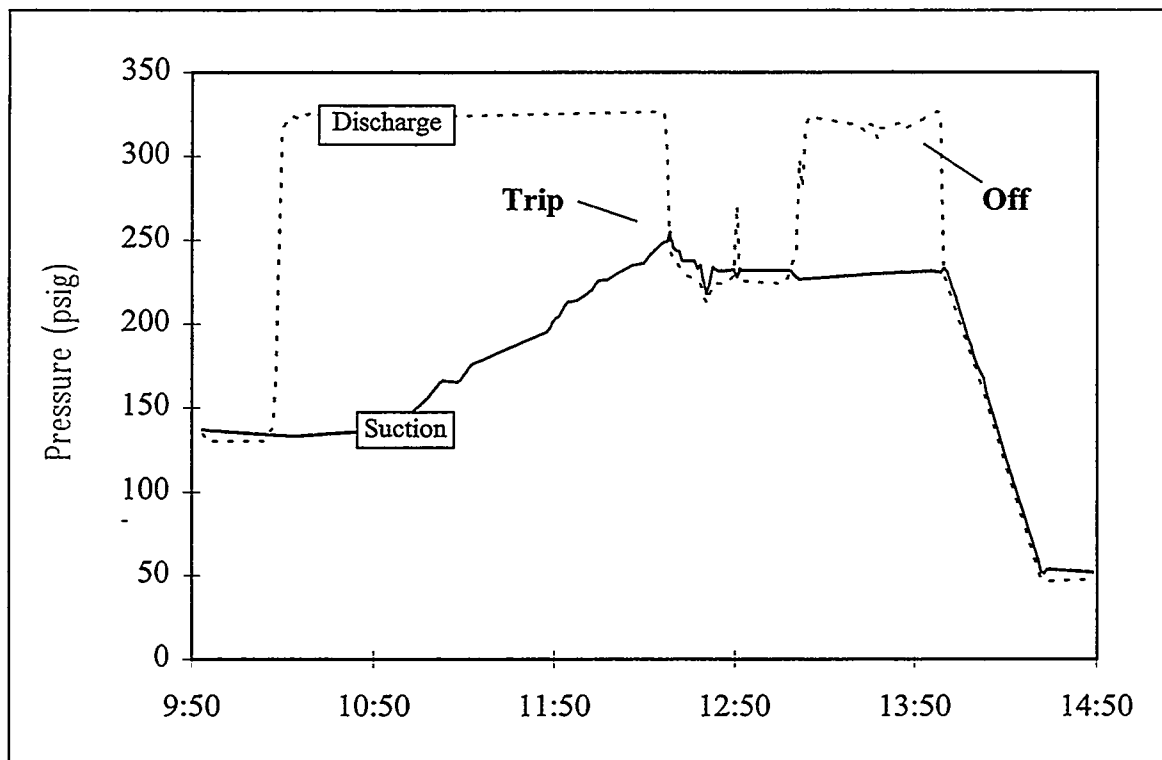
Figure 8.4.2-1 Recycle Gas Booster Compressor Commissioning June 29,1996

The functional checks were completed May 17, 1996, with only minor problems encountered and addressed. On May 20 and 21, a vendor representative verified the compressor piston striking distance, crosshead distances, proper installation of the compressor valves, motor and compressor-side thrust, and coupling alignment. After these checks, the compressor was successfully started and run using instrument air with an intake pressure of 50 psig and discharge around 100 psig. During operations the motor amps were checked and found acceptable. On June 29 the compressor was run again so that it could be tested under normal operating conditions. The compressor was started with a suction pressure of 130 psig, and the suction pressure was gradually increased to 250 psig while the discharge pressure was controlled at 325 psig via pressure controller, PIC478. Only minor problems were encountered which were solved by changing a switch point setting and a few PLC rungs. During the operating period various controllers were tuned and it was demonstrated that a smooth transition could be made from air to recycle gas for fluidization of the combustor heat exchanger. Also, vibration readings were taken and found acceptable. The compressor tripped (as programmed) once during this period due to a high suction pressure. Figure 8.4.2-1 shows a graph of this operating period.

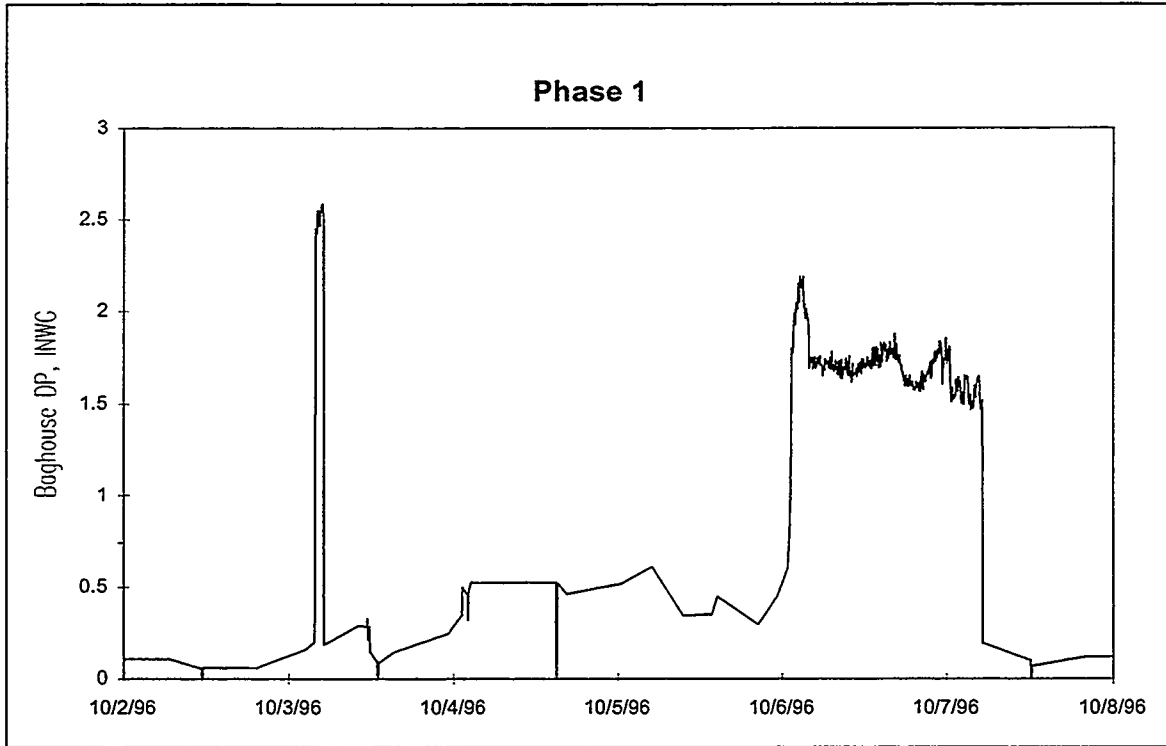
Figure 8.9.1-4 Baghouse  $\Delta P$  CCT2A

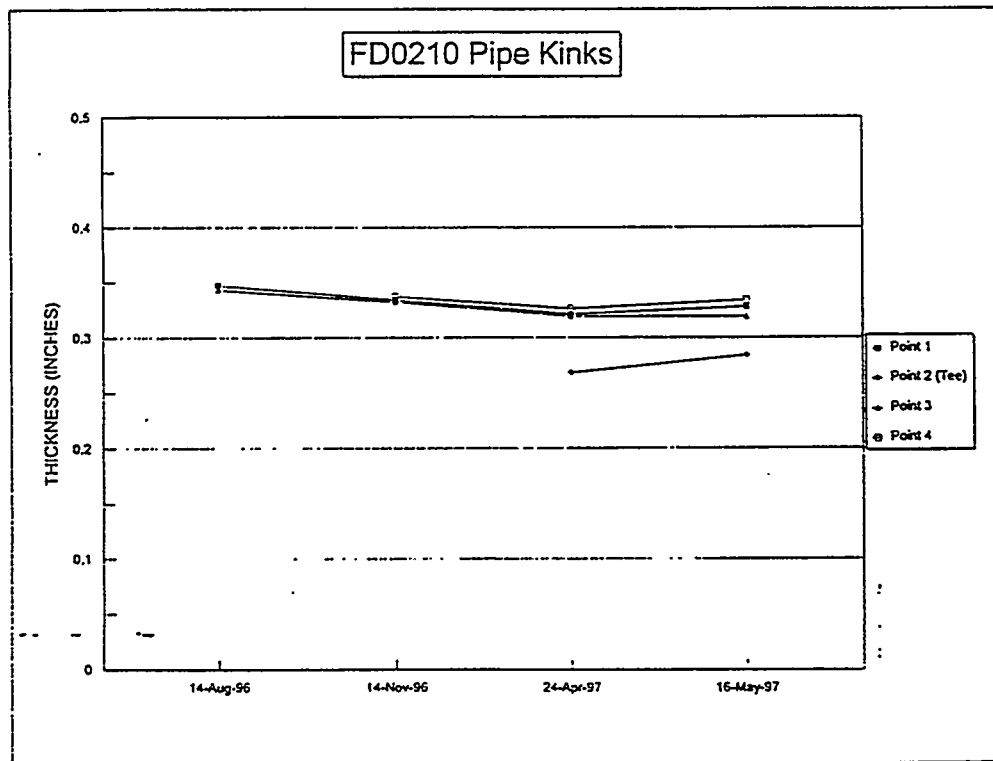
Figure 9.2.1-2 Typical Trend Plot for Pipe Kinks in the FD0210 Line
