## **APPENDIX C – GRAPHS**

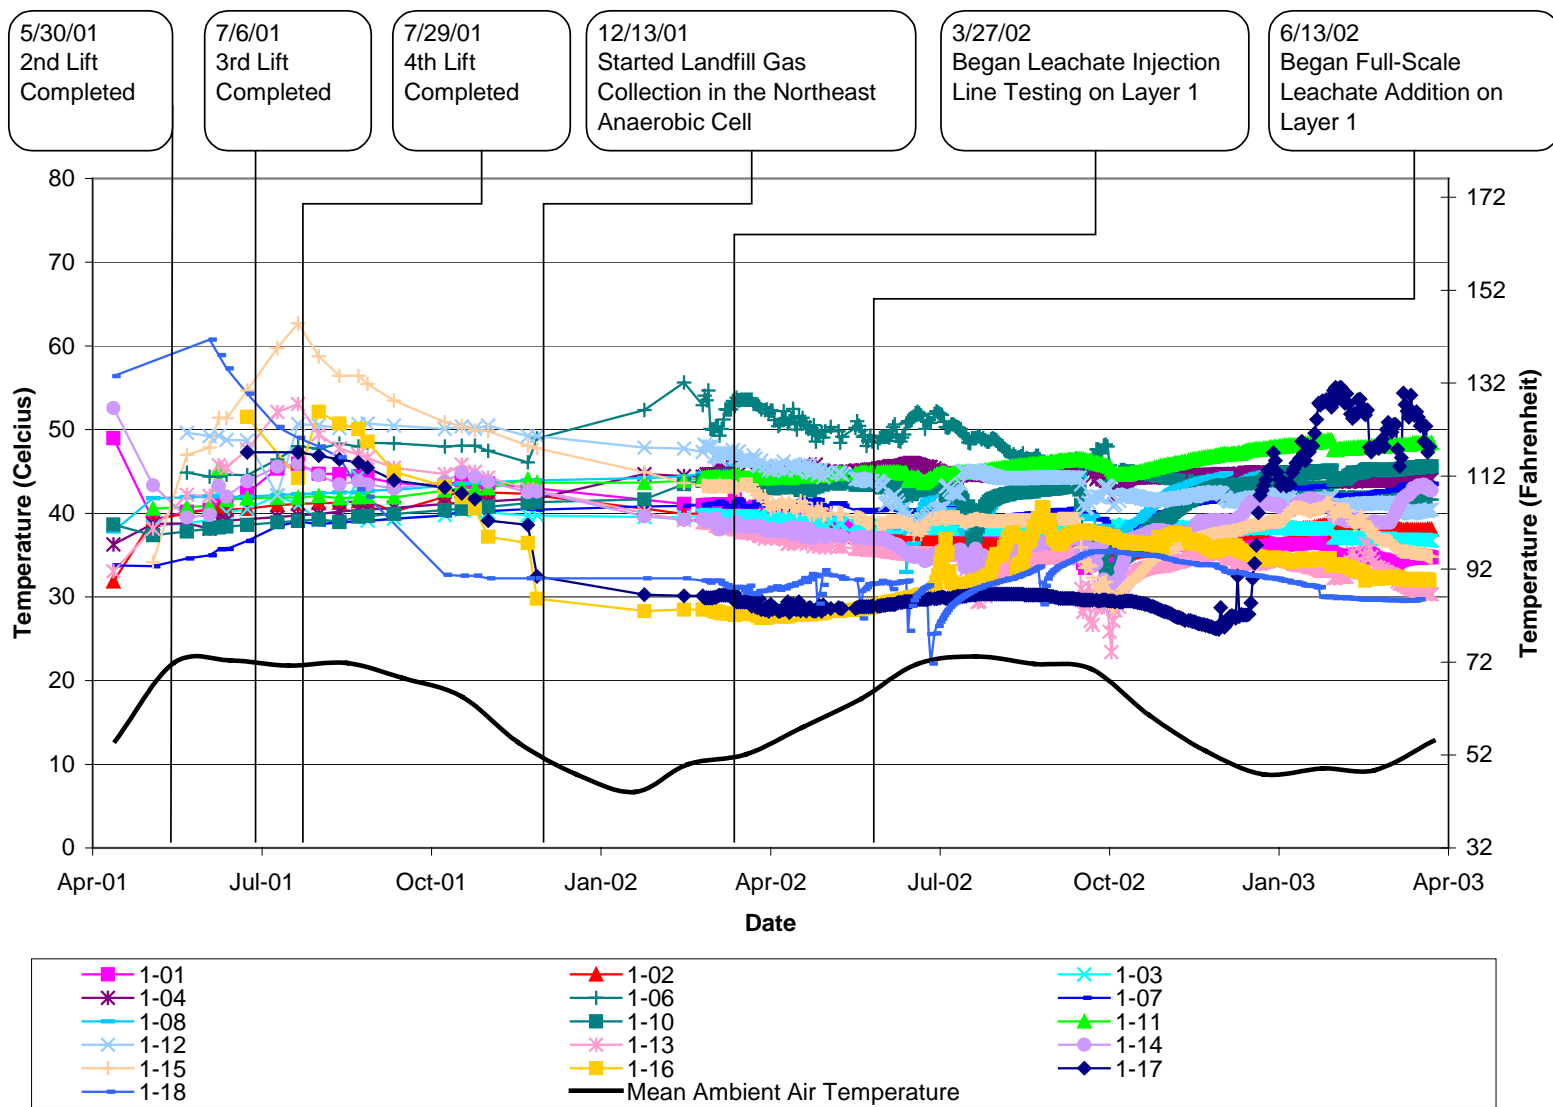
**Figure 3-2. Northeast Anaerobic Cell Layer 1 Temperature Readings**

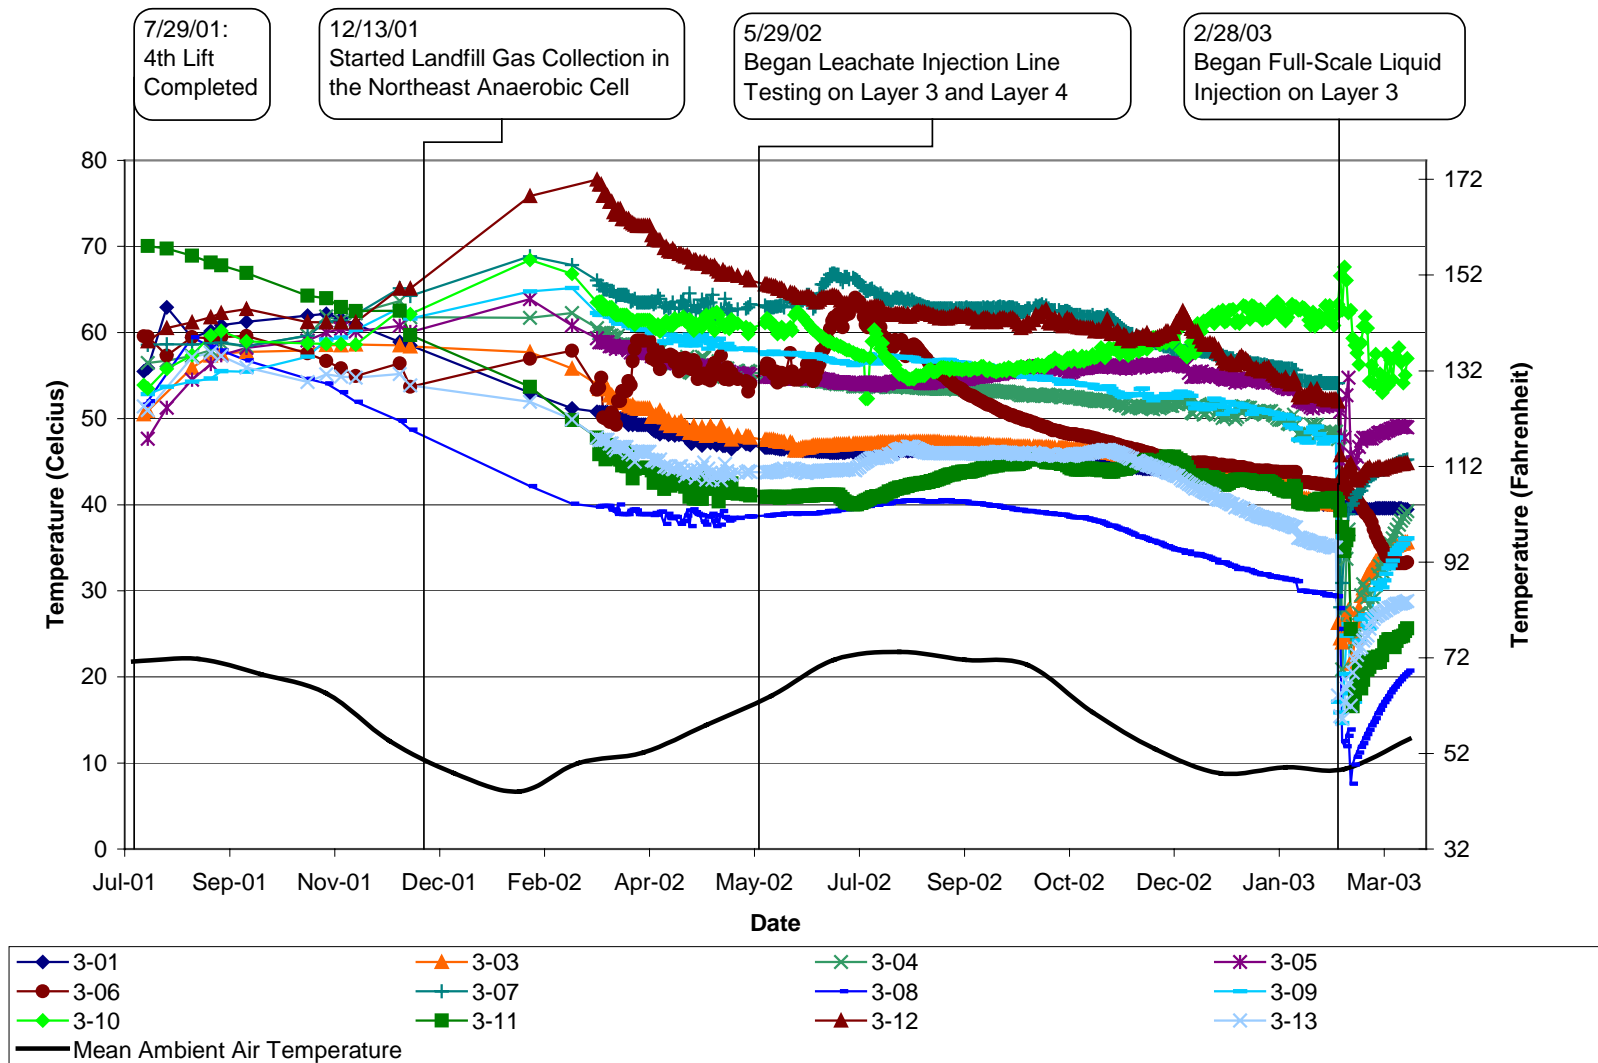
**Figure 3-4. Northeast Anaerobic Cell Layer 3 Temperature Readings**

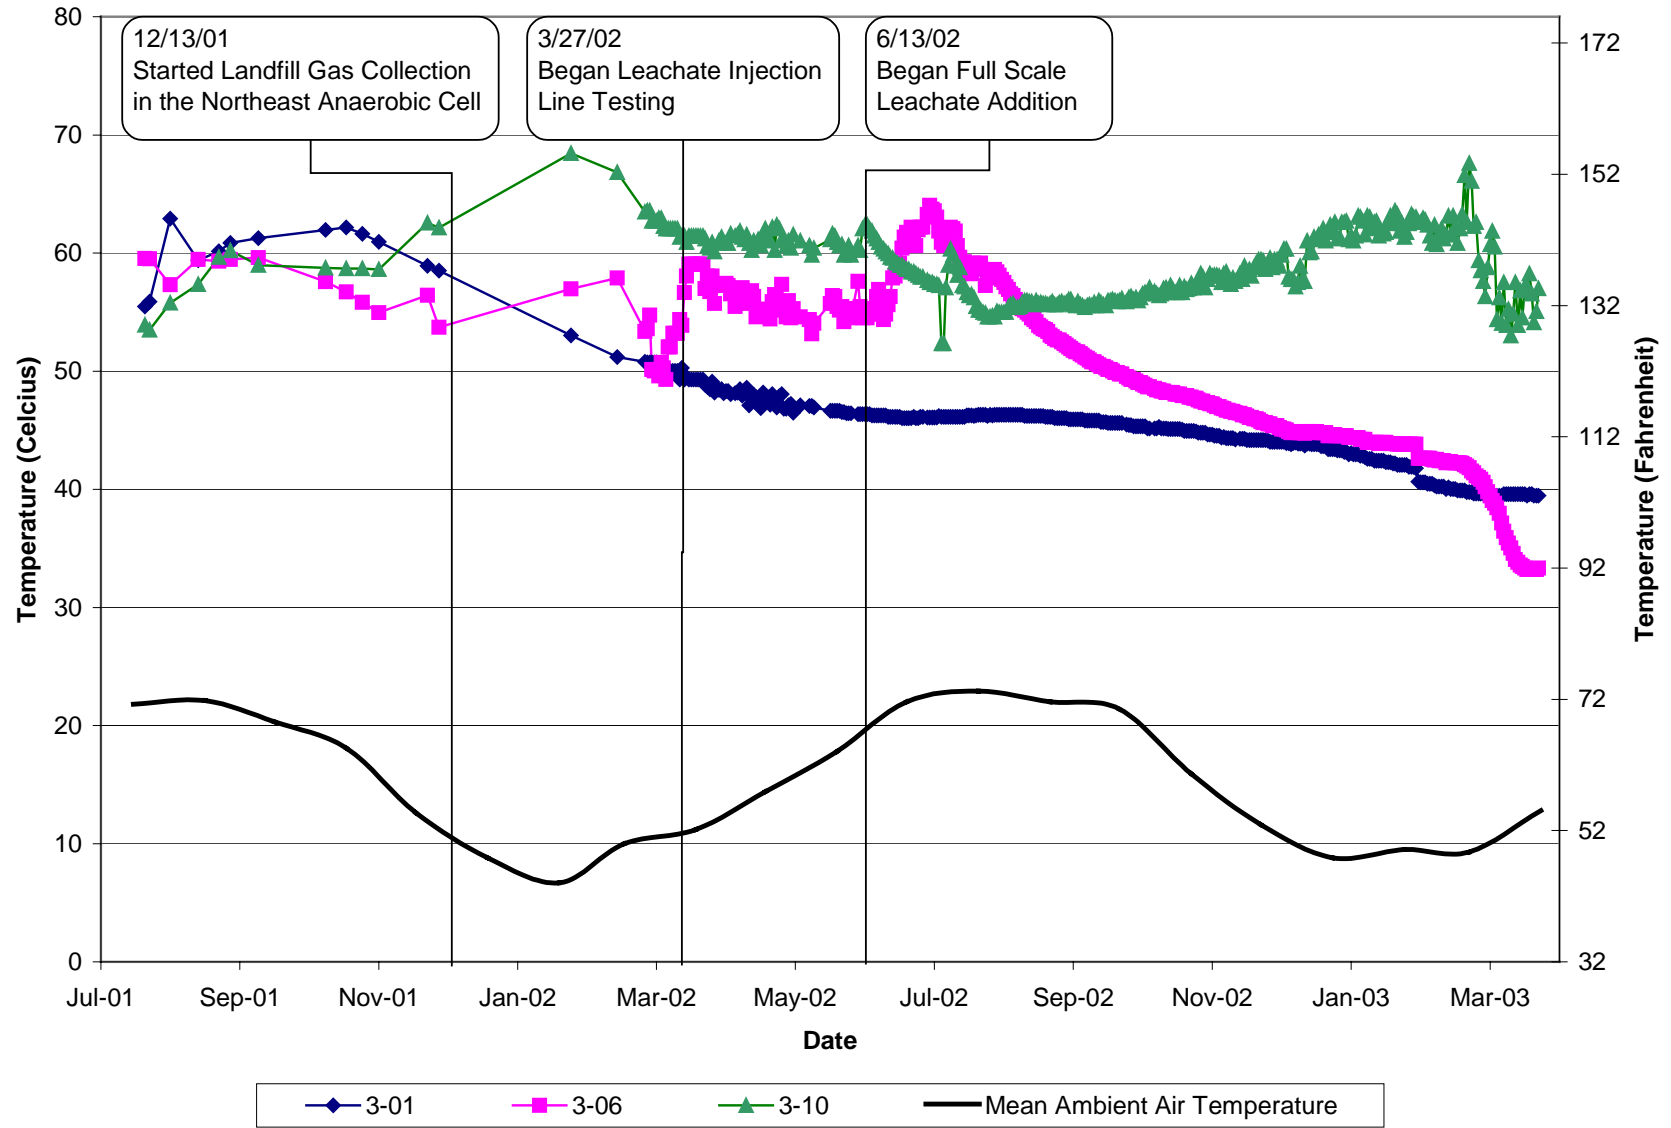
**Figure 3-5. Northeast Anaerobic Cell Selected Temperature Readings**

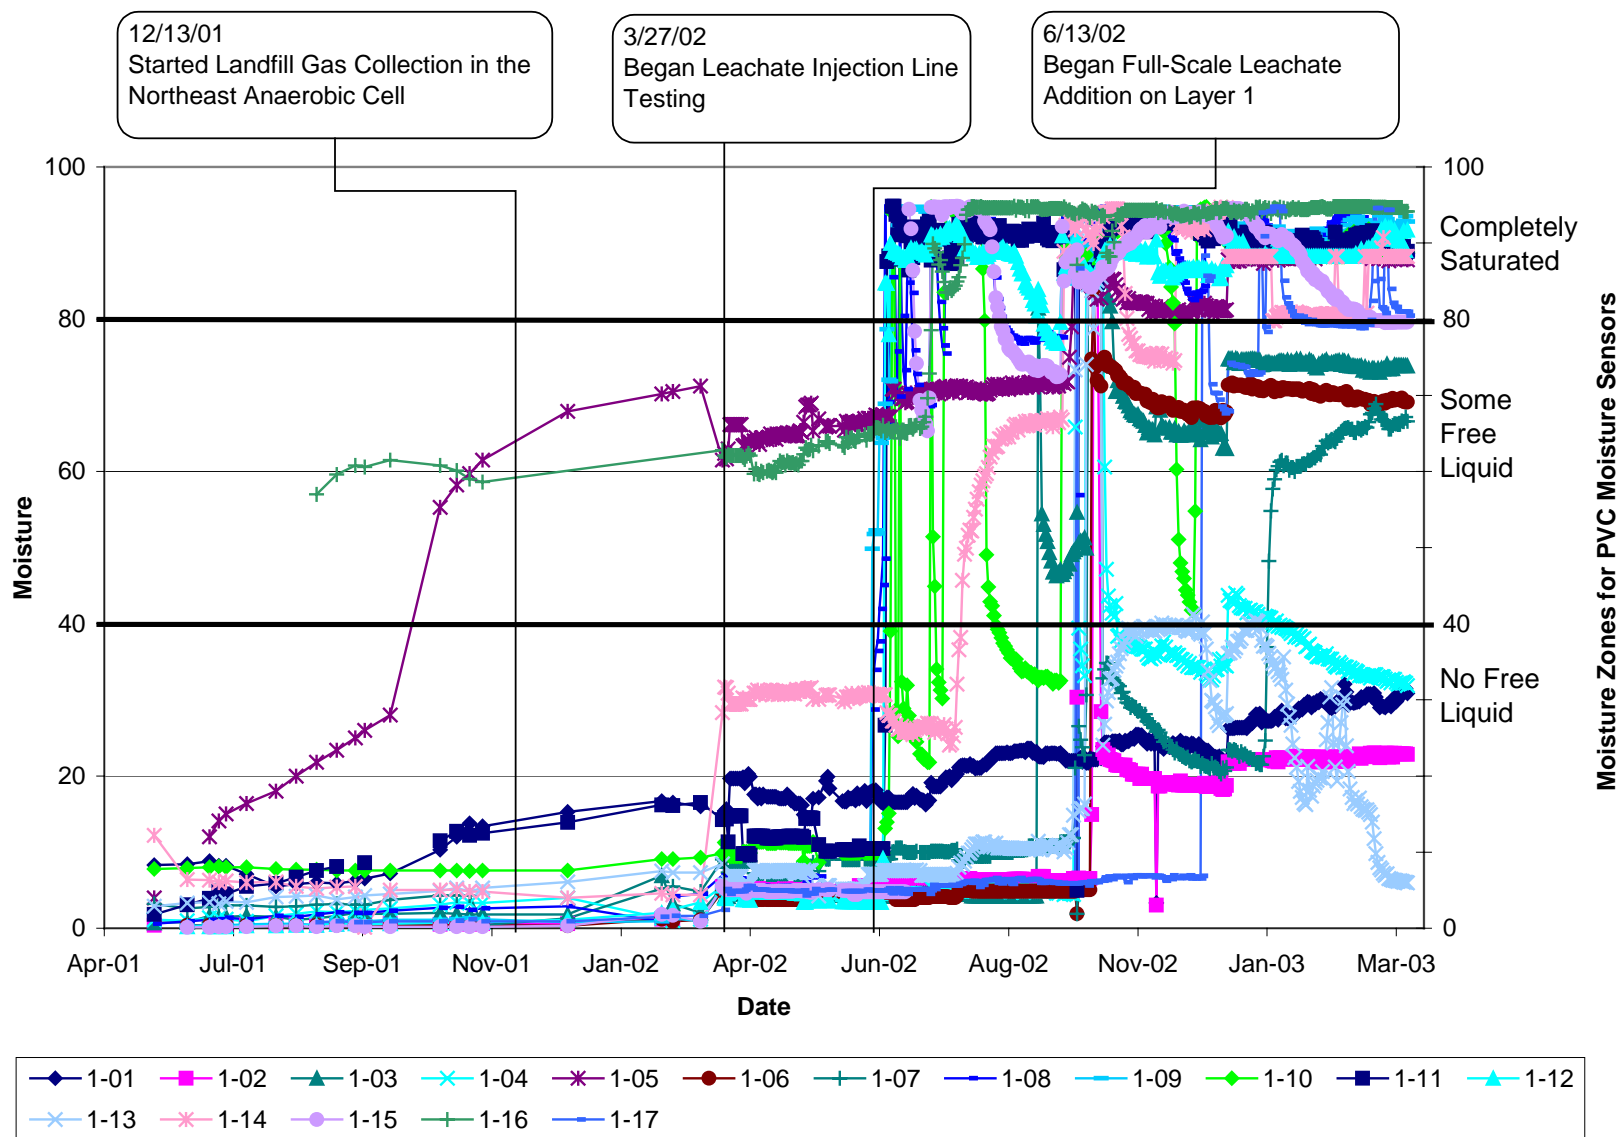
**Figure 3-7. Northeast Anaerobic Cell Layer 1 PVC Moisture Readings**

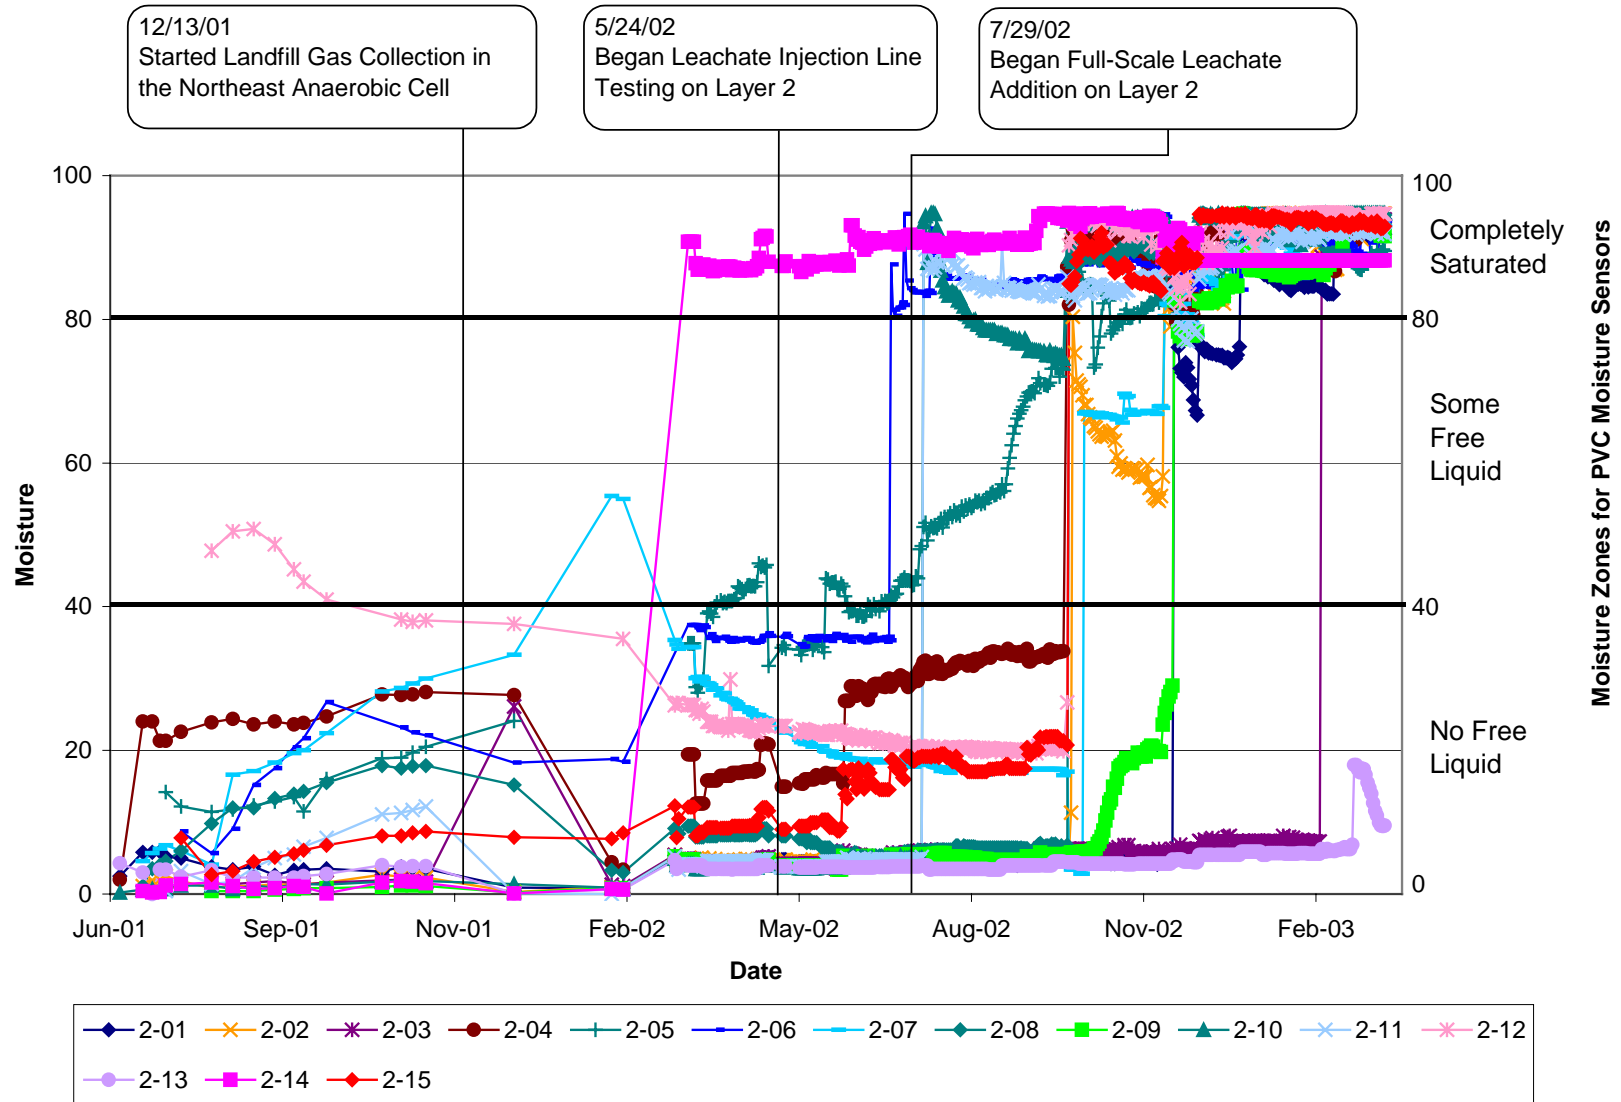
**Figure 3-8. Northeast Anaerobic Cell Layer 2 PVC Moisture Readings**

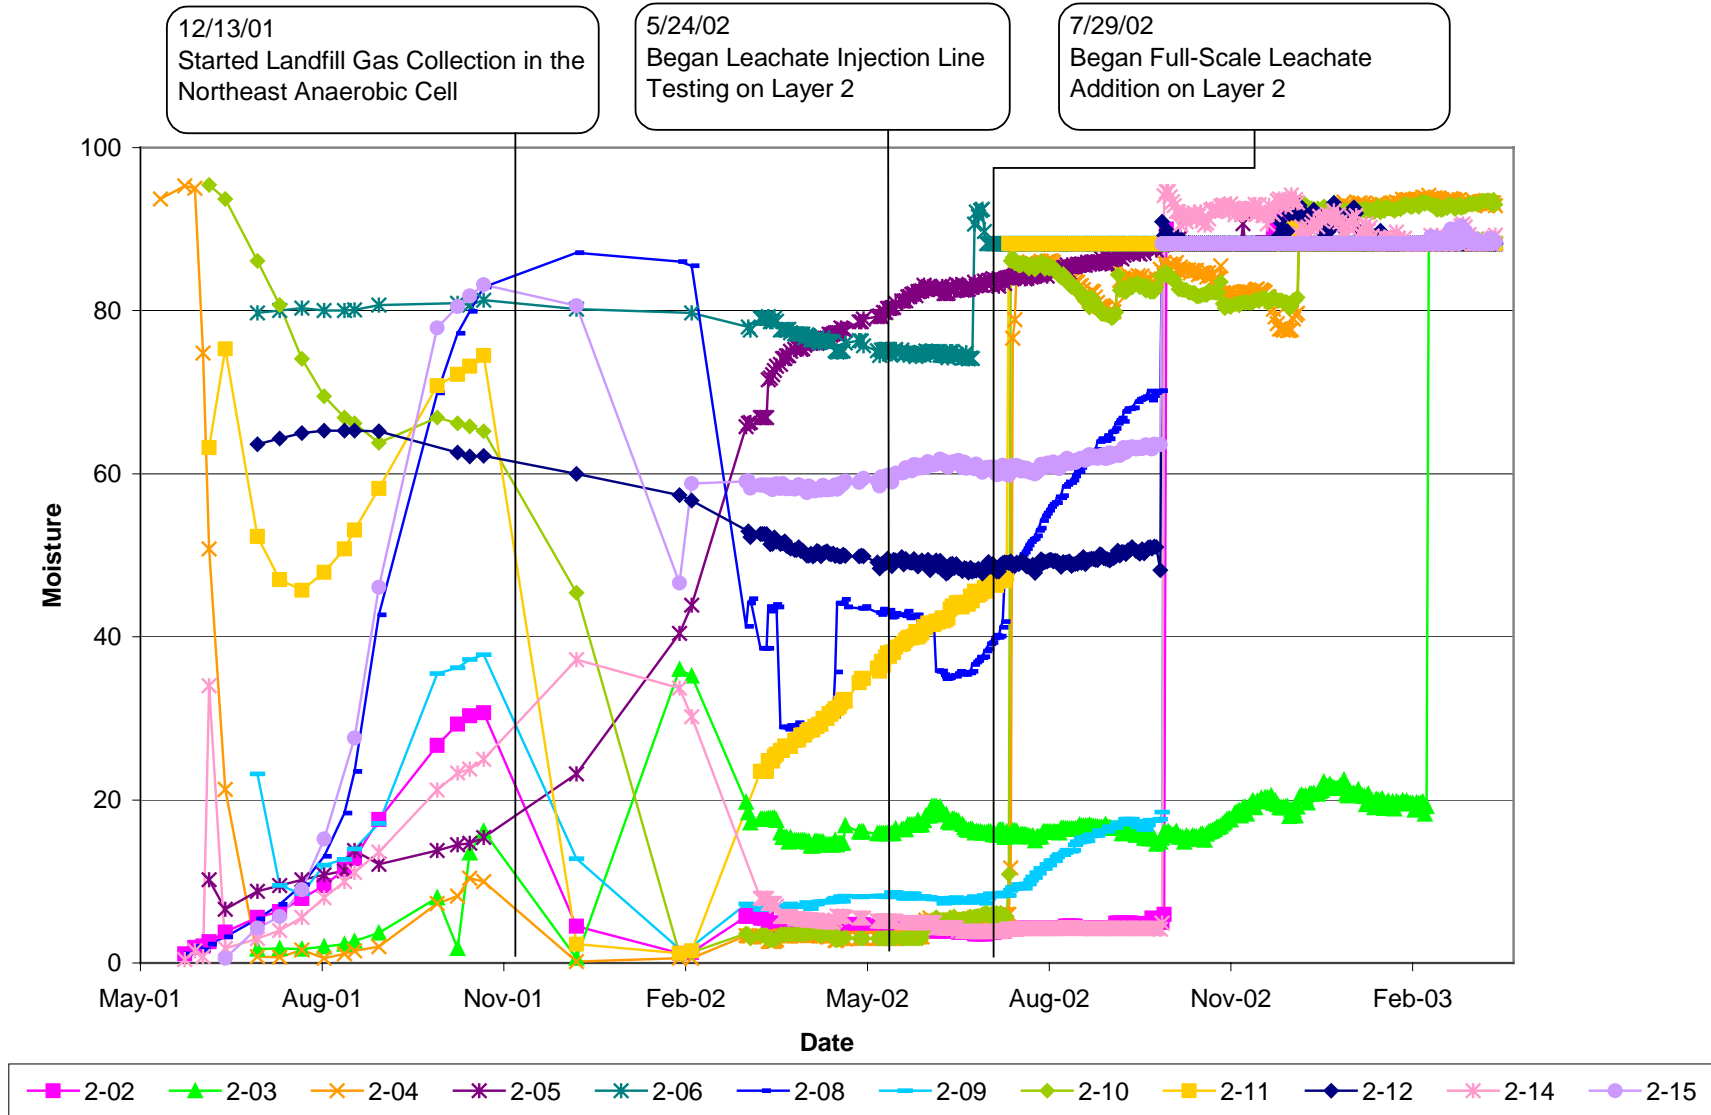
**Figure 3-9. Northeast Anaerobic Cell Layer 2 Gypsum in Plaster Moisture Readings**

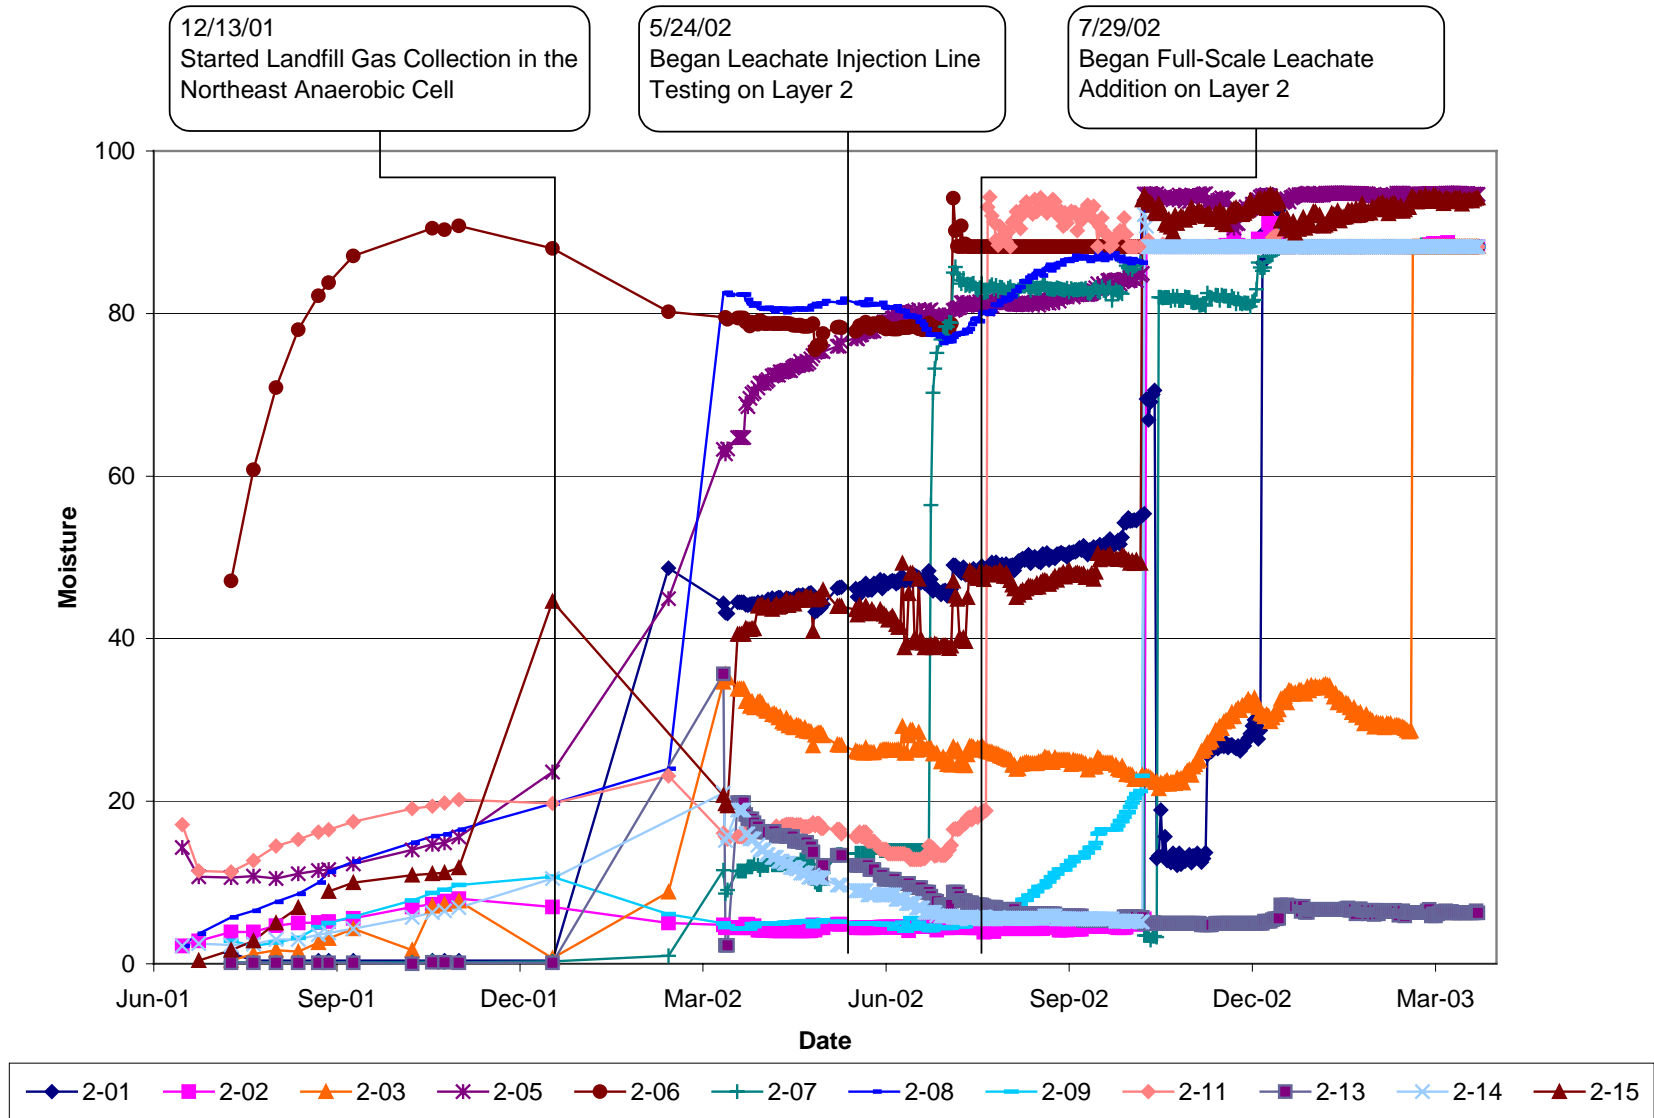
**Figure 3-10. Northeast Anaerobic Cell Layer 2 Gypsum in Soil Moisture Readings**

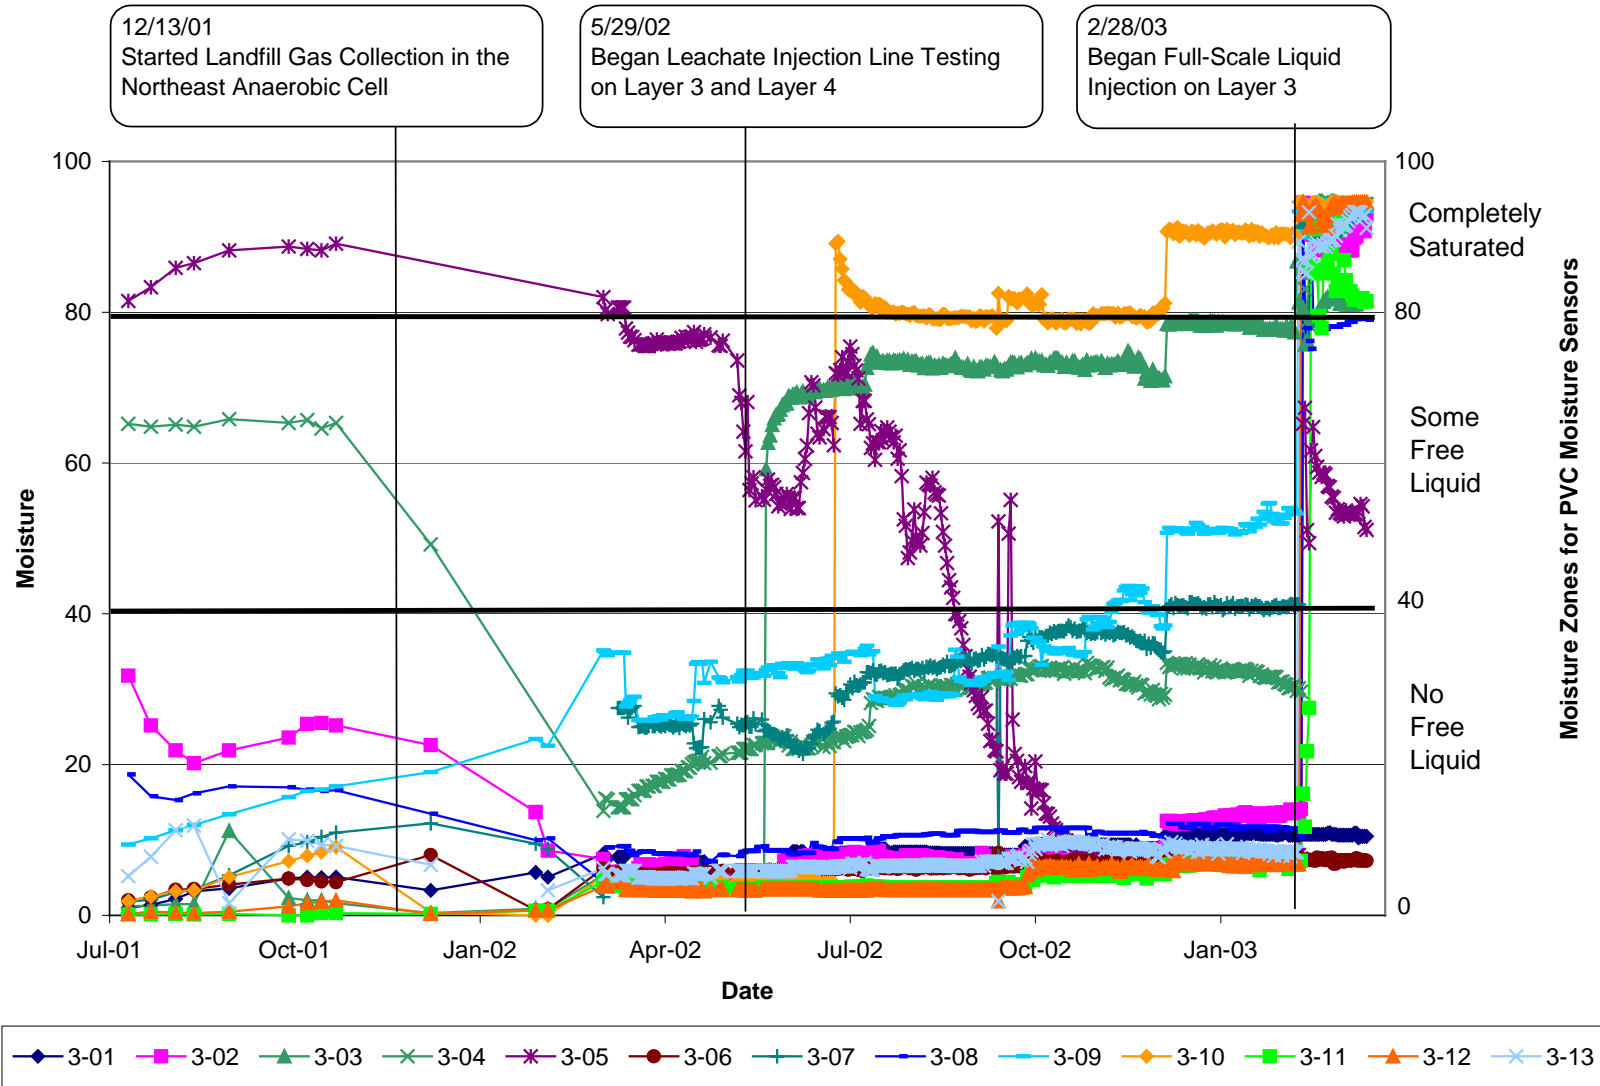
**Figure 3-11. Northeast Anaerobic Cell Layer 3 PVC Moisture Readings**

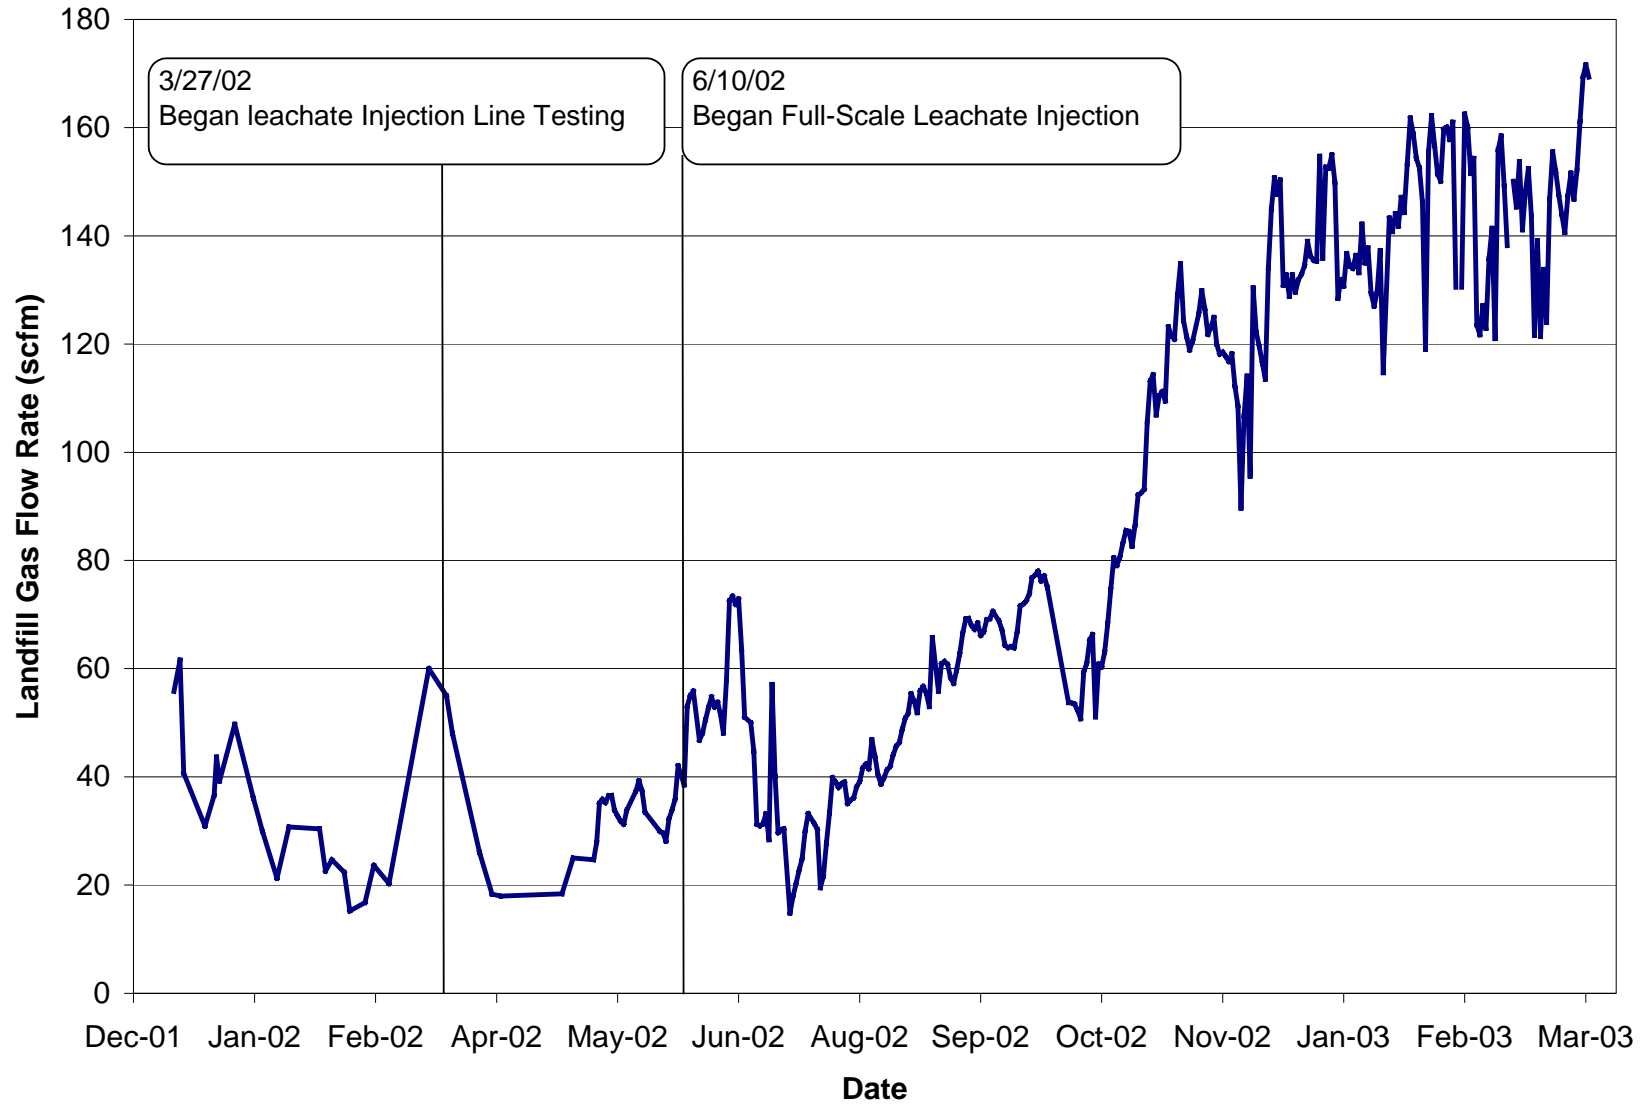
**Figure 3-14. Northeast Anaerobic Cell Landfill Gas Flow Rate**

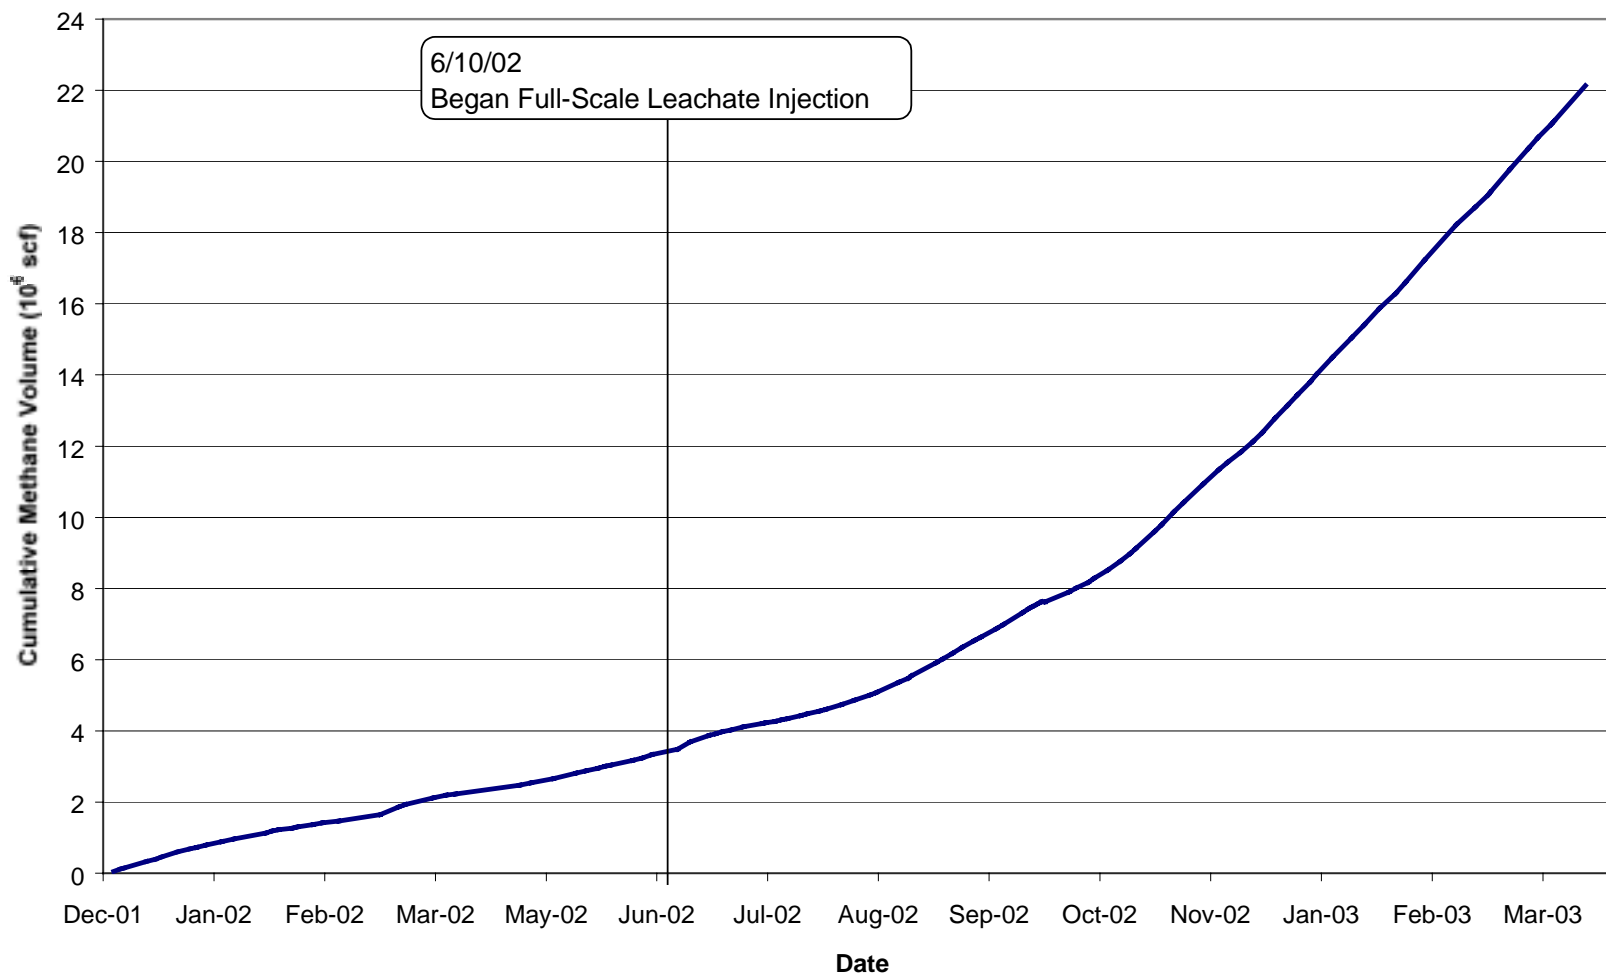
Figure 3-15. Northeast Anaerobic Cell Cumulative Methane

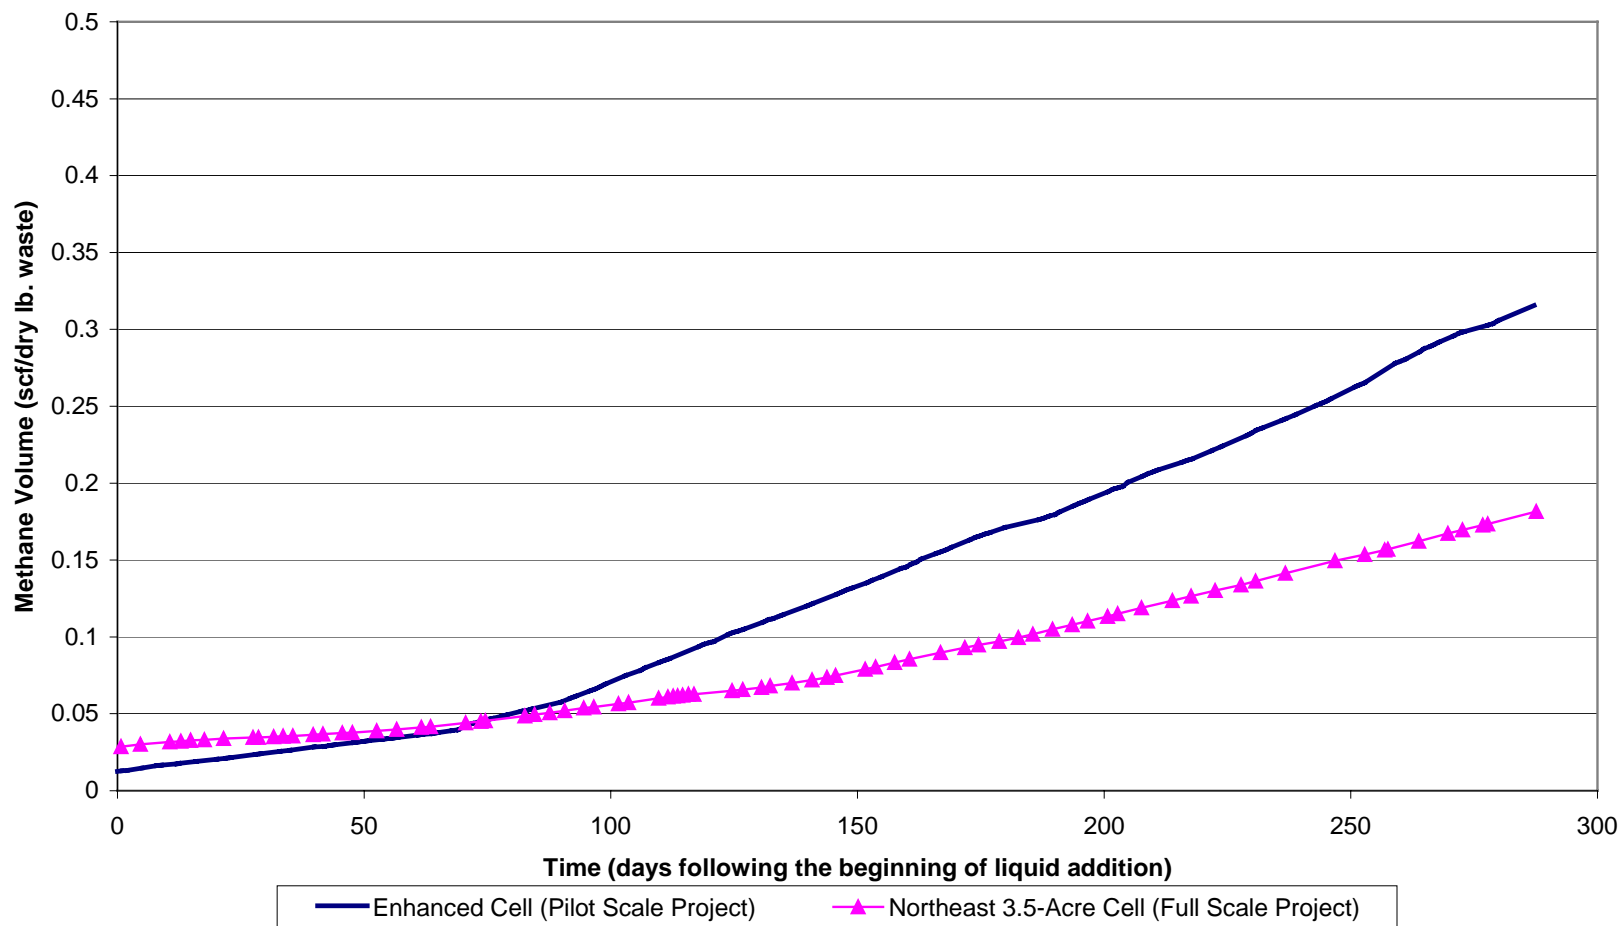
**Figure 3-16. Cumulative Methane from the Northeast Anaerobic Cell and the Enhanced Cell from the Pilot Scale Project**

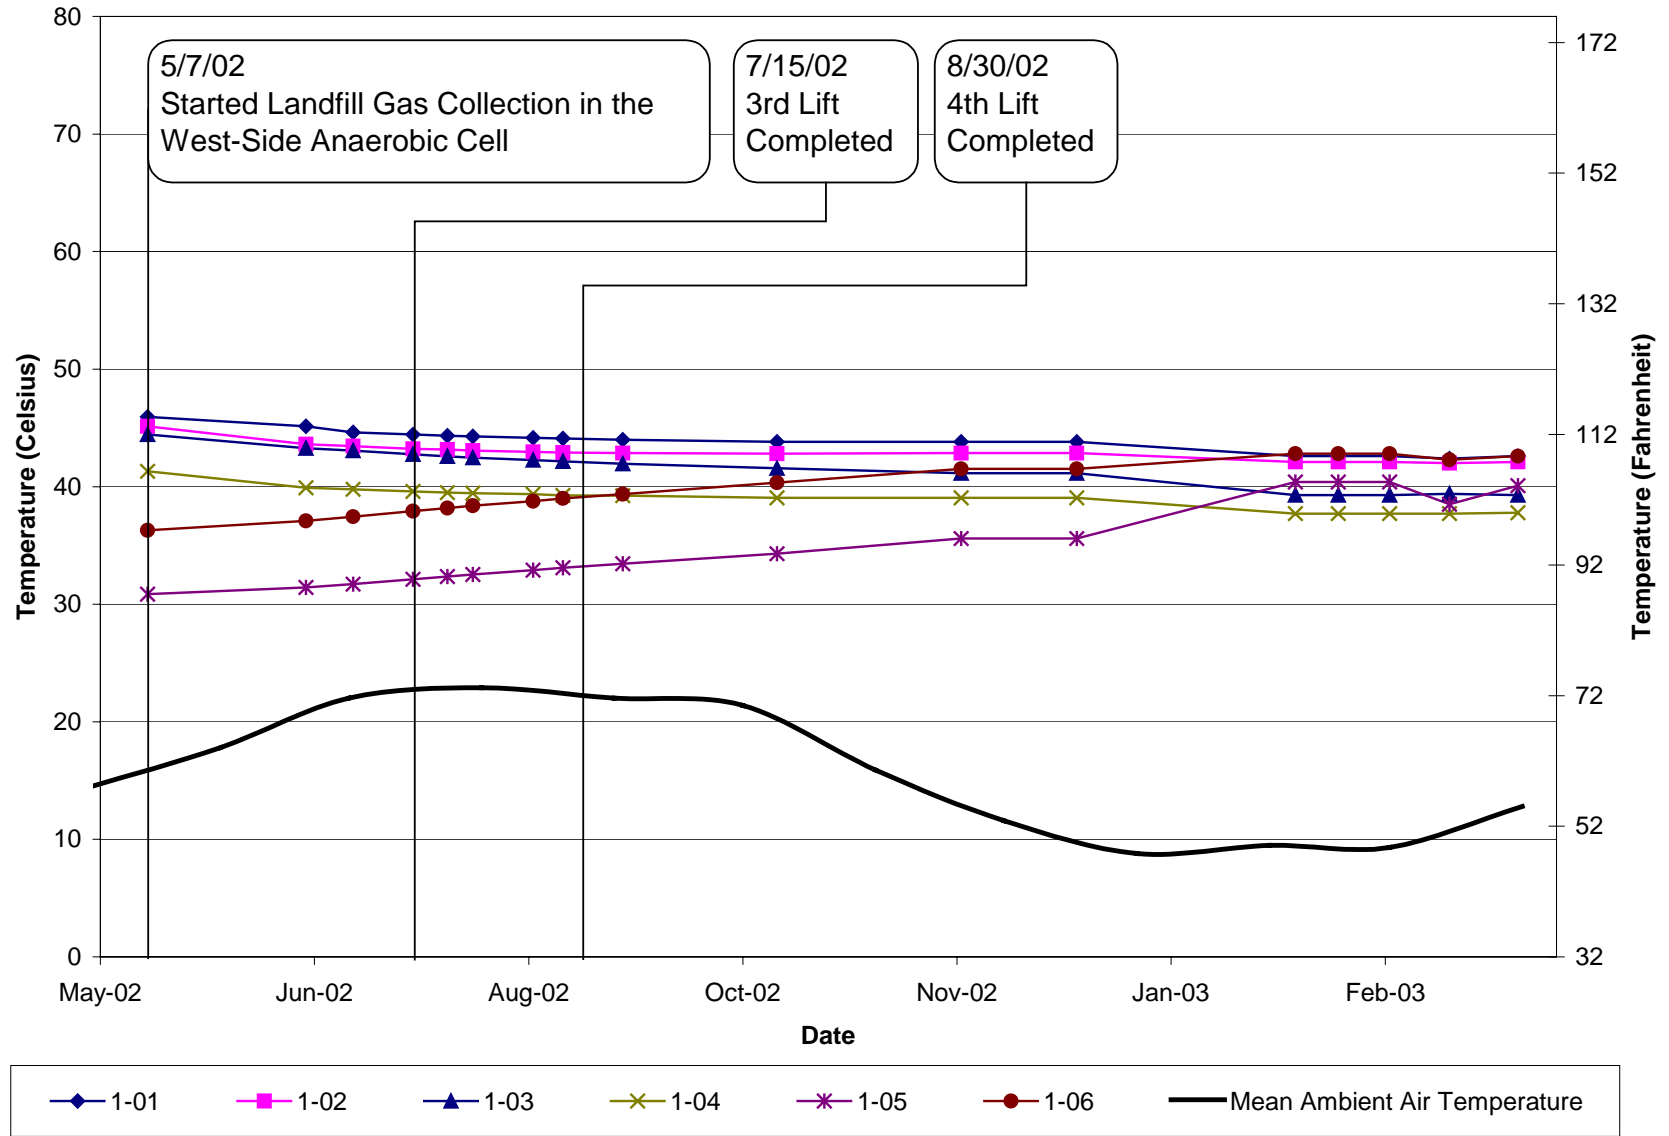
**Figure 4-1. West-Side Anaerobic Cell Layer 1 Temperature Readings**

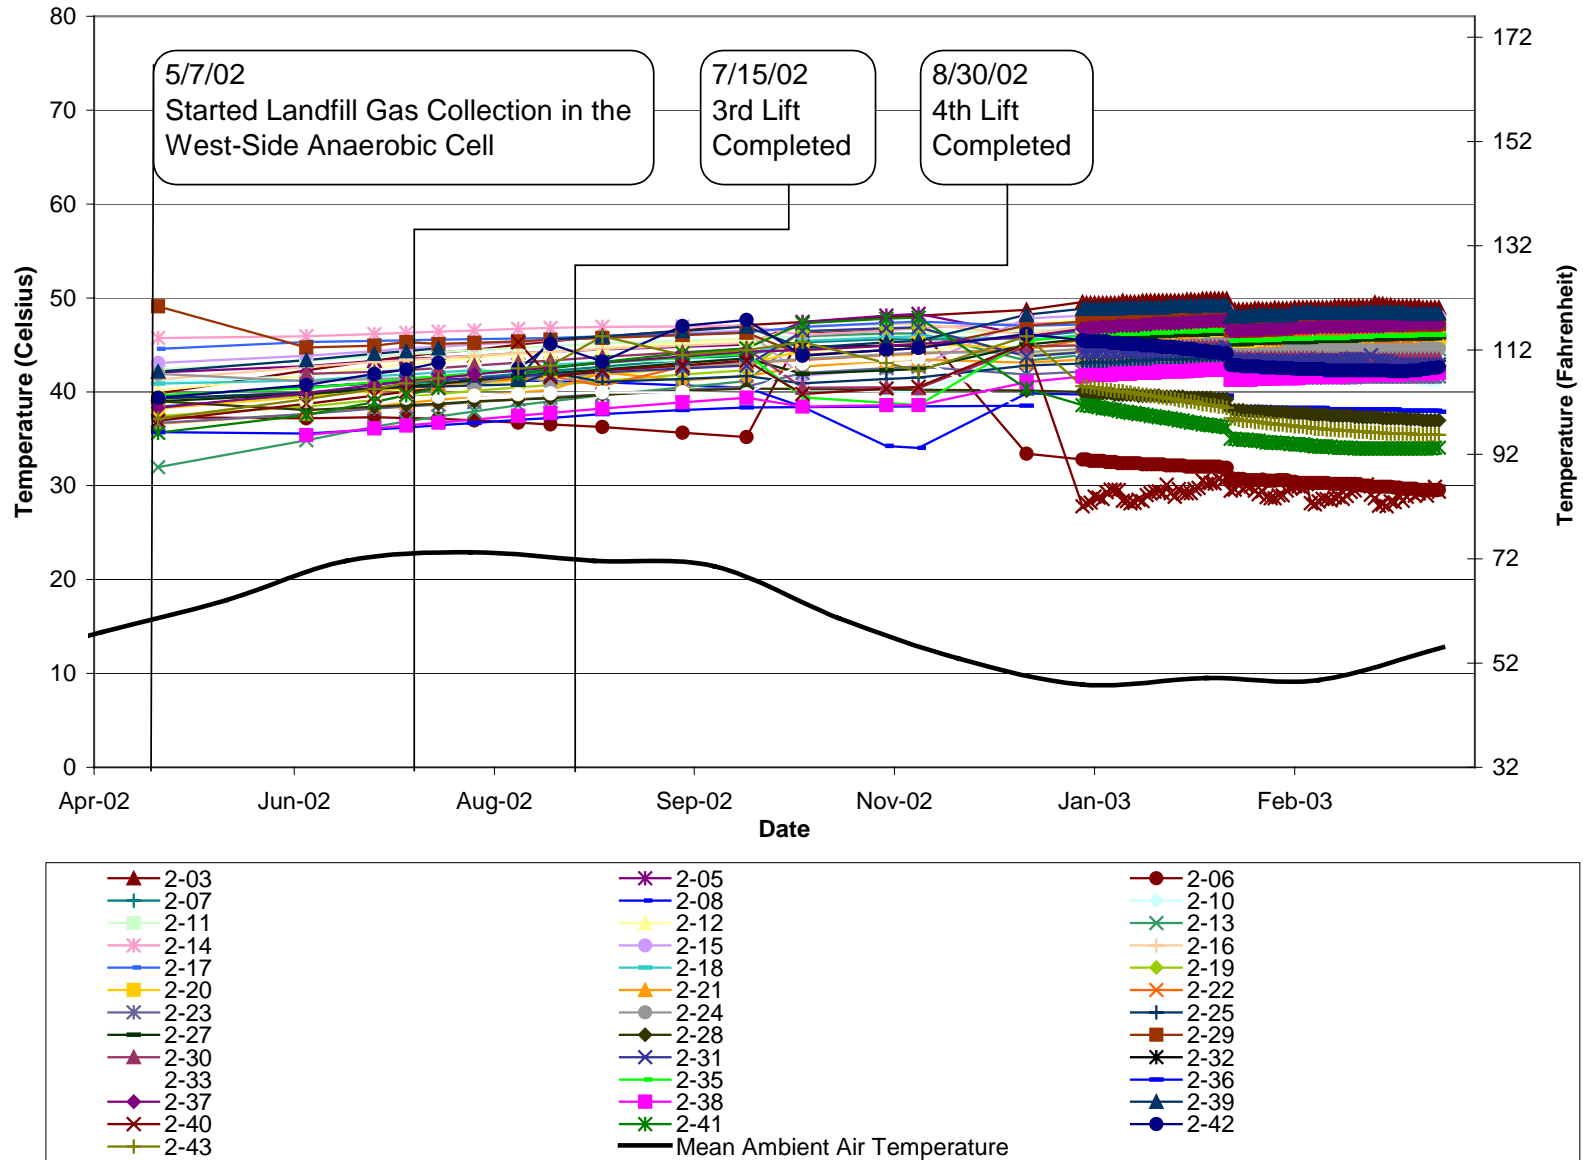
**Figure 4-2. West-Side Anaerobic Cell Layer 2 Temperature Readings**
