## **APPENDIX C – GRAPHS**

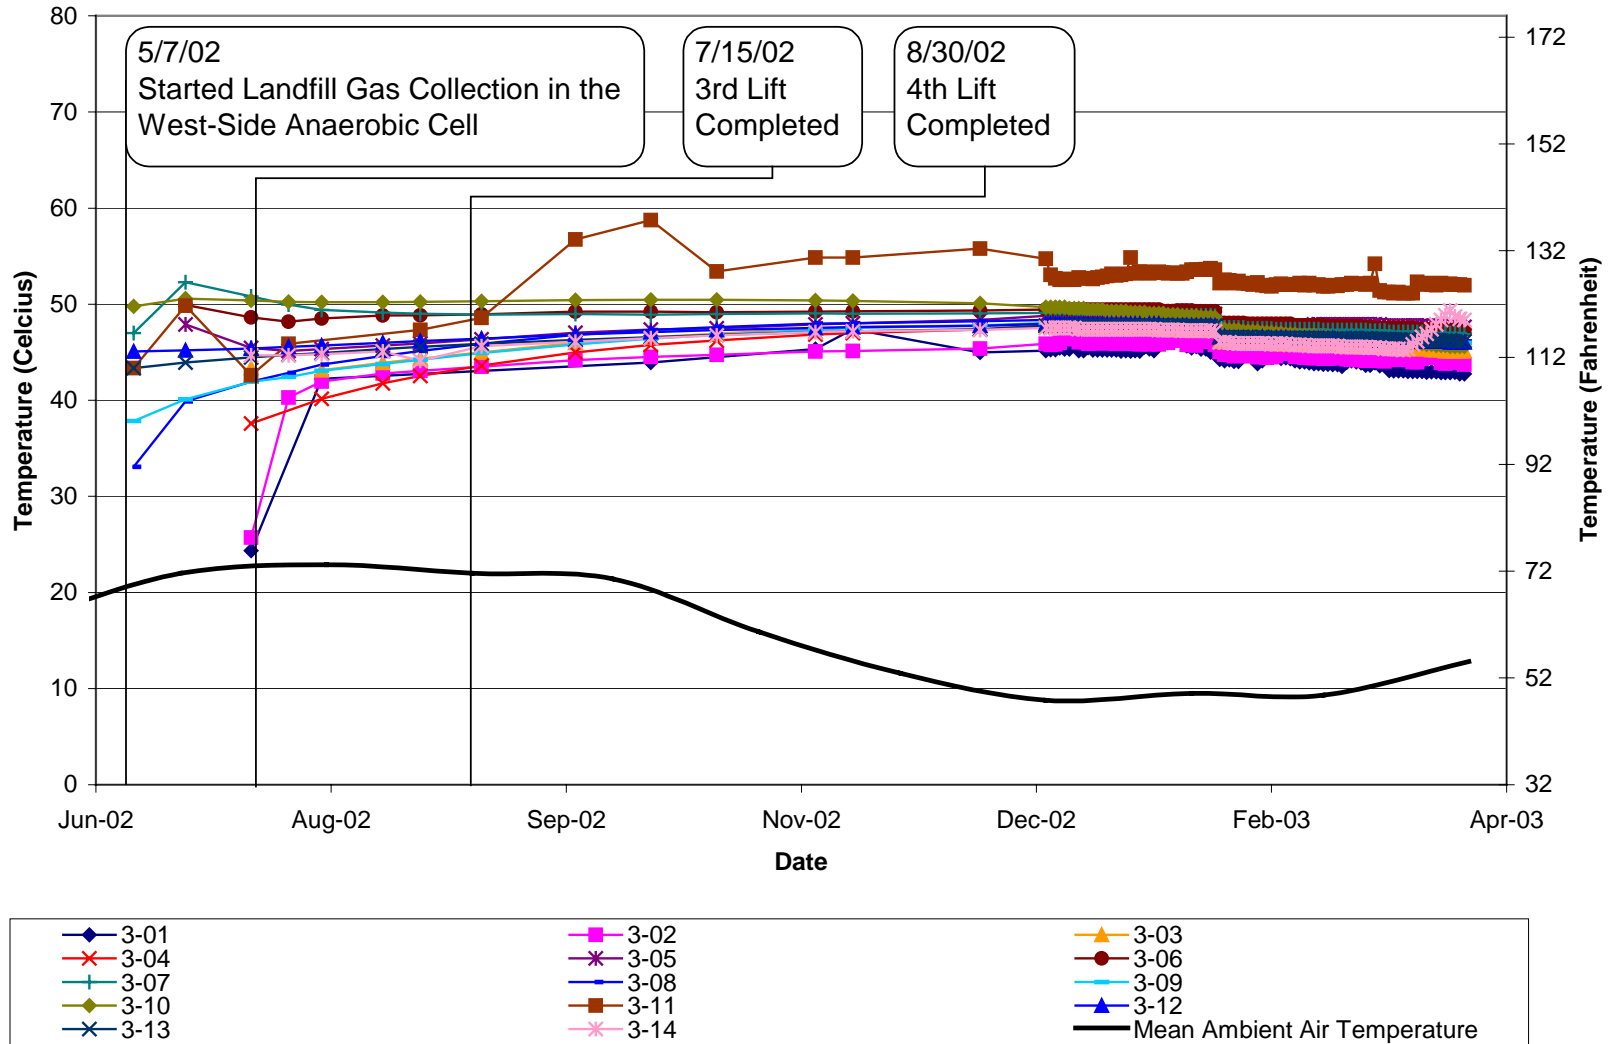
**Figure 4-3. West-Side Anaerobic Cell Layer 3 Temperature Readings**

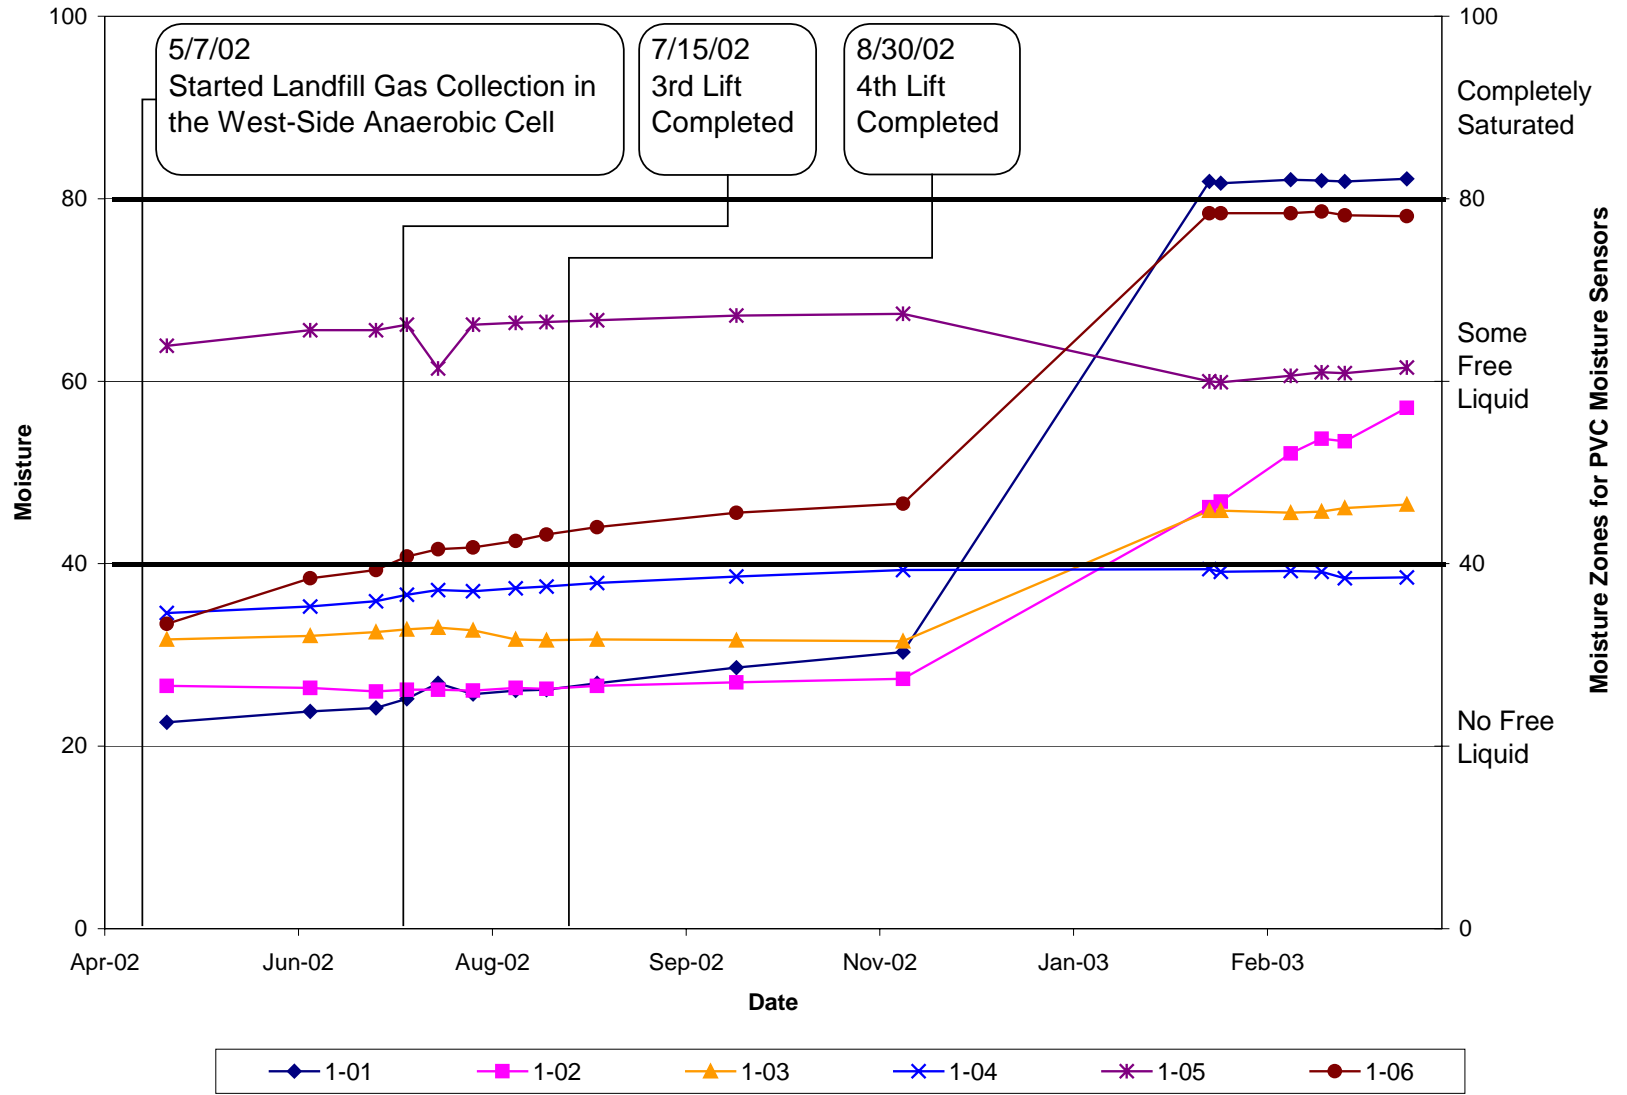
**Figure 4-5. West-Side Anaerobic Cell Layer 1 PVC Moisture Readings**

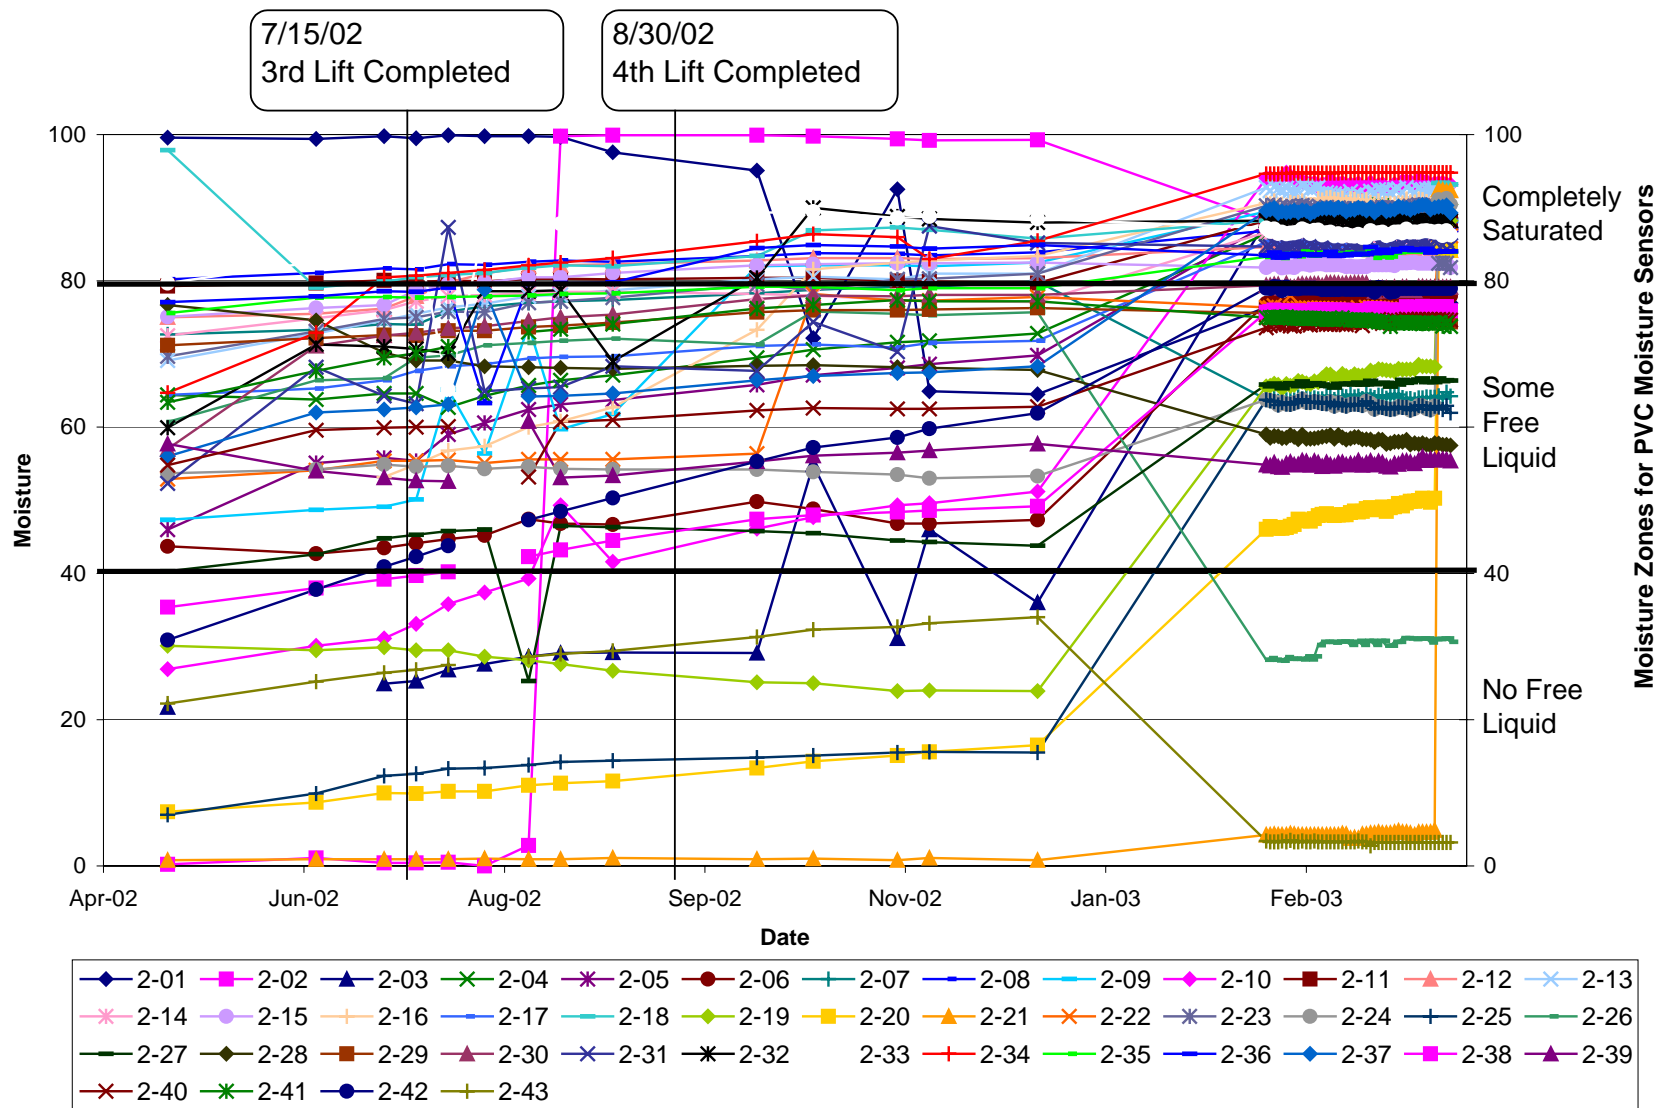
Figure 4-6. West-Side Anaerobic Cell Layer 2 PVC Readings

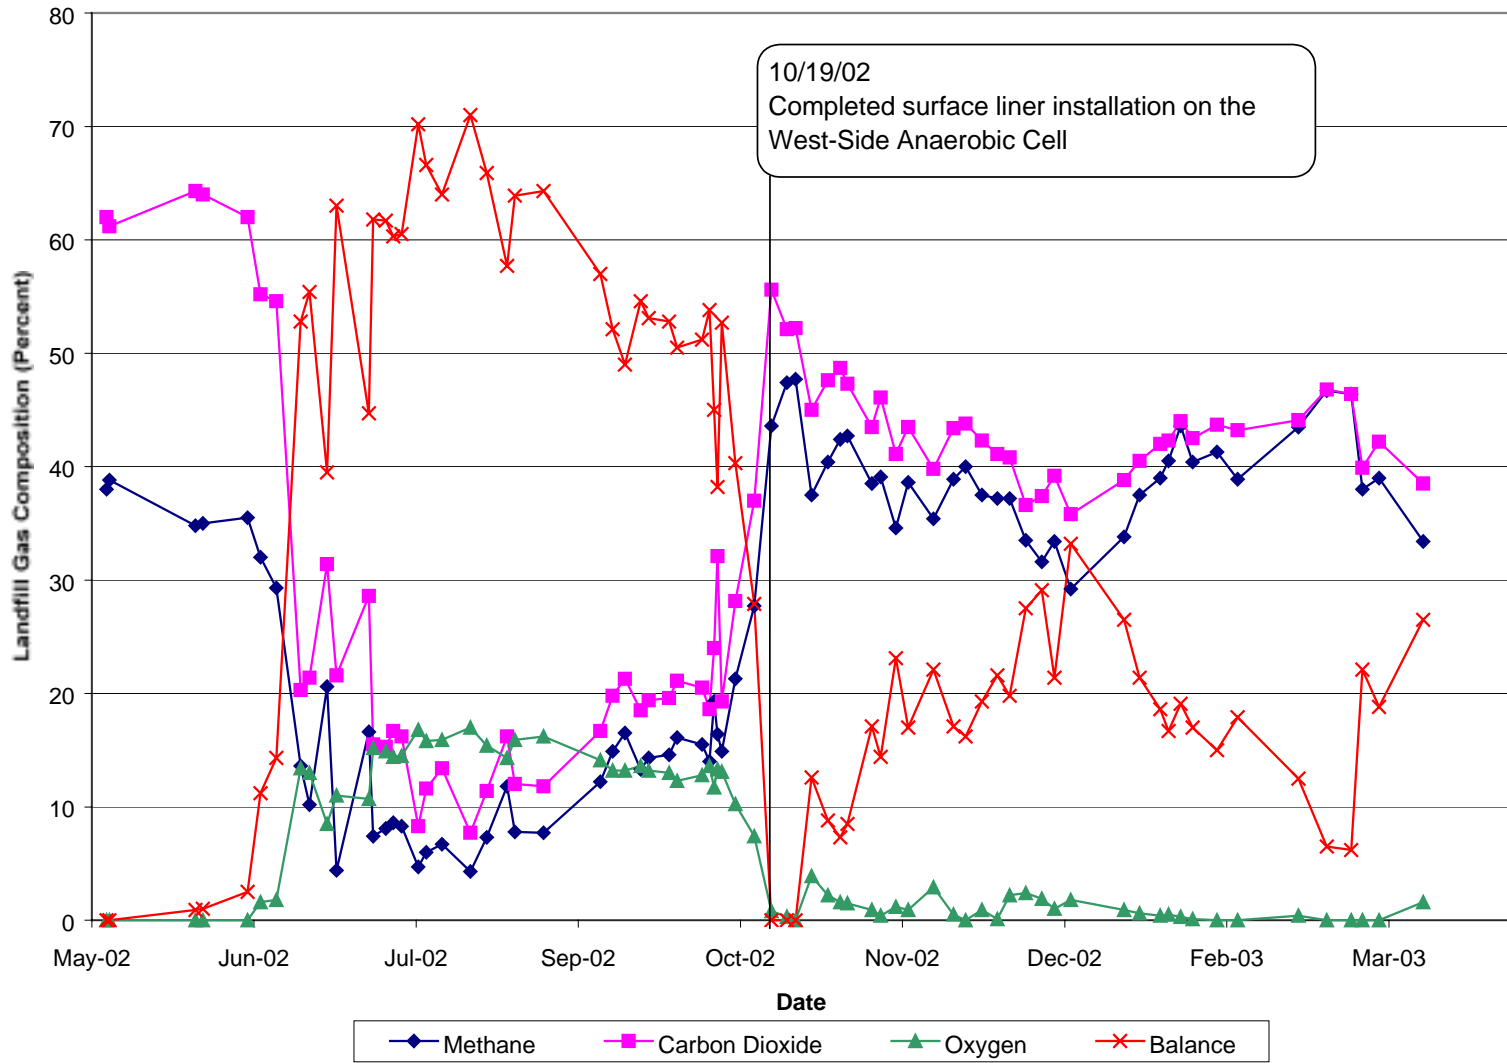
**Figure 4-9. West-Side Anaerobic Cell Landfill Gas Concentrations from Header Line**

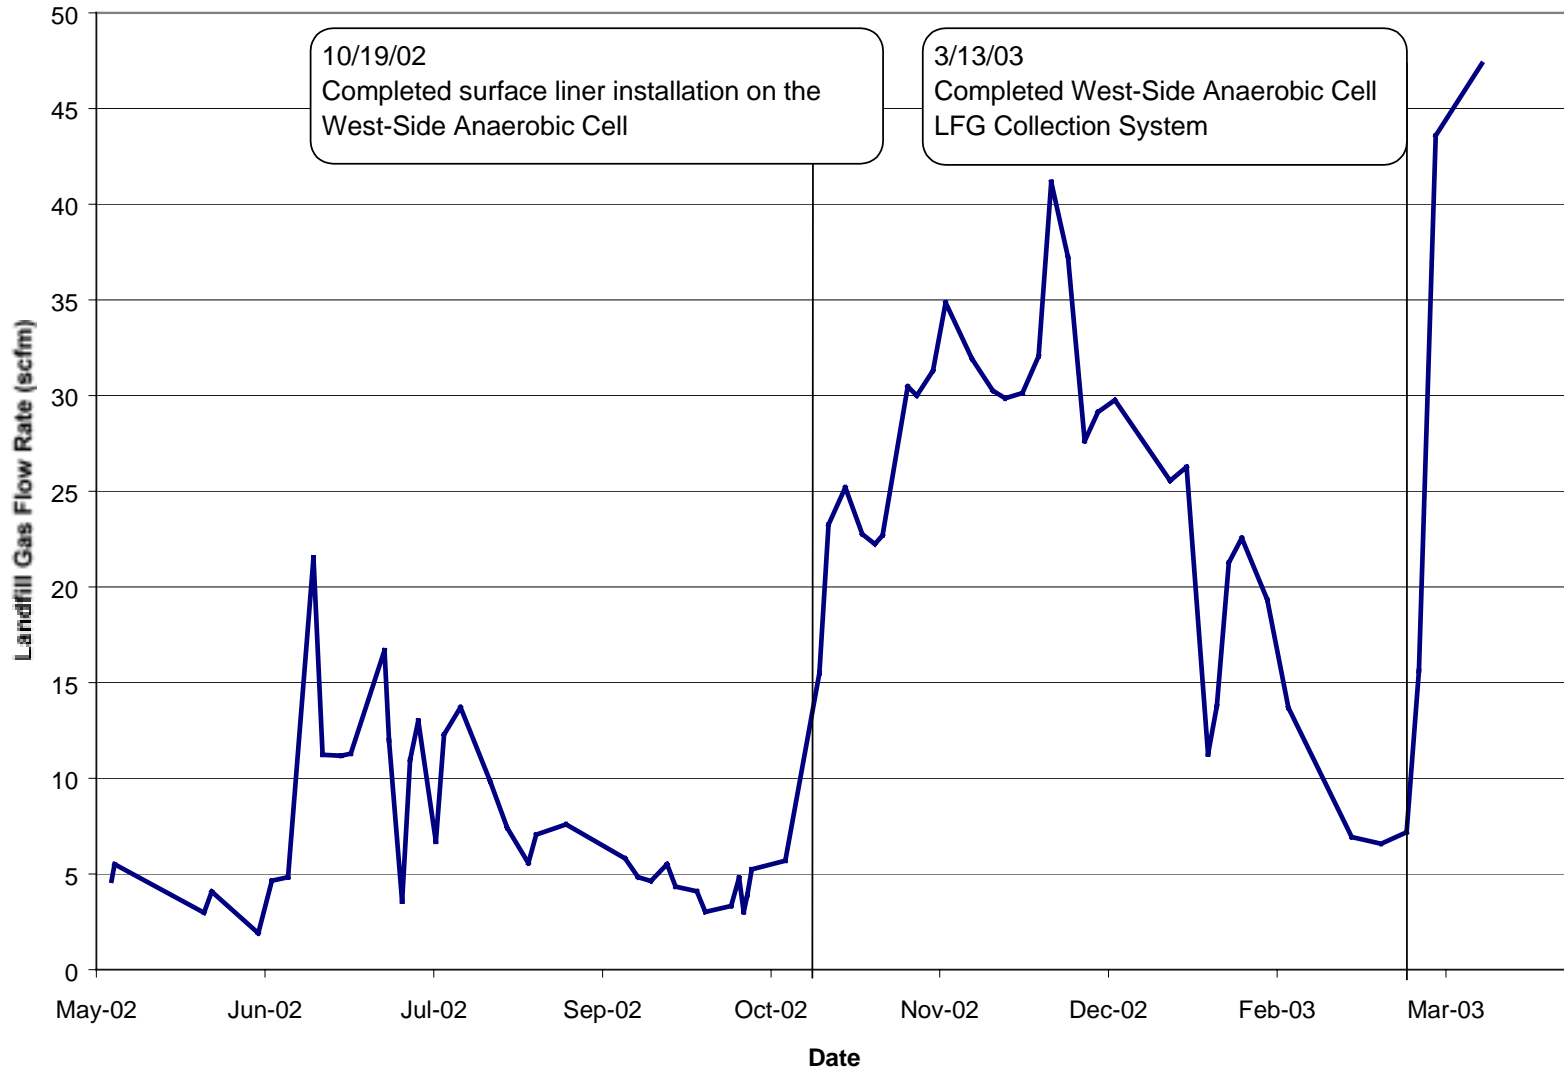
**Figure 4-10. West-Side Anaerobic Cell Landfill Gas Flow Rate**

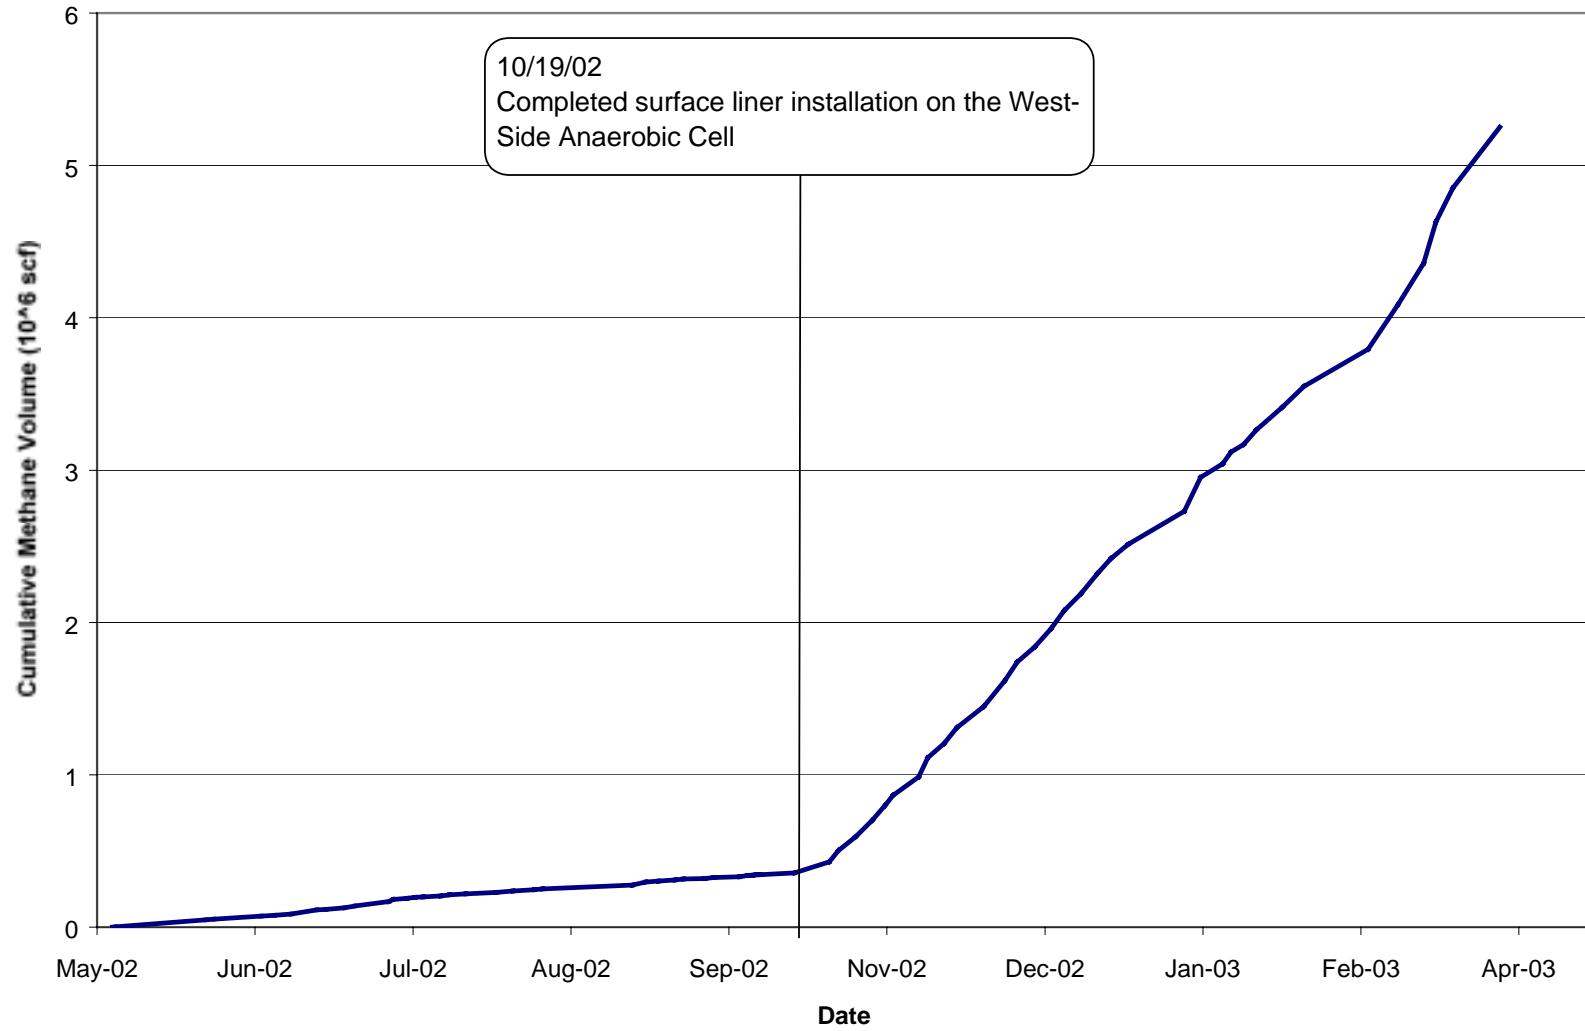
**Figure 4-11. West-Side Anaerobic Cell Cumulative Methane**

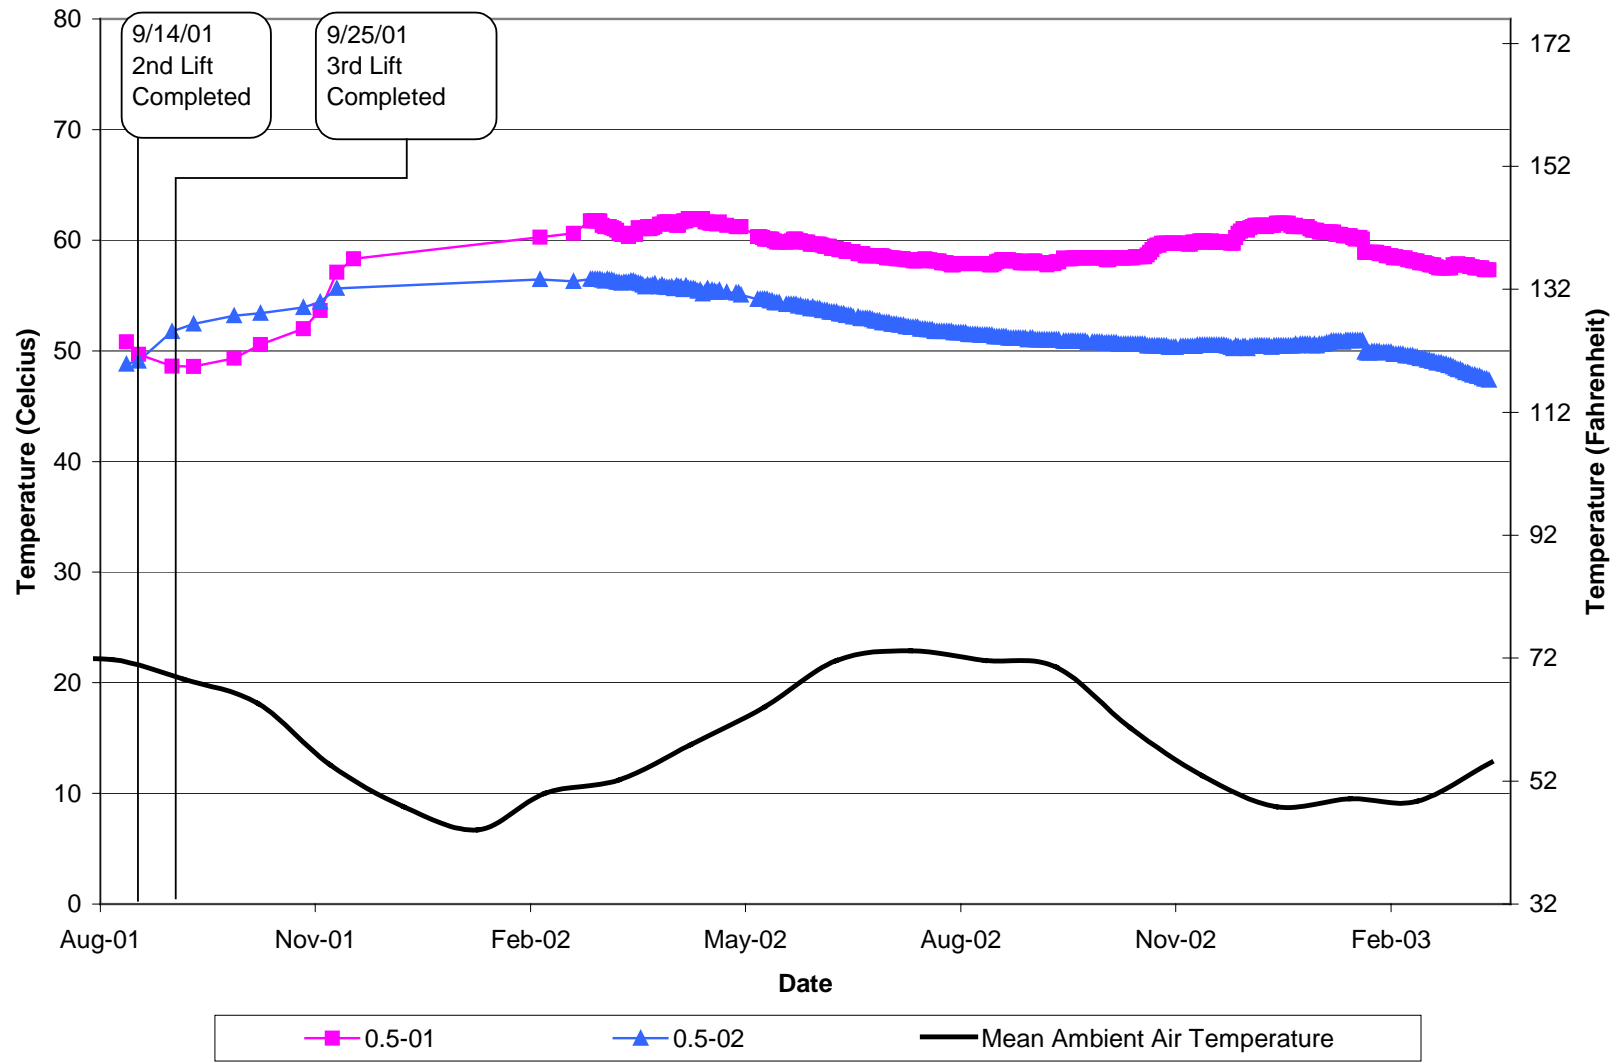
**Figure 5-2. Aerobic Cell Layer 0.5 Temperature Readings**

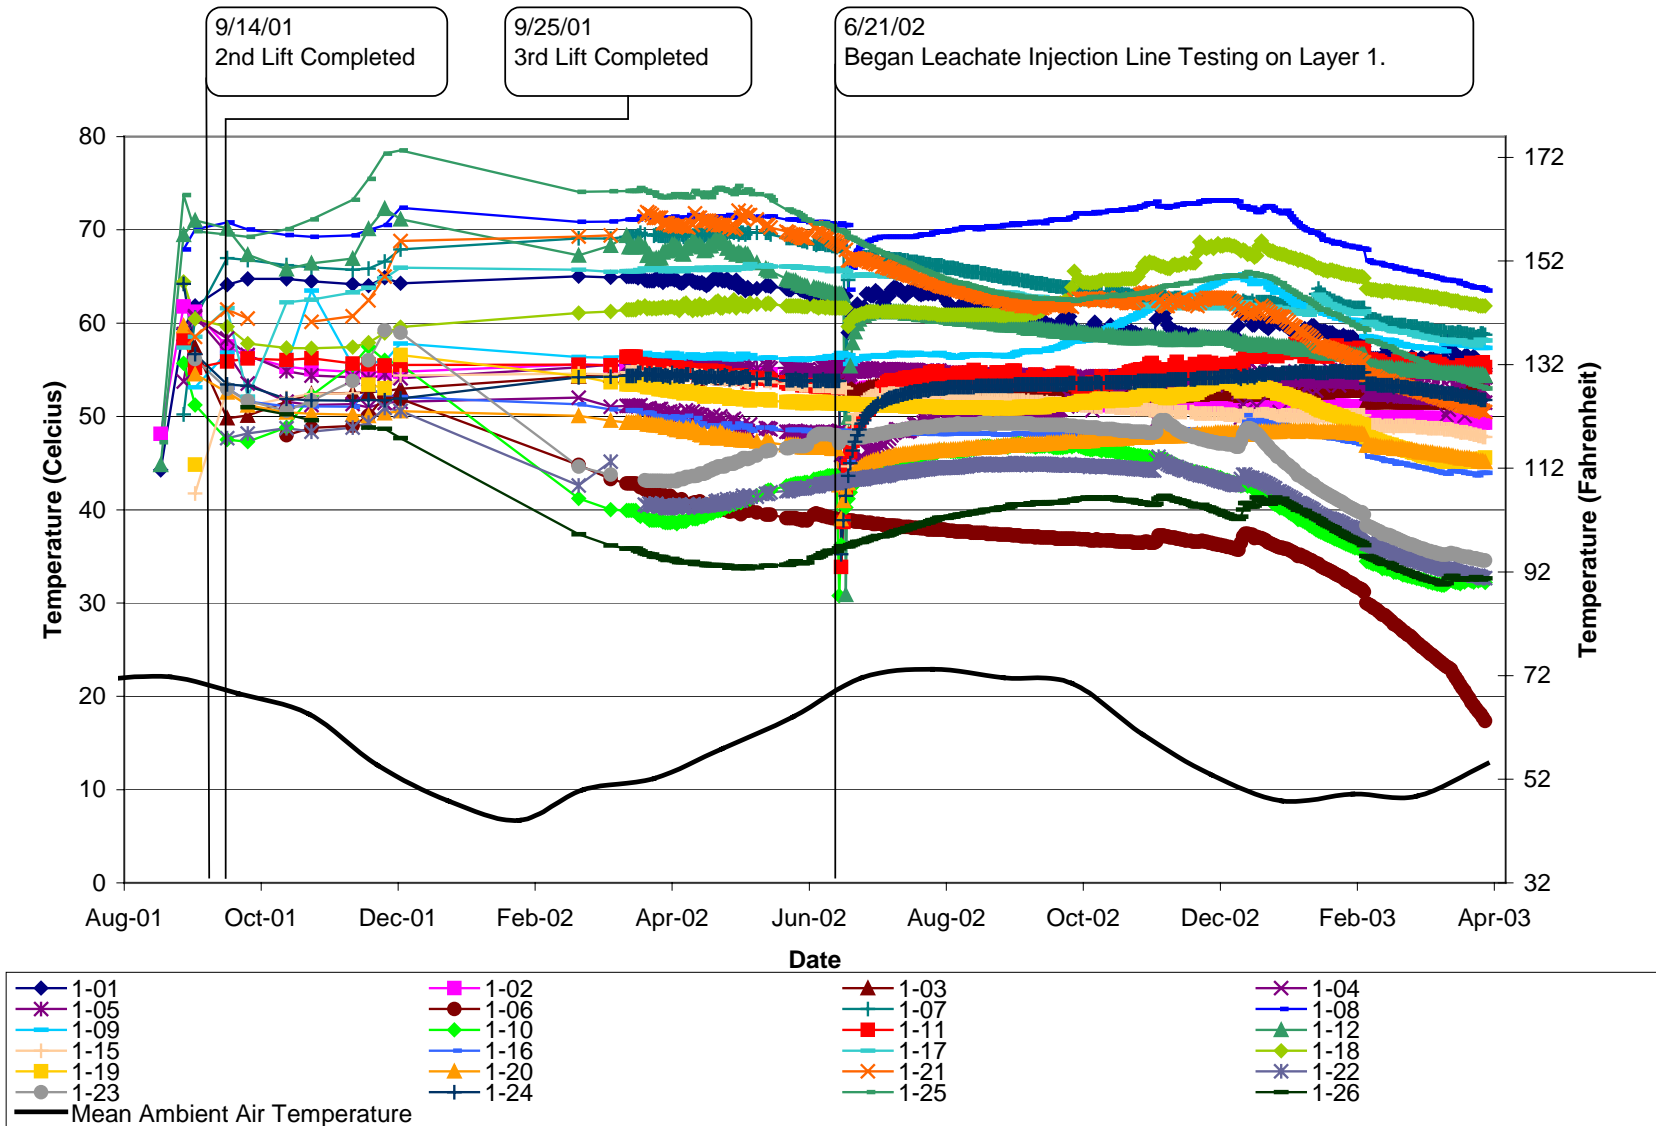
**Figure 5-3. Aerobic Cell Layer 1 Temperature Readings**

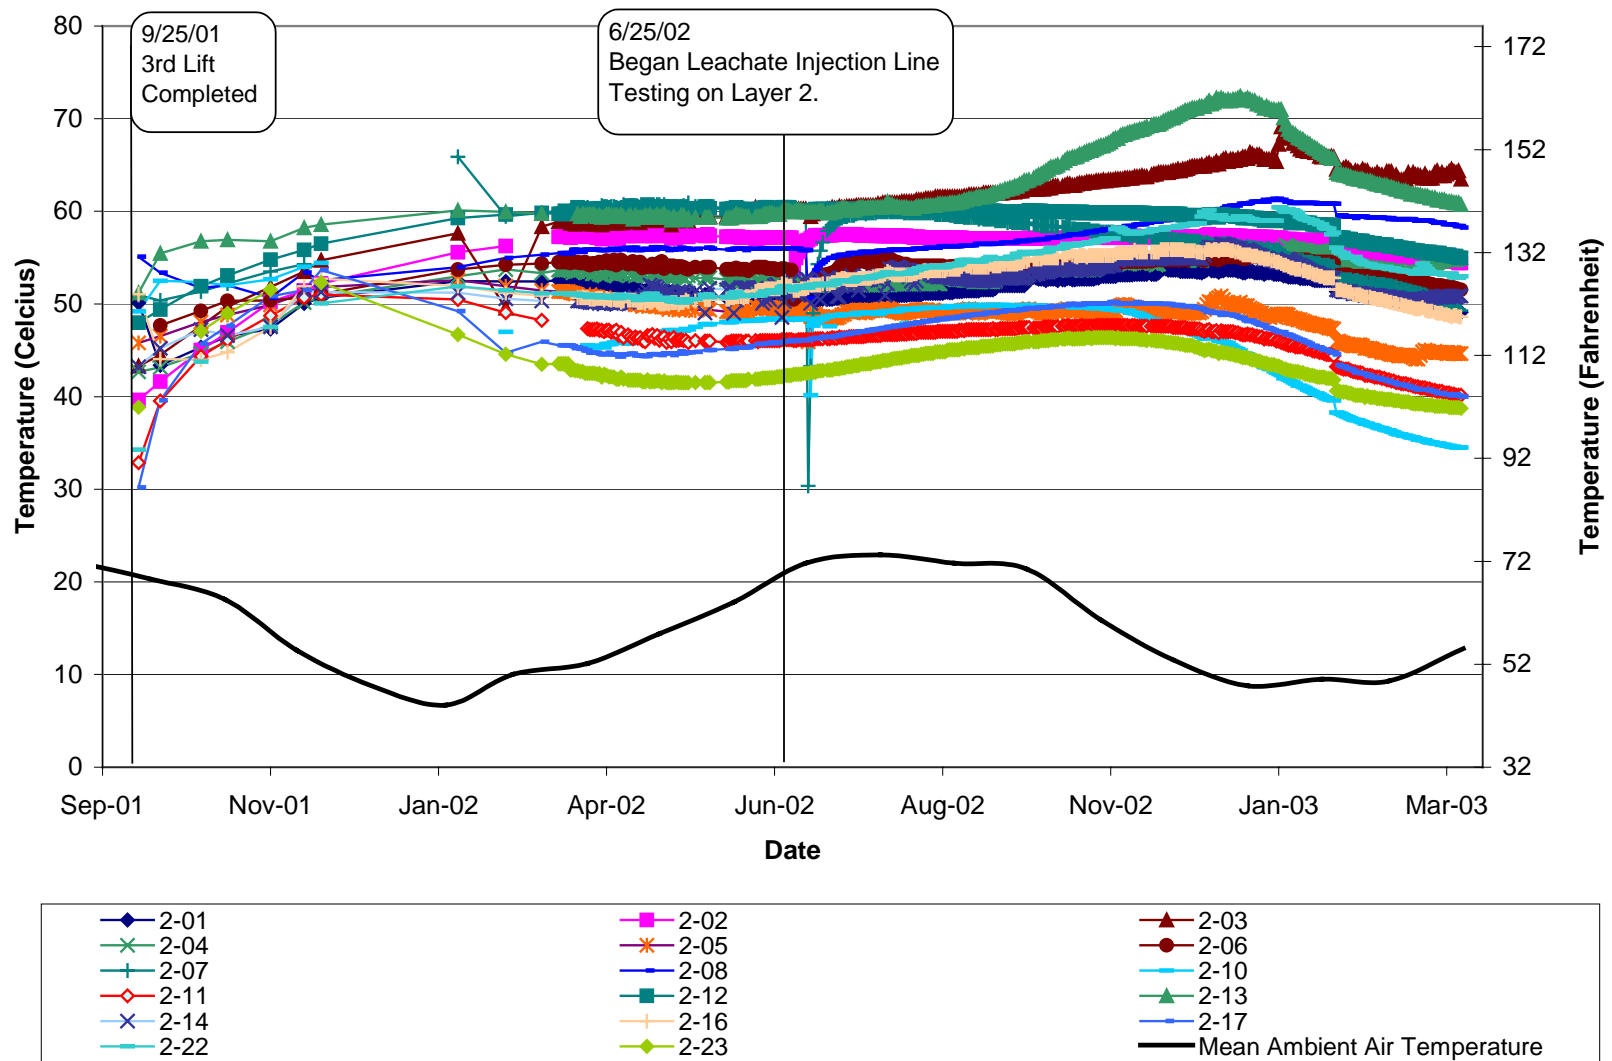
**Figure 5-4. Aerobic Cell Layer 2 Temperature Readings**

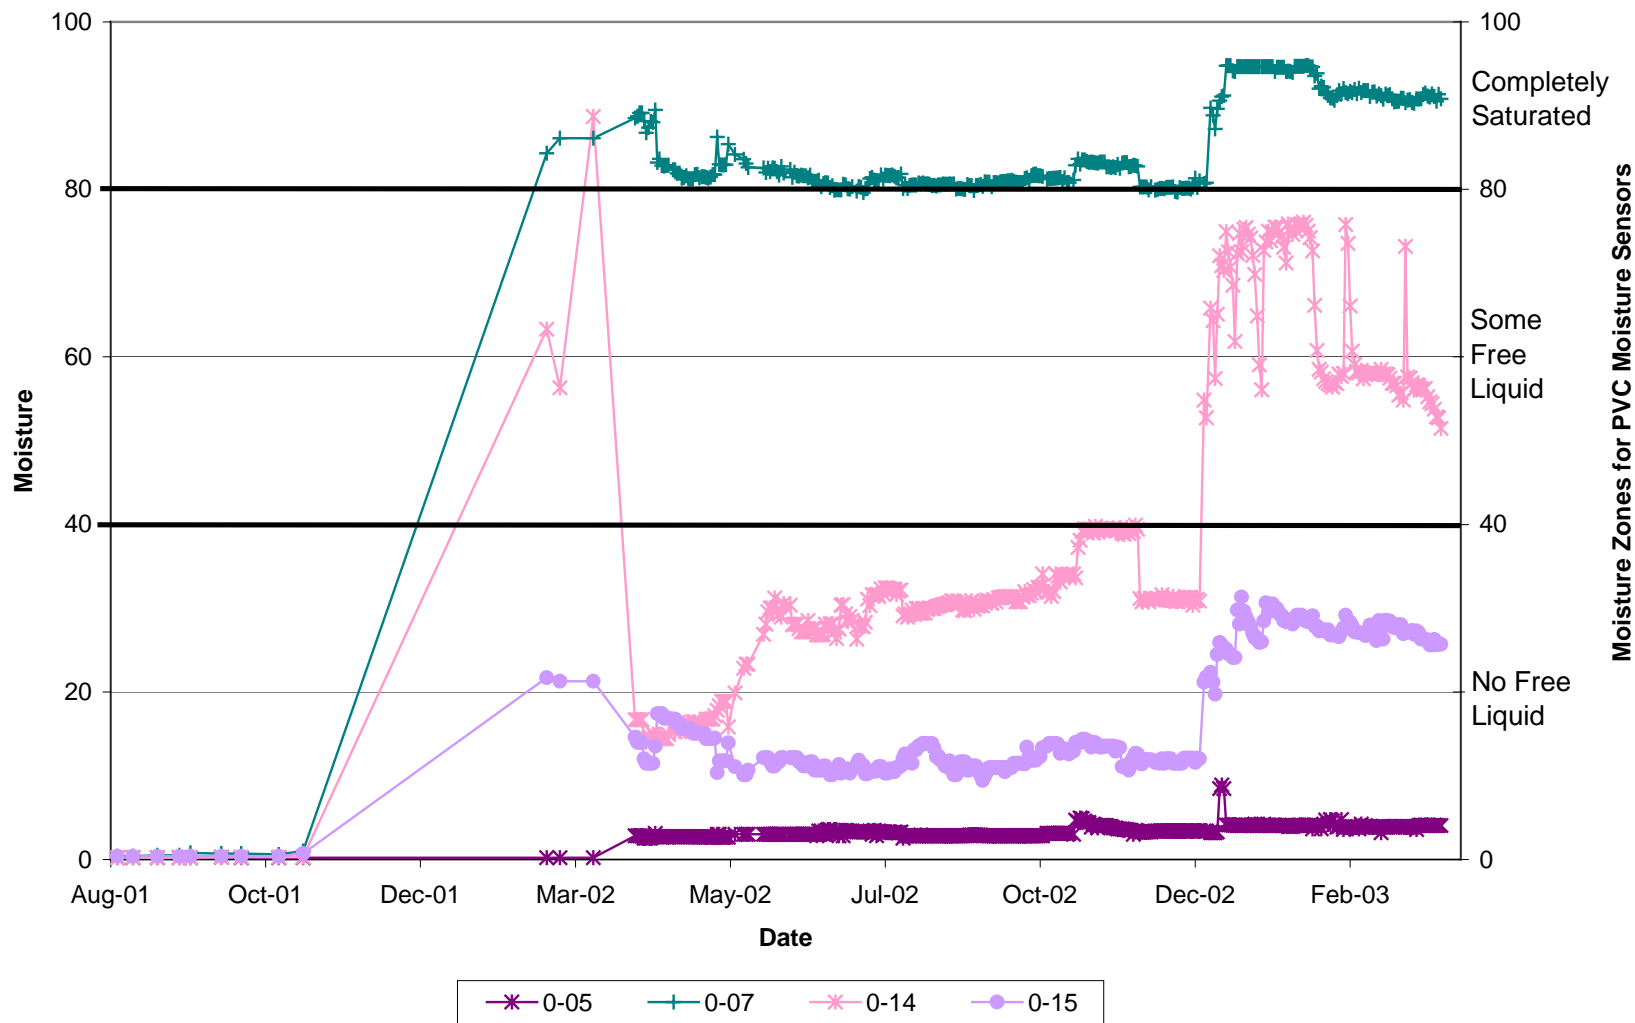
**Figure 5-6. Aerobic Cell Base Liner PVC Moisture Readings**

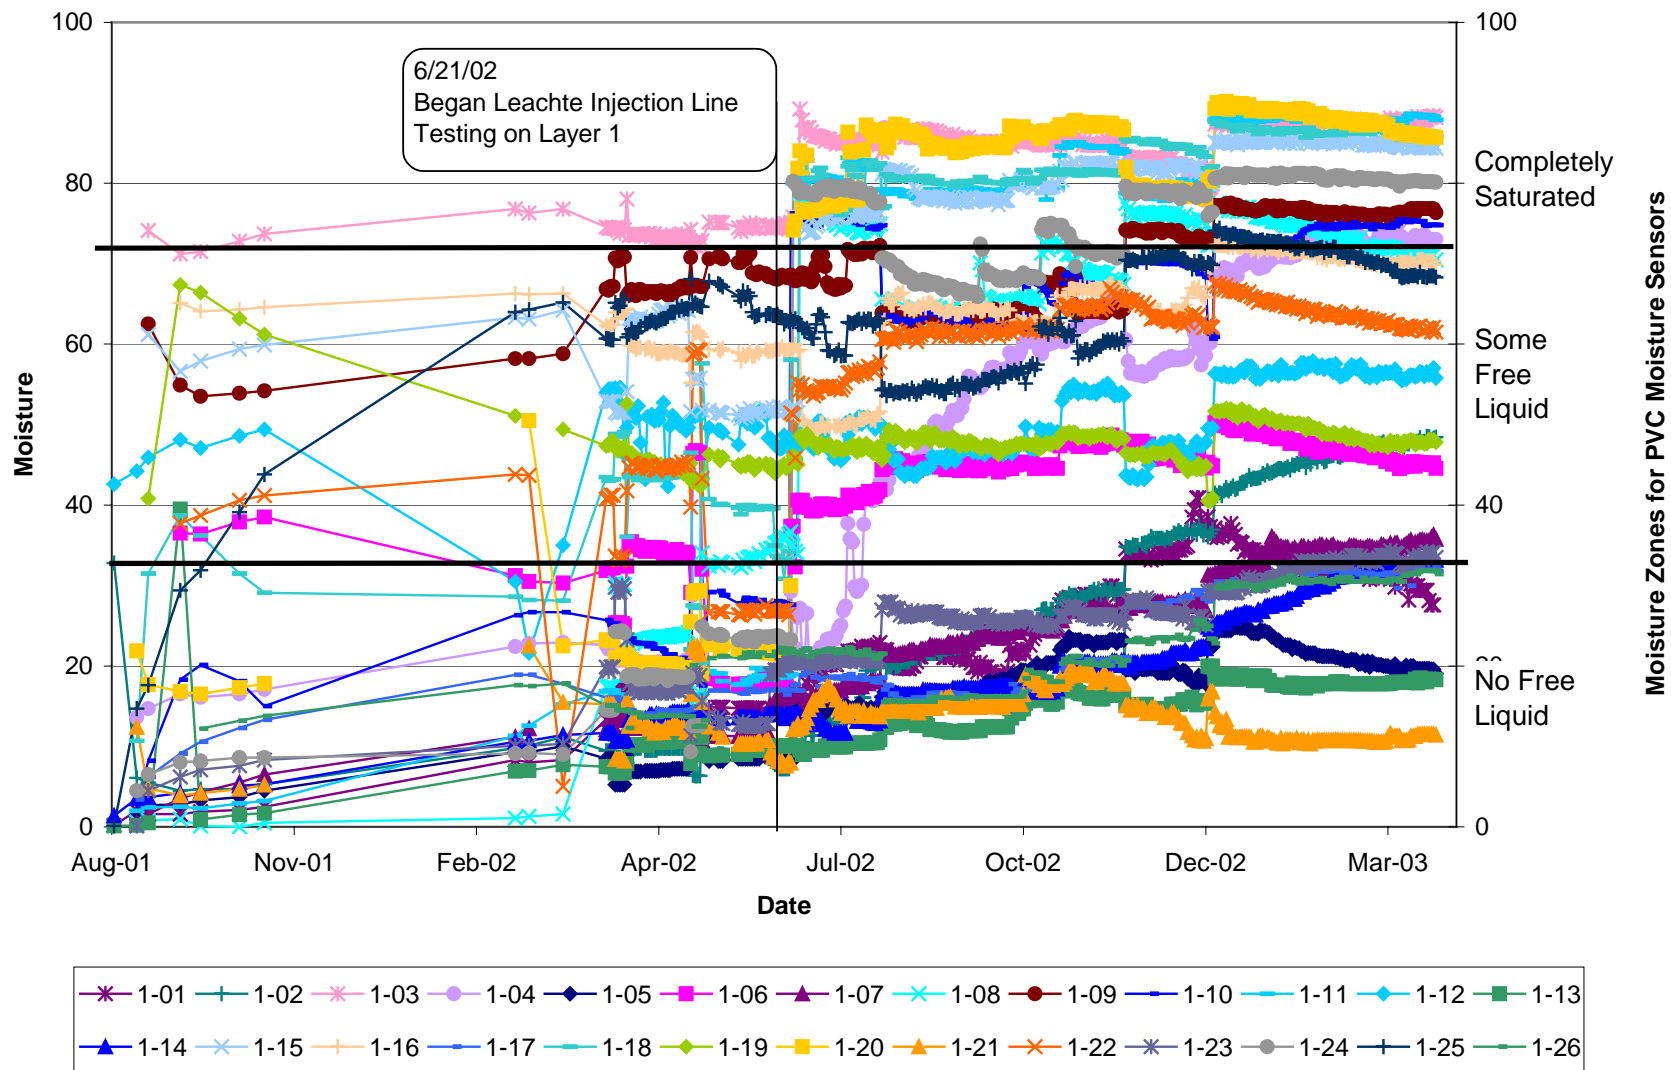
Figure 5-8. Aerobic Cell Layer 1 PVC Moisture Readings

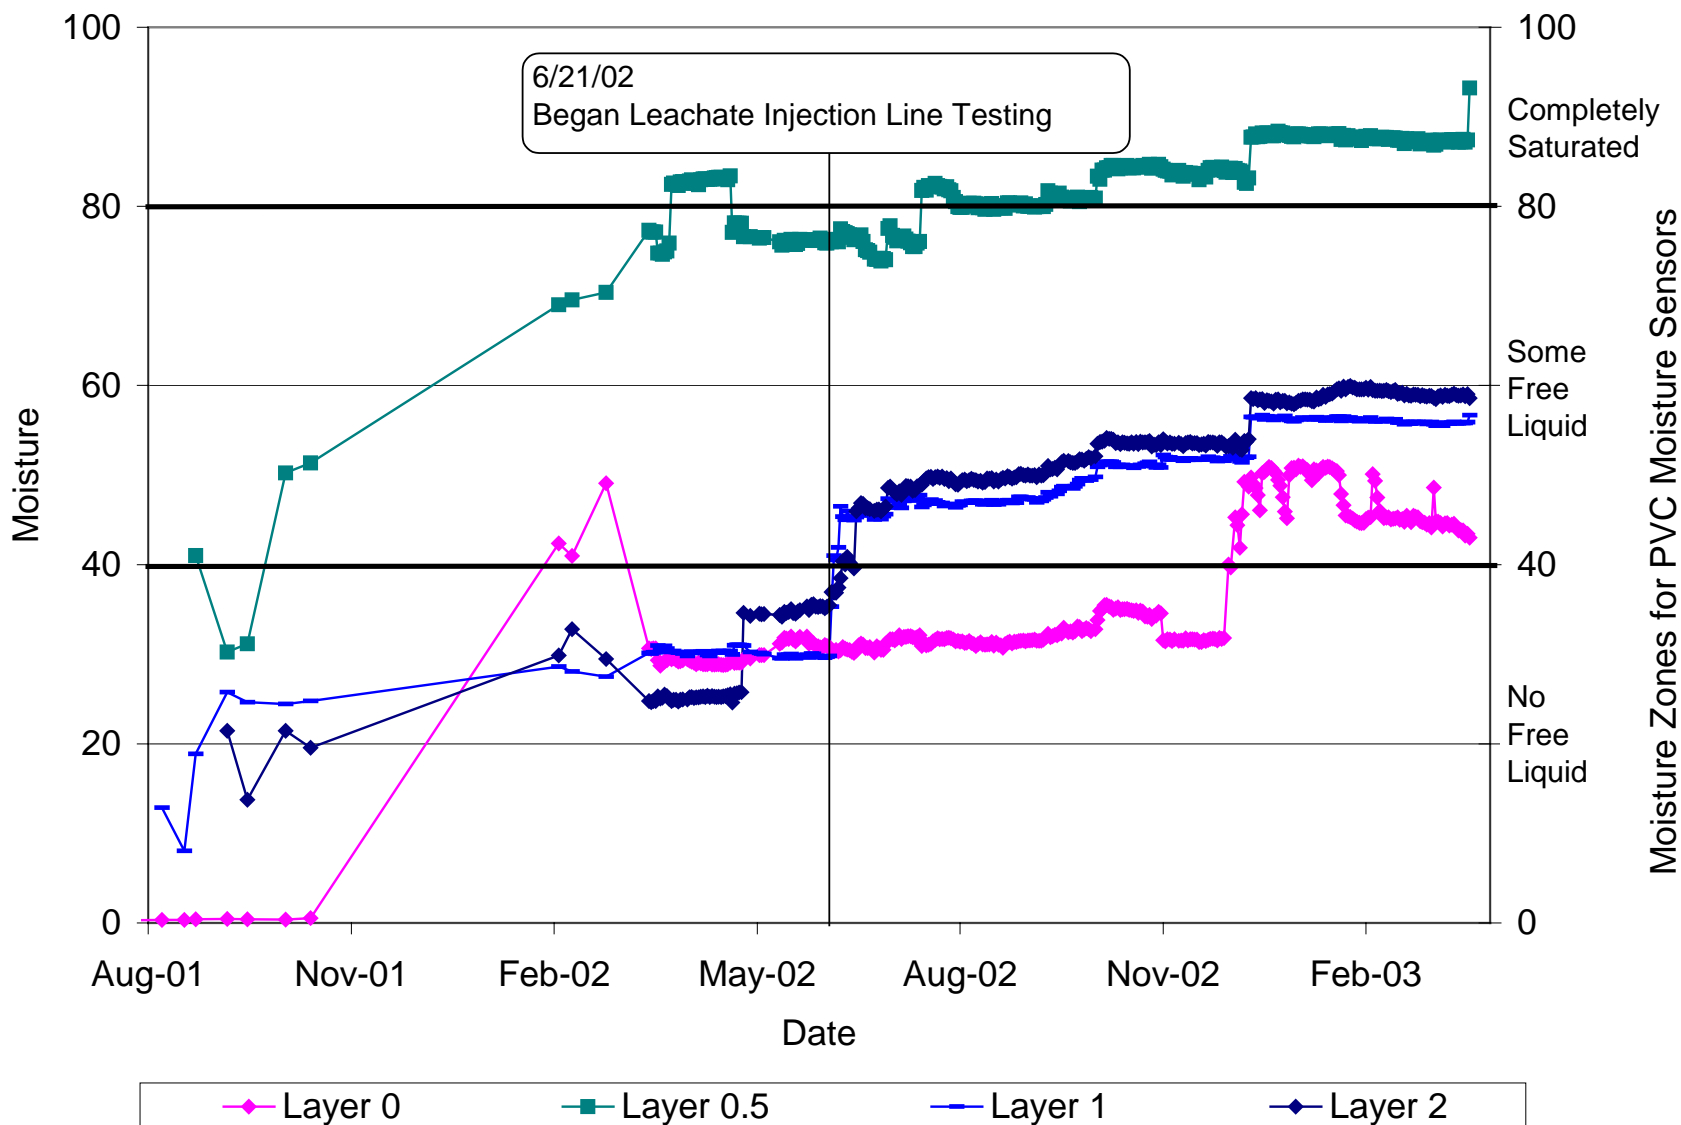
Figure 5-9. Aerobic Cell Layer 2 PVC Moisture Readings

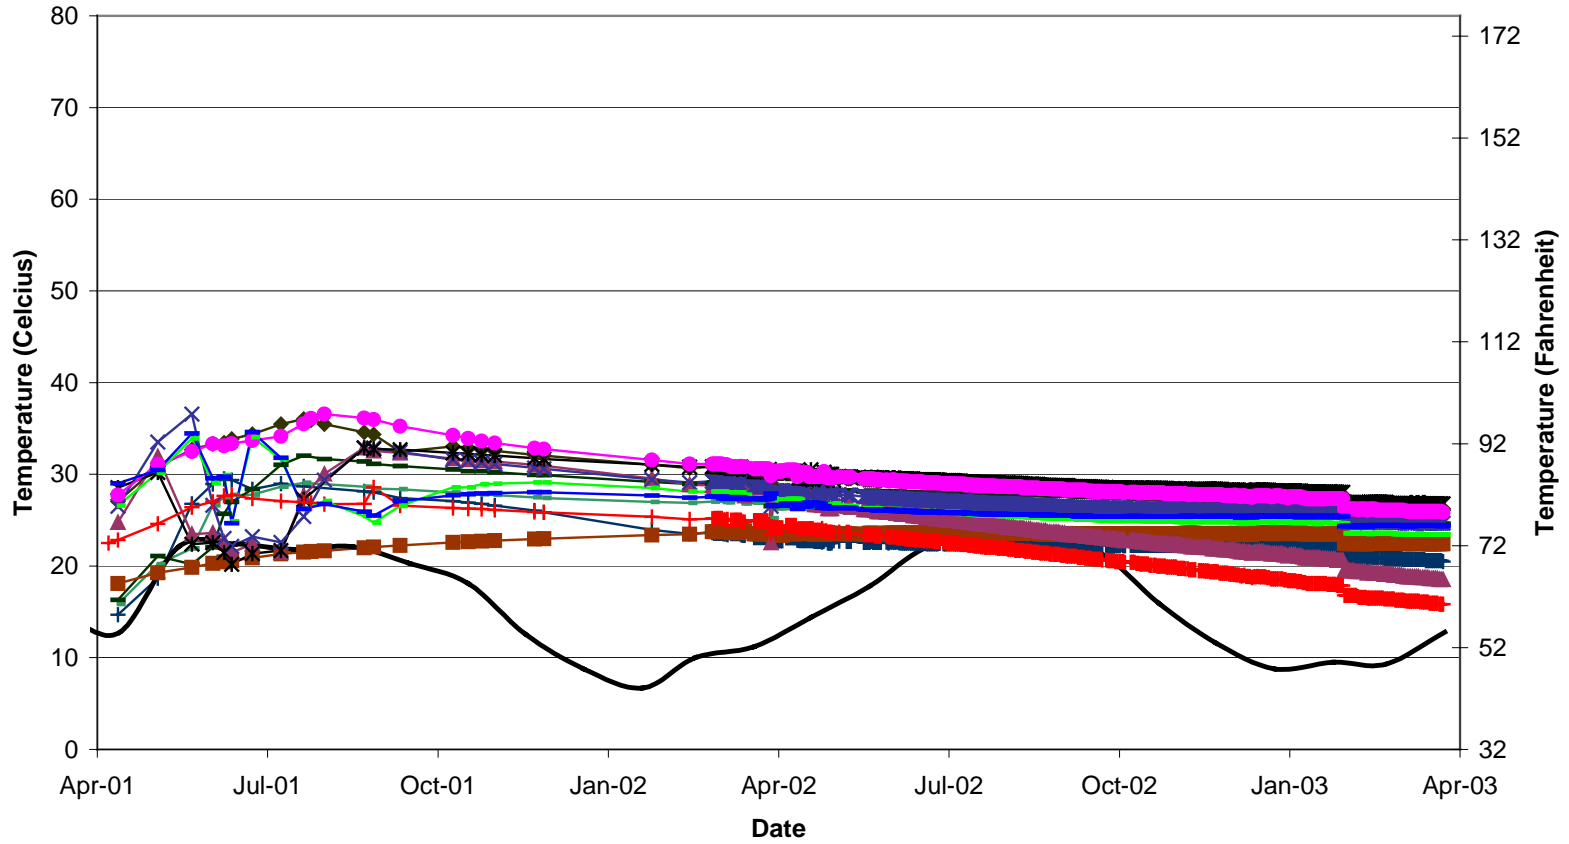
Figure 6-2. Module D Base Liner Temperature Readings (Southwest Quadrant)
