## **APPENDIX C – GRAPHS**

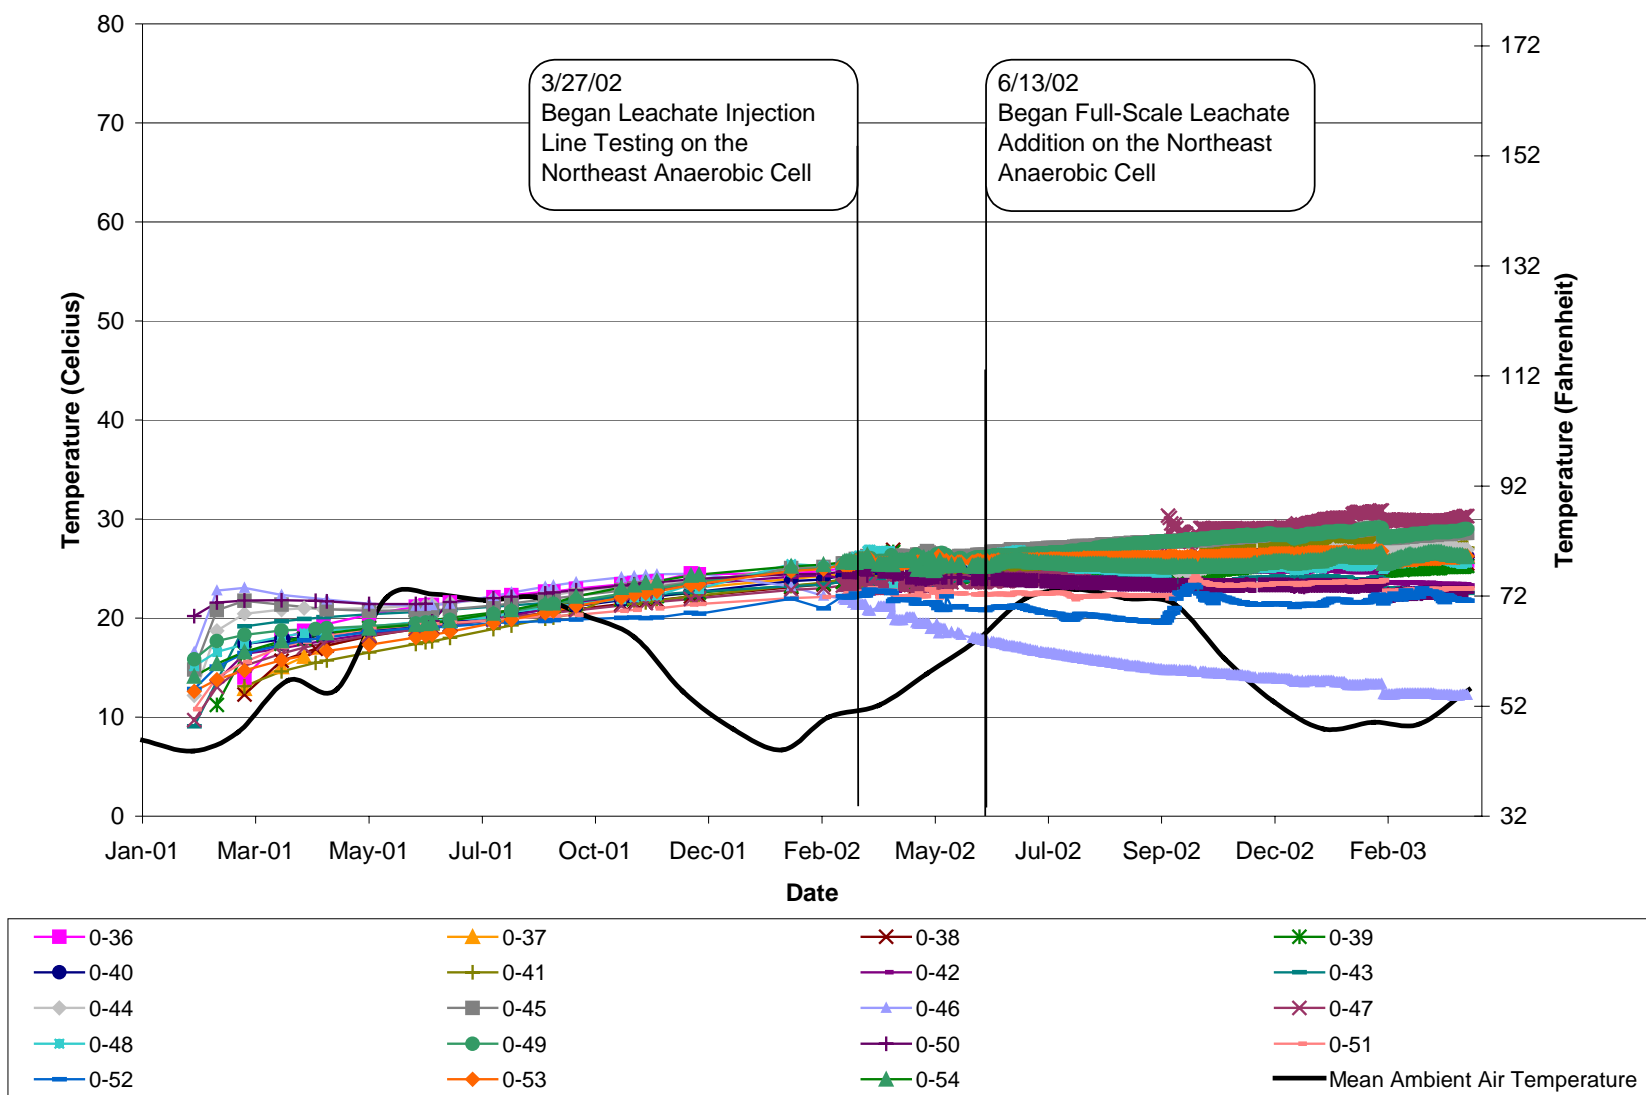
**Figure 6-3. Module D Base Liner Temperature Readings (Northeast Quadrant)**

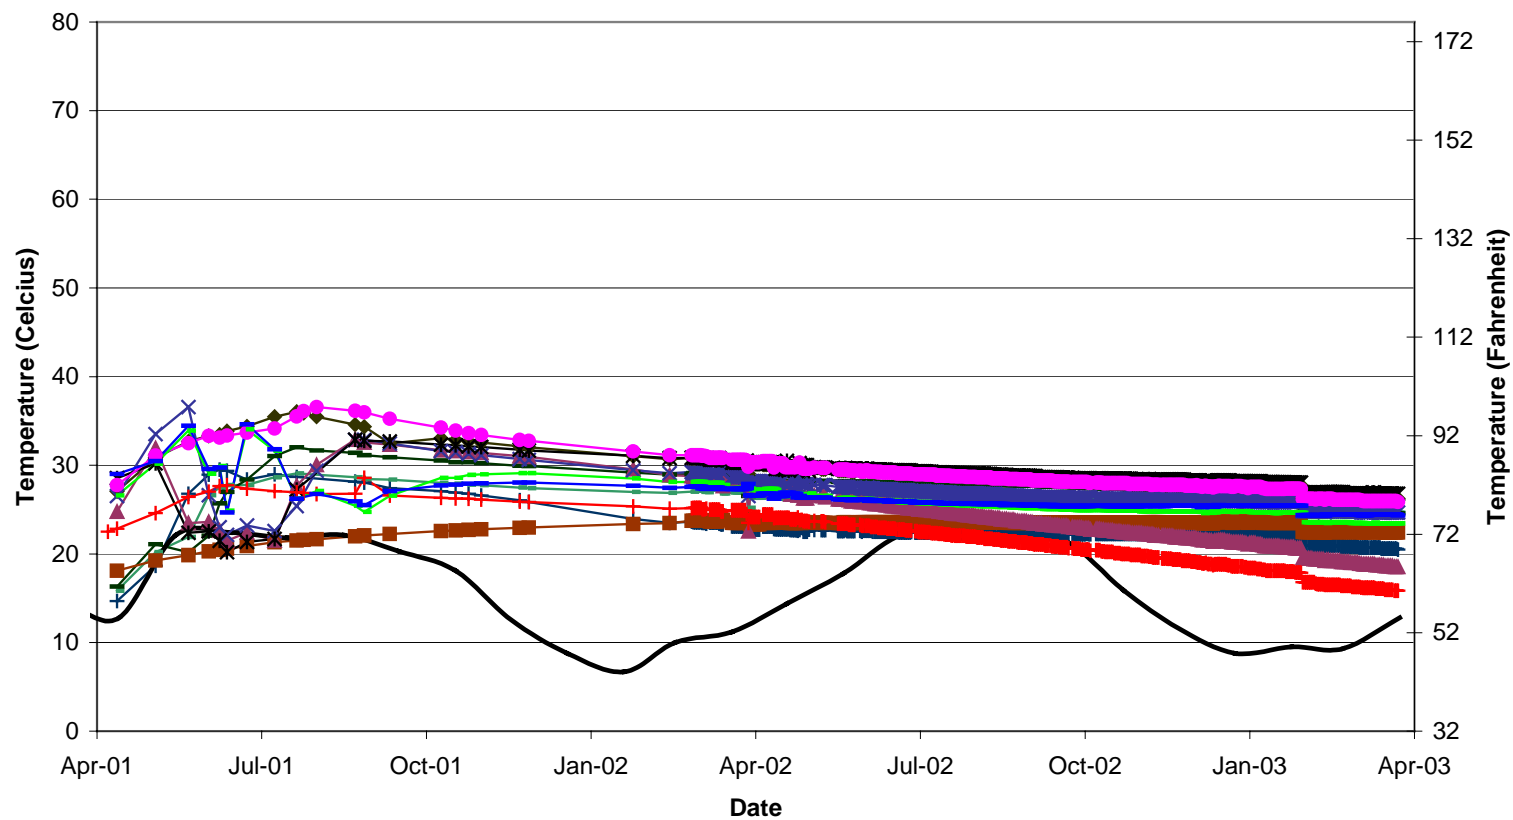
**Figure 6-4. Module D Base Liner Temperature Readings (Southeast Quadrant)**

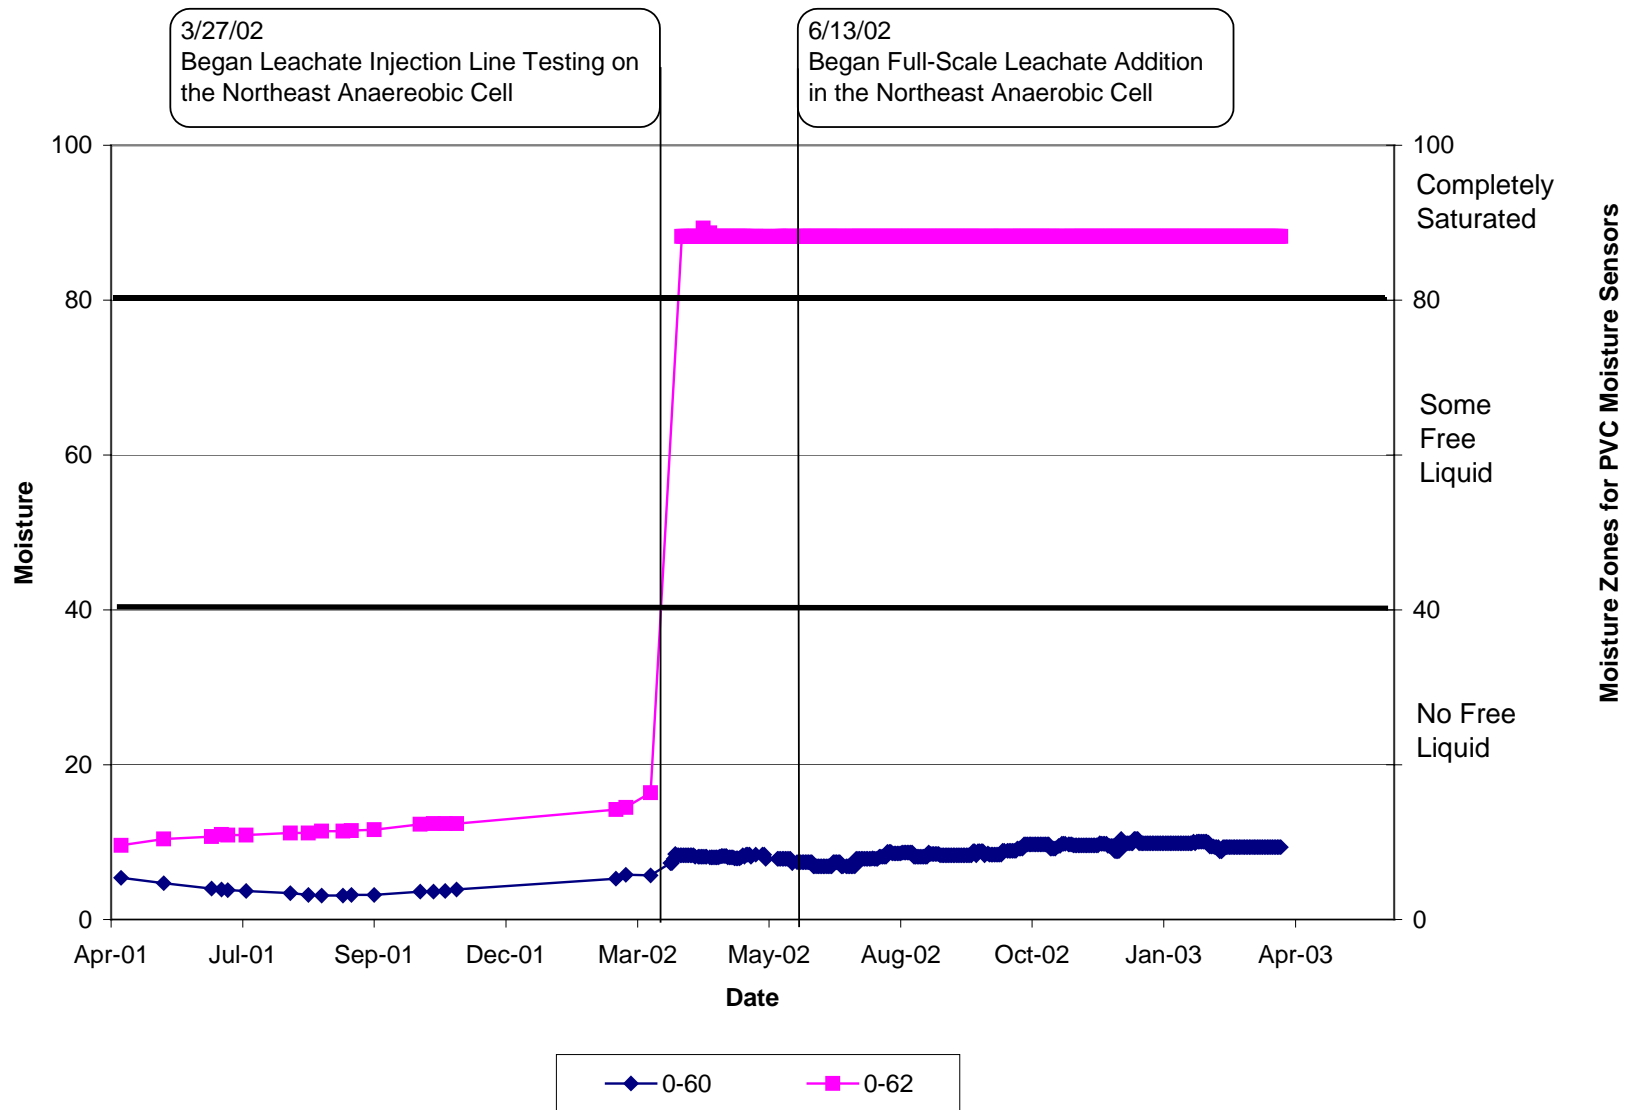
**Figure 6-8. Module D Base Liner PVC Moisture Readings (Southeast Quadrant)**

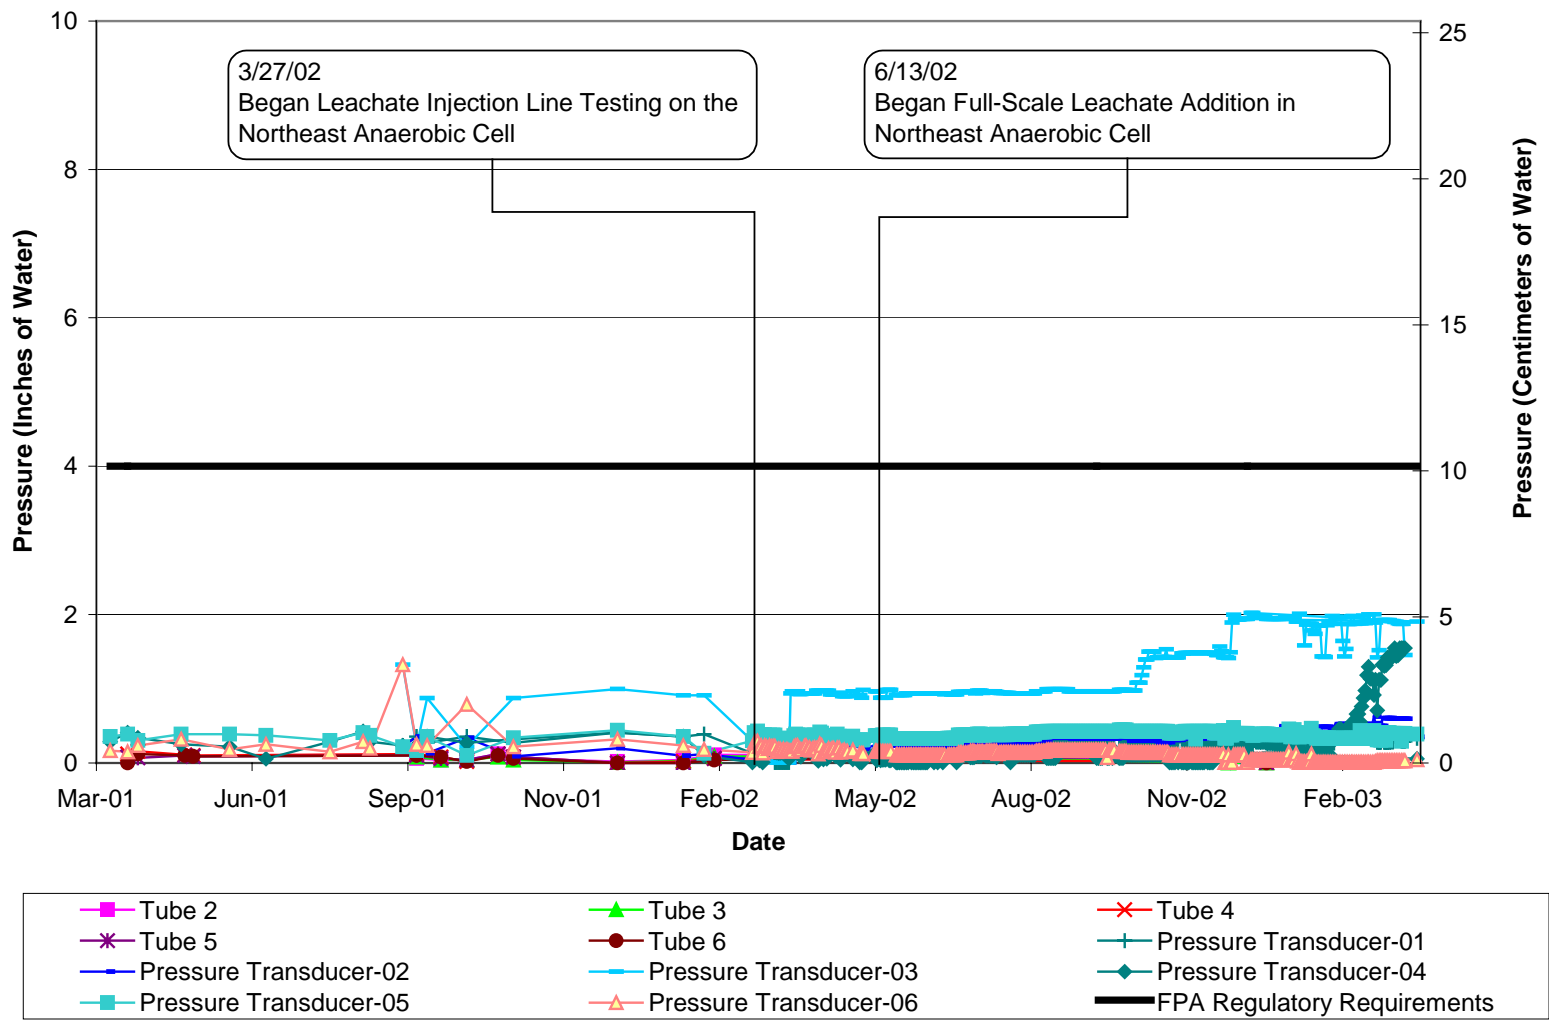
**Figure 6-10. Module D Base Liner Pressure Transducers and Adjacent Tubes**
