Advanced Hot Gas Filter Development

Topical Report: Task 3 & Task 4
September 29, 1994 to March 31, 1998

AlliedSignal Composites Inc. (formerly DuPont Lanxide Composites Inc.)
1300 Marrows Road
P. O. Box 9559
Newark, DE 19714-9559

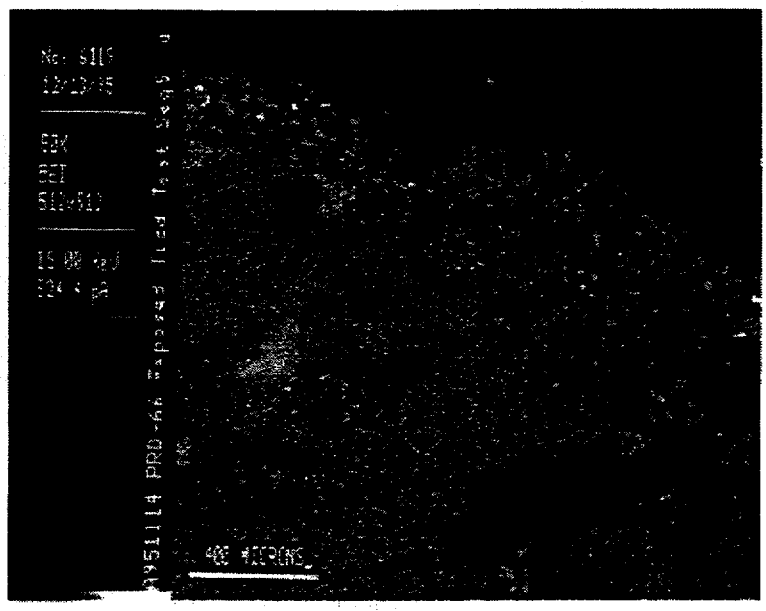
Based on this evidence, a hypothesis of the failure mechanism of PRD-66 candle filters in Test Segment 5 was formulated. Despite earlier results of room temperature and high temperature tests to the contrary, ash that contained adsorbent penetrated the surface membrane of the PRD-66 filters. This ash then became trapped in the bulk filtering body of the candle. Once trapped there, it was subjected to long term exposure of hot SO2 gas, causing in situ sulfation of the ash to calcium and/or magnesium sulfates in the pores and microcracks of the filters.

Figure 15 - White deposit (middle left) in vicinity of "divot" (upper right).

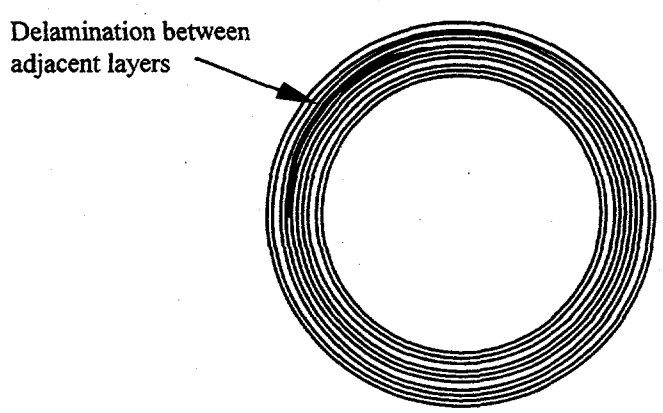
After two hours of high temperature exposure in Westinghouse's HTHP facility, outer membranes on the reduced backpressure and dual membrane filters delaminated. This was the most probable failure mode of these candles. The "strengthened flange" filter, which had the baseline surface membrane, did not delaminate.

Figure 20 - Exaggerated illustration of a PRD-66 delamination

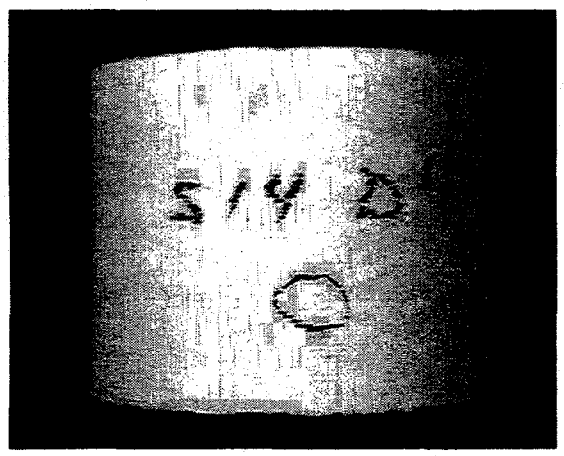
transmitted light inspection (Figure 25). Further, these defects were detectable in the filters prior to firing, allowing for the application of additional membrane filler before the final ceramic conversion firing.

Figure 24 - Hole in membrane, undetectable under direct light.

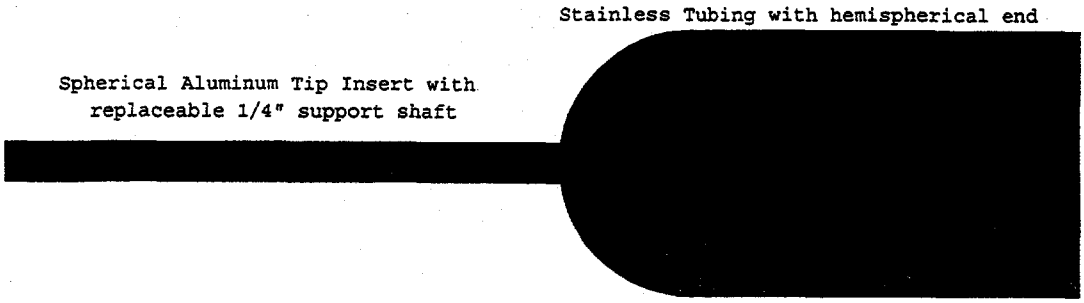
During this investigation, however, another reason for yarn breaks was observed. The yarn would most frequently break during the first 20 minutes of winding, when the guide changed direction at the tip-end of the mandrel. The mandrel on which the PRD-66 filter element was wound had a hemispherical shape at the tip end, going from 45 mm down to 6 mm in diameter in approximately 1" of length, as shown in Figure 33.

Figure 33 - Tip of original steel mandrel

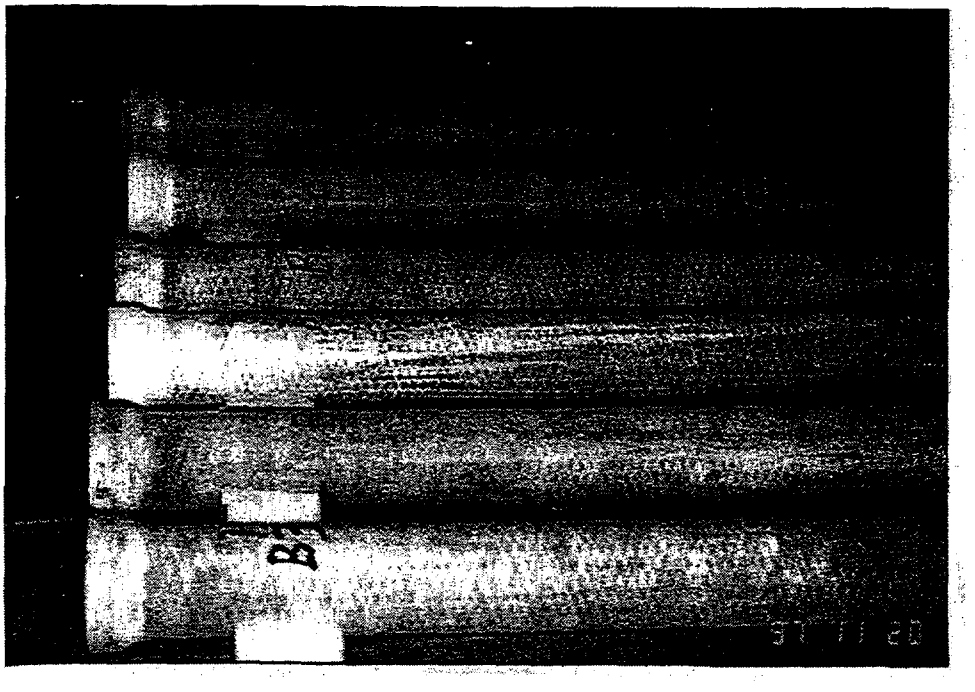
At the conclusion of the run, the six PRD-66C elements that were exposed for the entire 581 hours, and the one candle that was exposed for a total of 342 hours, all looked good. All but one of the elements had been cleaned by brushing and vacuuming prior to inspection, see photograph in Figure 38. There was no sign of any material deterioration in the possible forms of "divots", abrasion, poor membrane adhesion, or cracking. A significant amount of ash, however, was observed in the wall of the inside diameter, though it was much less for the element that was only exposed for 342 hours.

Figure 38 - Karhula-exposed PRD-66C filters

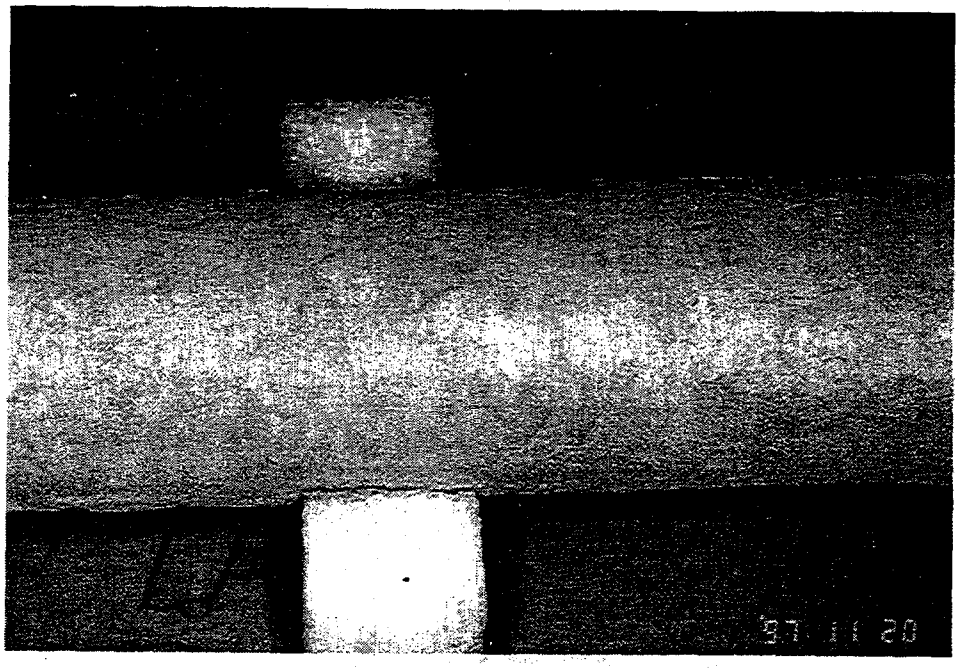
A single candle was examined before any ash had been cleaned from the material. A conditioned ash cake layer, approximately 2mm thick, had formed along the outside diameter, see photograph in Figure 39. The ash was soft and easily removable by handling or by brushing. The inside diameter was also caked with ash, approximately 2mm thick, with at least six inches of loose ash present in the tip of the candle.

Figure 39 - Outside diameter of Karhula-exposed element before ash removal

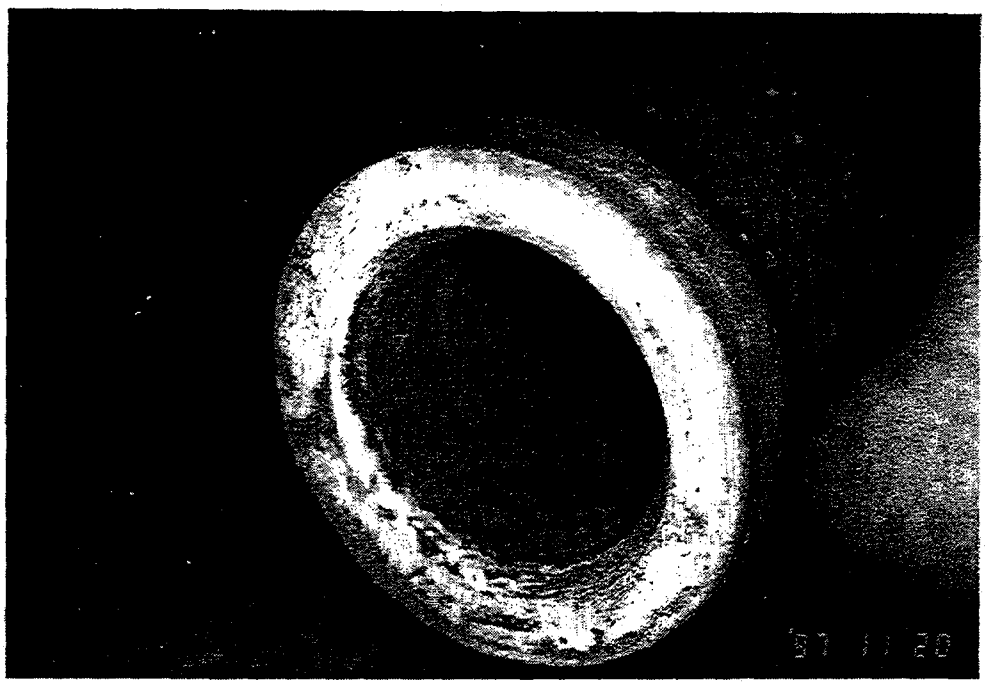
Figure 40 - Inside diameter of Karhula-exposed element before ash removal

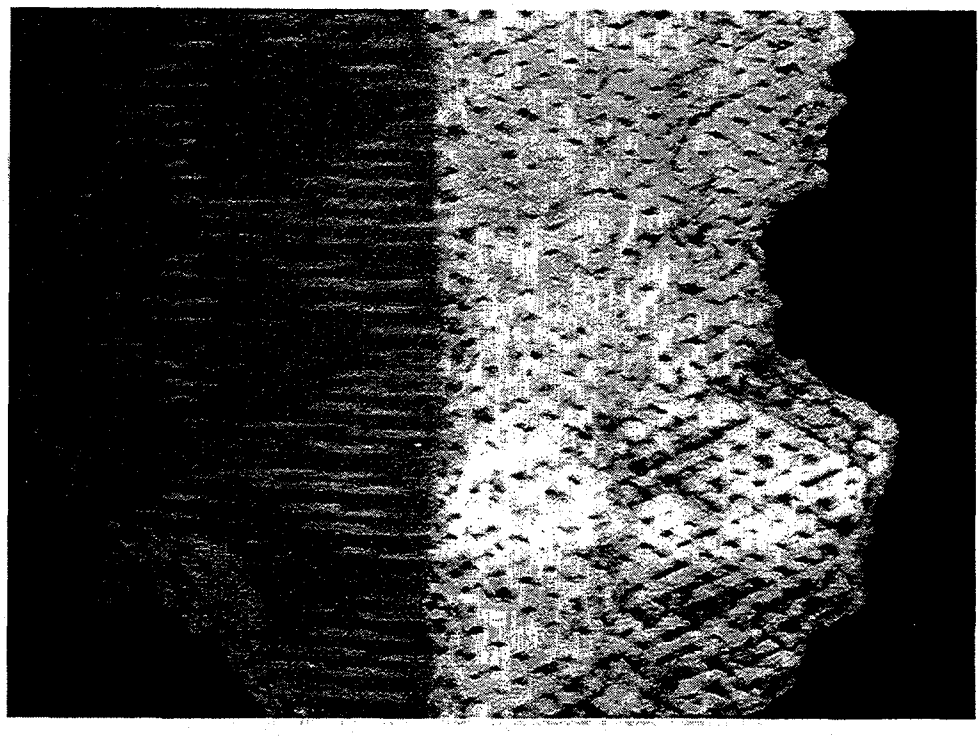
effective surface filter for PCFBC applications. It is significant that, no "divots" occurred despite the large volumes of ash that penetrated from the "clean side".

Figure 42 - Wall interior of Karhula-exposed candle #577

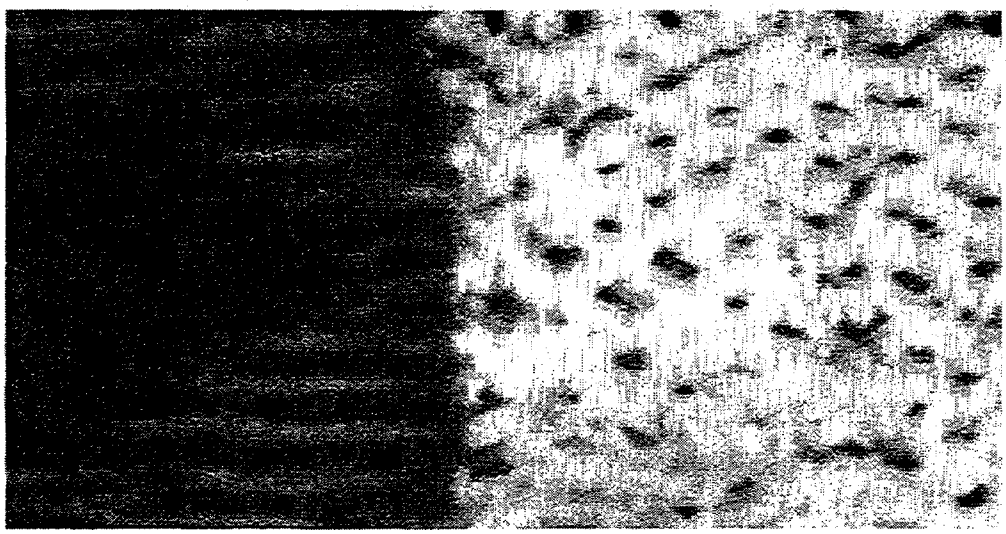
Figure 43 - Close-up of #577 - OD surface and 1-2mm below
