APPENDIX D

PRESSURE DROP TRACES FROM  
PFBC SIMULATOR FILTER TEST WRTX-9 AND WRTX-11

Two cross flow filter elements were successfully tested under simulated PFBC conditions for over 1300 hours, thus representing the longest successful test campaign on this barrier filter technology. The filter operation was terminated when the dust loading on the filter outlet increased up to 100 ppm and the system permeability profiles suggested that a breach had developed on at least one of the elements. Post test inspection of the filter system revealed that one of the elements had developed a longitudinal crack on the ceramic flange, and the flange corners of both elements were crushed by the metal clamping plates. Neither filter showed any signs of delamination failure which had historically plagued the first generation of cross flow filters.

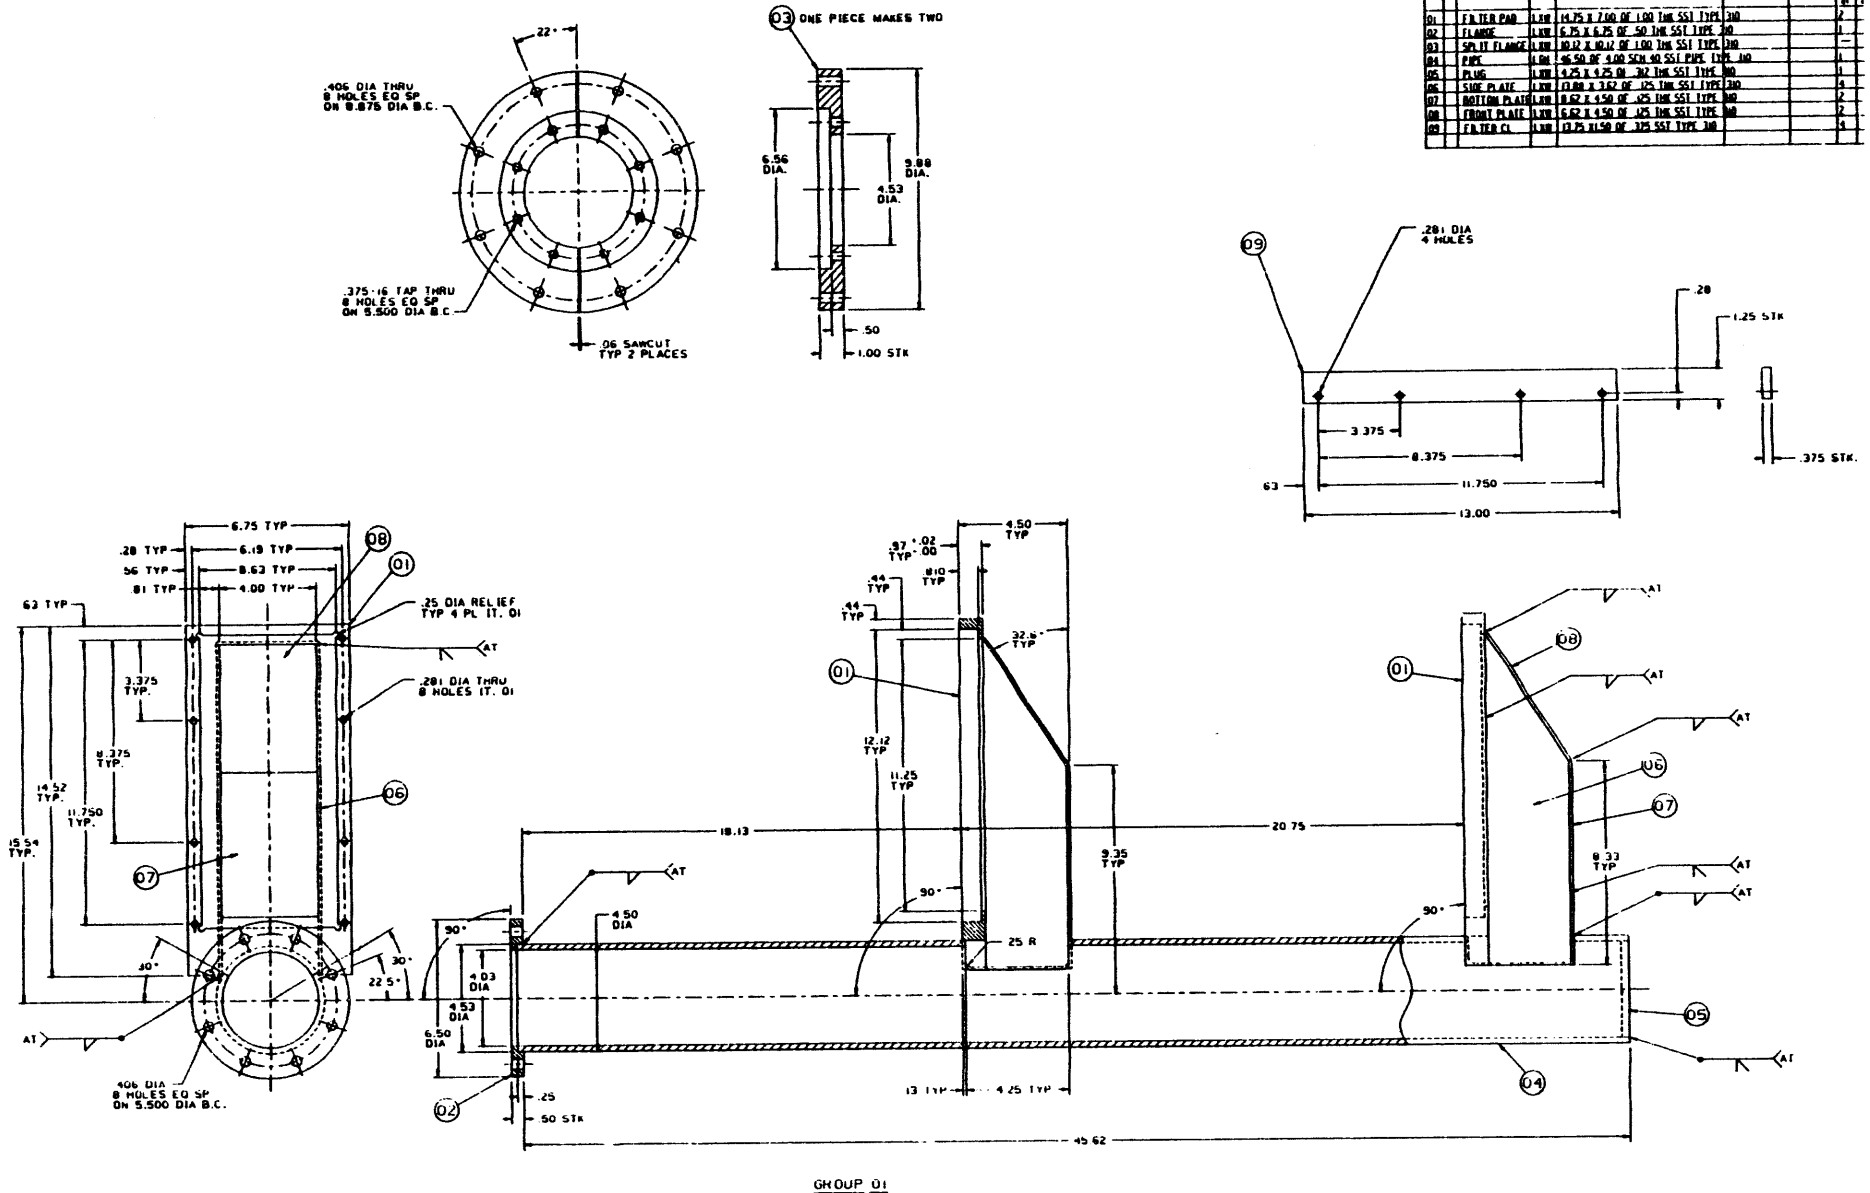
Figure E.1 - Typical Element Mount Configuration

Figure E.1 is an engineering drawing of a typical element mount configuration. The element rests on a stainless steel ledge which is welded to the support fixture. After installation the ceramic flanges on the element are nearly flush with the upper surface of the fixture. The filter flanges are clamped to the fixture by means of stainless steel plates, 13 inches long by 1.25 inches wide and 0.375 inch thick. Each plate is held by four 0.25 inch 316 stainless steel bolts.

In an effort to eliminate the deficiencies in the current filter mounting apparatus a retrofit design has been developed as shown in Figure E.16. The salient features of this retrofit are now outlined.

4. The eight 316 stainless steel bolts are substituted by 14 bolts made of creep resistant Incoloy 800 alloy. During the assembly procedure a 270 lbs weight is placed on the element to pre-compress the bottom gasket. The clamping device is now mounted and the 14 bolts are sequentially torqued up to 10 in-lbs. After removal of the 270 lbs weight, the two gaskets will be loaded in series to approximately 2700 lbs of seating force. For the retrofit design Figure E.17 shows the effect of long duration bolt creep on the seating forces acting on the filter. Comparing with Figure E.15 it is clear that the seating forces are held to a relatively steady value with a substantial margin over the hydrostatic reverse forces generated during pulse cleaning. Note also that this high seating force is calculated to prevail over at least a 4 year operating period.

5. The filter seating area is elevated by the use of a spacer such that no dust can accumulate between the flange and the metal fixture. Notwithstanding the rugged gasket seating properties of the modified design, this feature ensures that no residual transverse stresses can act on the flange during shutdown conditions.

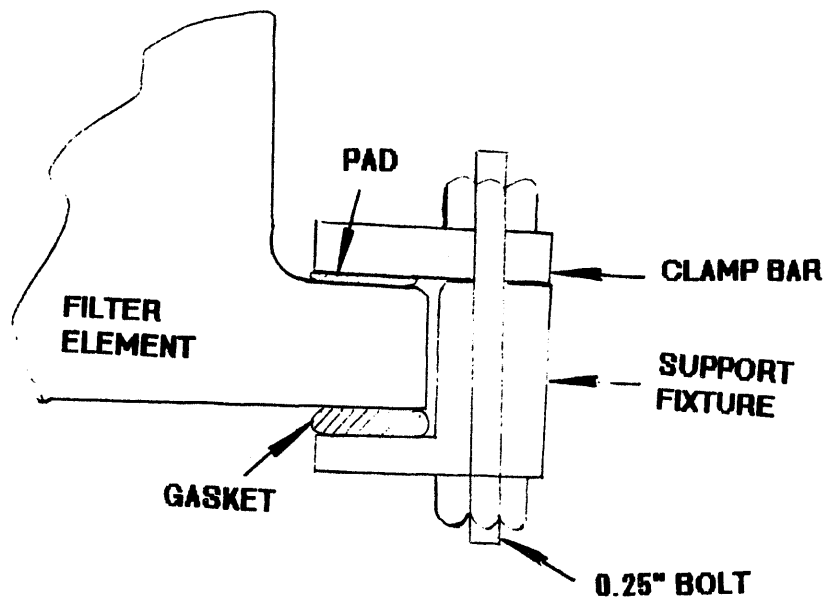
Figure E.2 - End View of an "Ideal" Assembled Filter Element

Figure E.2 shows an end view of a fully assembled "ideal" filter element (i.e., an element that meets all dimensional tolerances). The clamping plate would rest flat and parallel with the top surface of the flange with a compliant layer of gasketing material between the metal and the ceramic. Note also the position of the compressed gasket under the filter which functions as a dust seal during filtration (forward flow) periods and a partial gas seal during any pulse cleaning event (reverse flow).

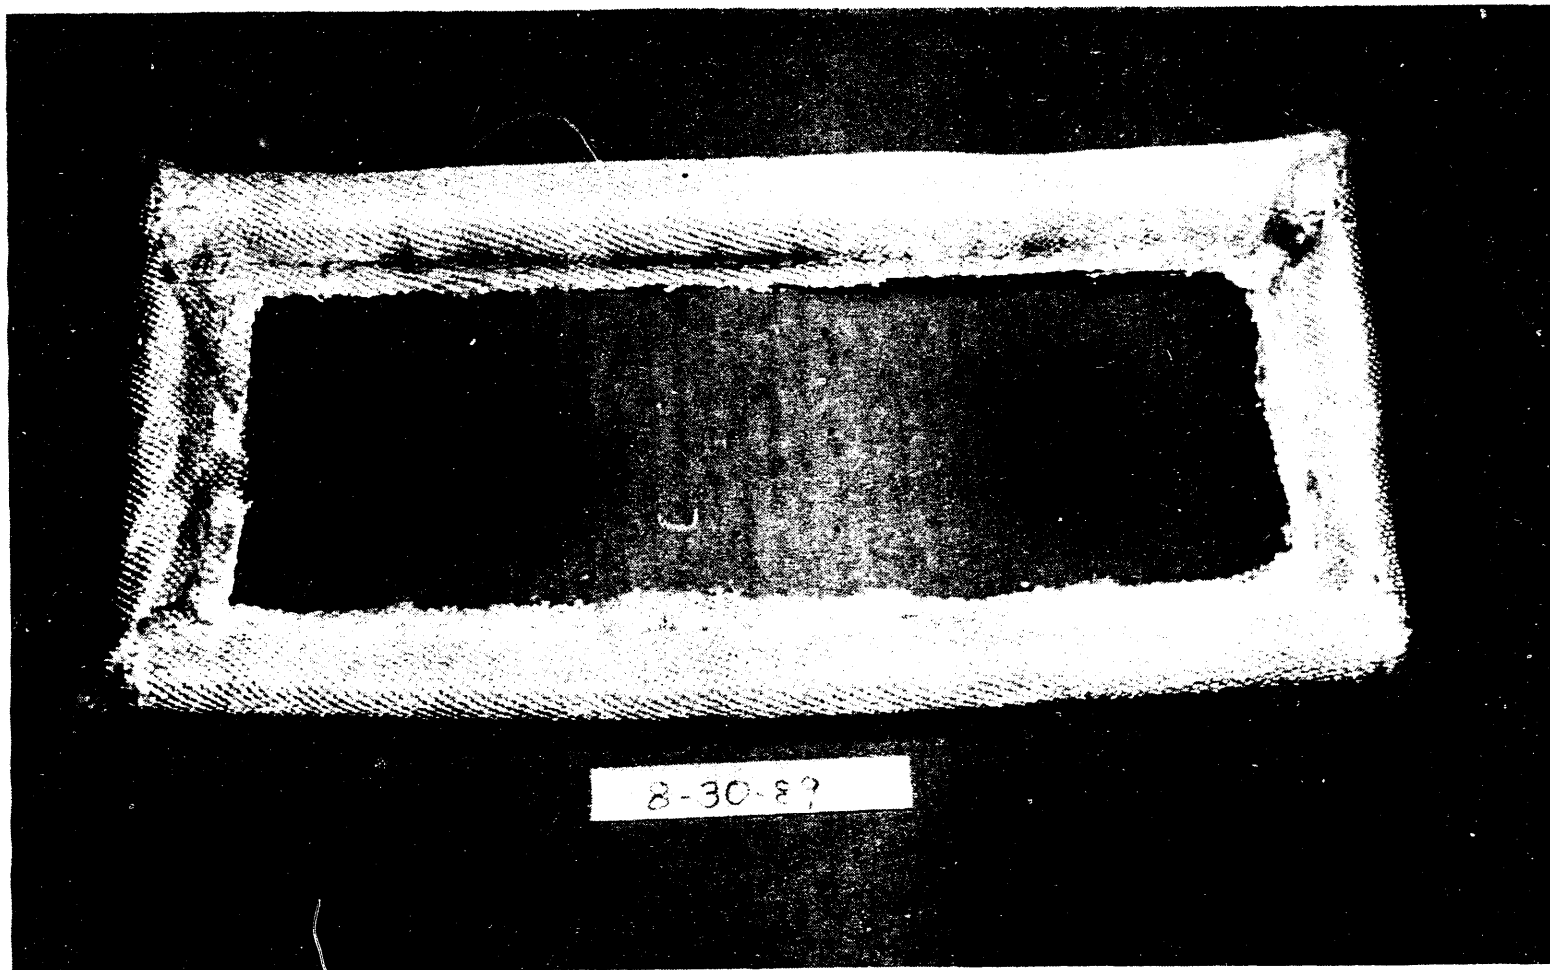
Figure E.4 - Photograph of Nextel Reinforced Fiber Blanket Pad Used as Dust Seal.

The bottom gasket, on which the element rests and which actually functions as the dust seal, is a Westinghouse assembled pad made of 3M's commercially available Nextel fabric and a silica-boria-alumina fiber blanket, shown in Figure E.4. After exposure to the PFBC simulator conditions for 1304 hours and 2068 pulse cleaning cycles, there was virtually no damage or distortion sustained by this gasket. The load-deflection characteristics for the unused and the exposed gasket, as measured on a standard testing machine, were found to be identical; thus indicating that the gasket does not experience any long term deterioration in its resiliency properties.

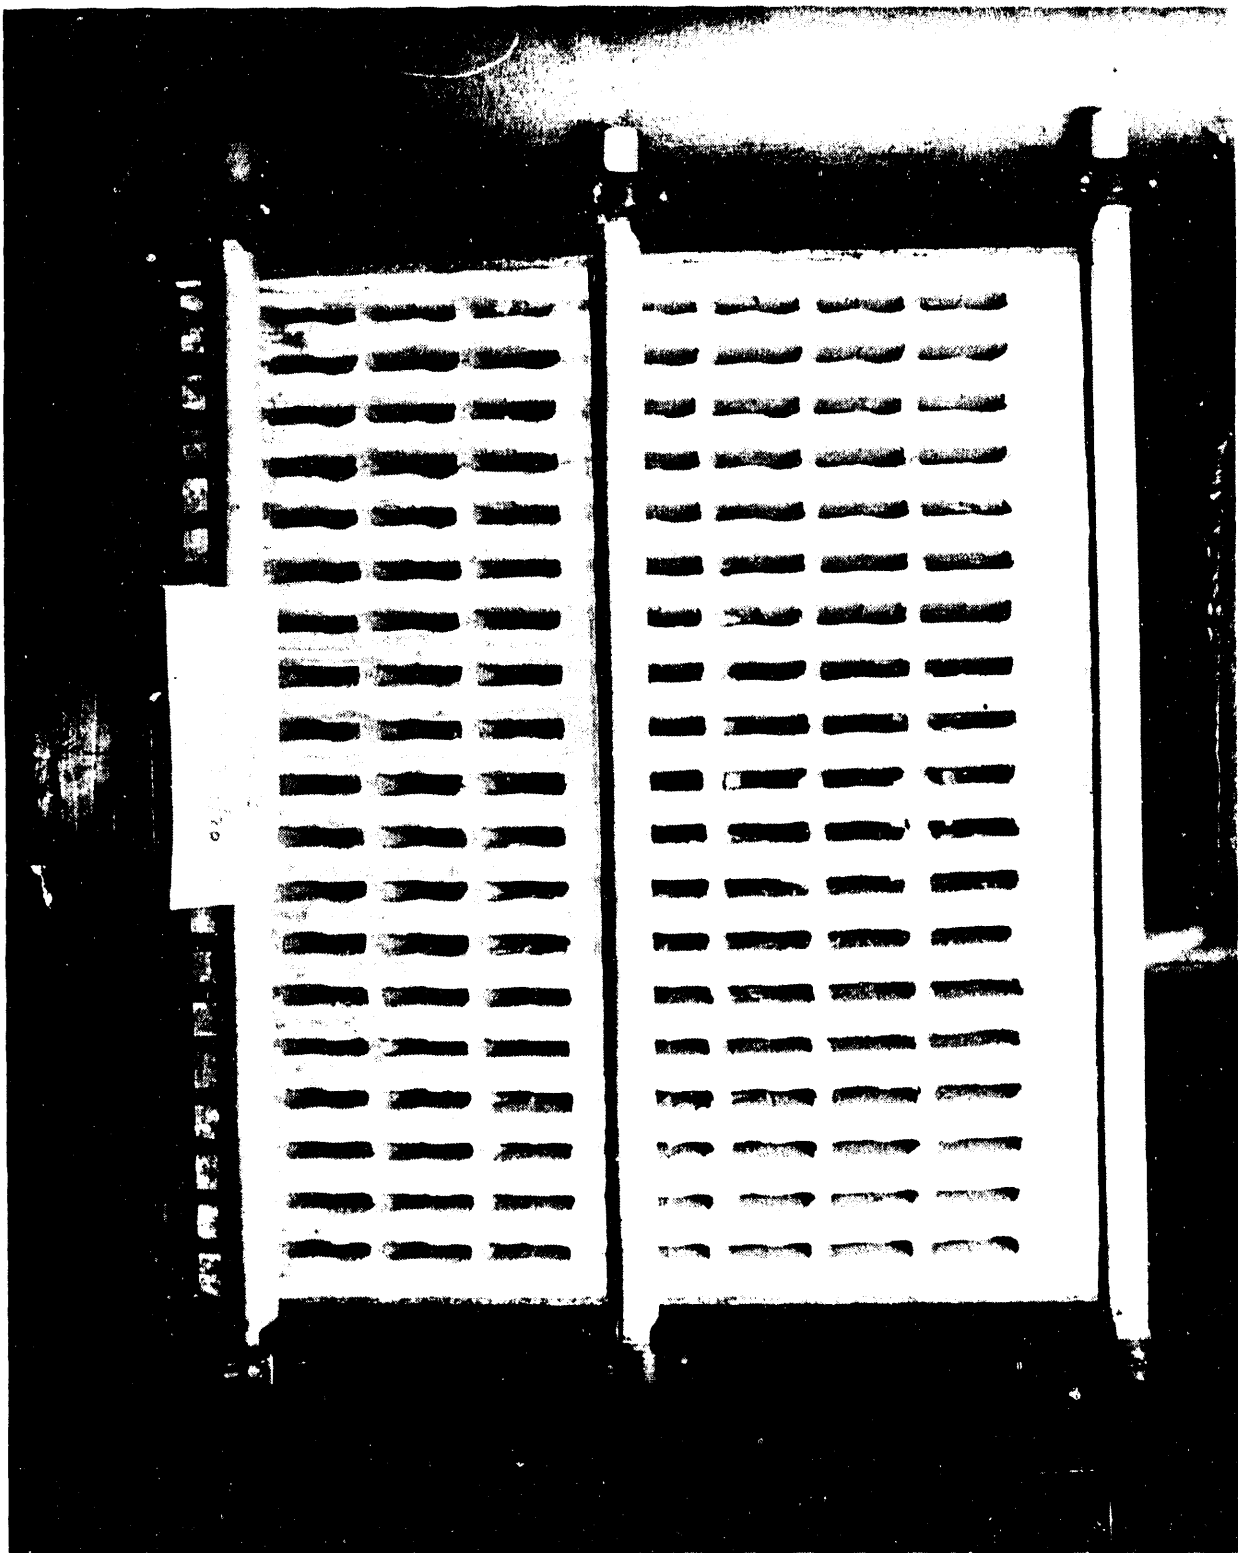
Figure E.5 - Photograph of an Assembled Filter Element

Each element is then mounted with side compression plates to provide precautionary reinforcement against element delamination. These plates are made of 4 inch by 12 inch by 0.25 inch thick 316 stainless steel plates, which are assembled using metal tie-rods to provide a compressive force of approximately 1400 lbs. Six ceramic rods are then fitted into corresponding slots on the sides of the parallel plates, these rods are held in place by compression collars. After assembling the ceramic rods the metal rods are removed. Interam pads are used as cushioning material between the metal end plates and the ceramic side walls of the filter. Figure E.5 shows a photograph of a typical fully assembled filter element.

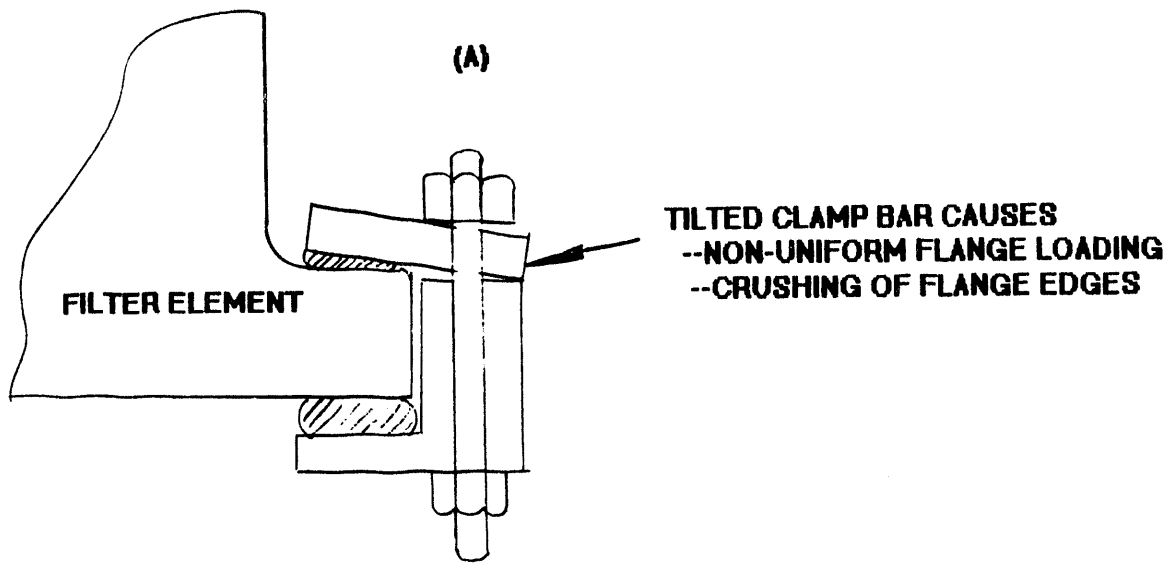
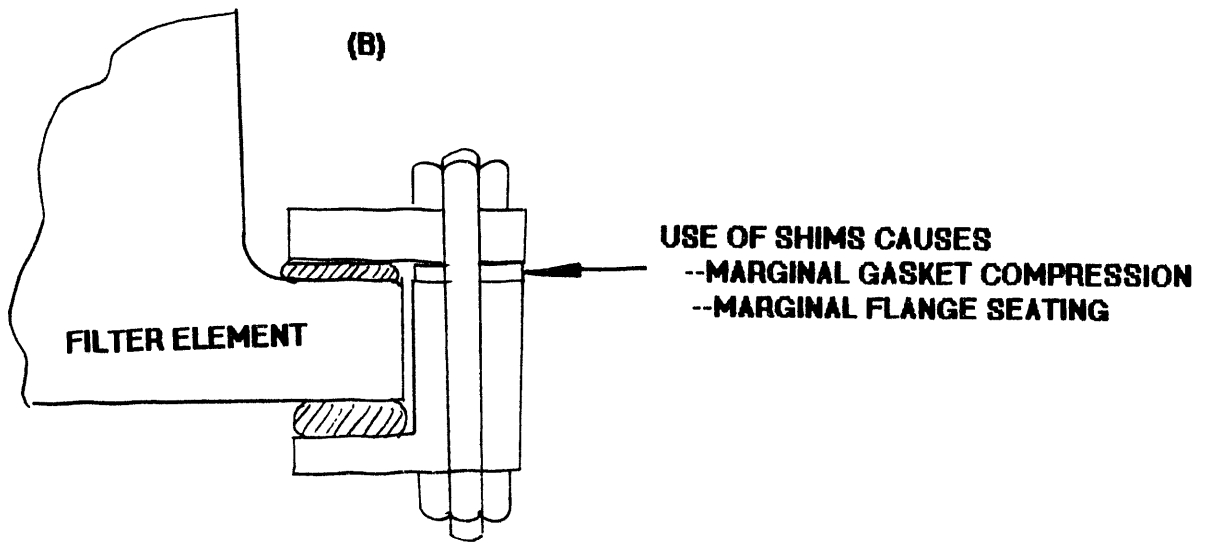
Figure E.14 - Typical Element Installation Problems with Current Mount Design

A. Non-uniform Loading of Filter Flanges

The filter support ledge is recessed inside the metal fixture so that the clamping plates are normally flat and horizontal in the assembled state. Such a perfect fitup of the element is seldom achieved in practice because the flange dimensions vary by 150 mils in thickness and 30 mils in flatness. Therefore, after installation, the clamp becomes tilted and imposes a direct crushing load on the longitudinal edges and corners of the flanges as shown in Figure E.14(a). Alternatively, shims are used to raise the outboard side of the clamping plates to achieve a horizontal fitup as shown in Figure E.14(b). The end result is that when the bolts are torqued the compression force only acts on the shim; the clamp transfers marginal compression to the ceramic flange again in the form of an edge load or moment. It is virtually impossible to (a) achieve uniform distribution of load along the flat surface of the flange, (b) to preclude any interference of the flange corners and

edges with the clamp plates, and, (c) to reliably translate the bolt loads into an equivalent seating force on the filter.

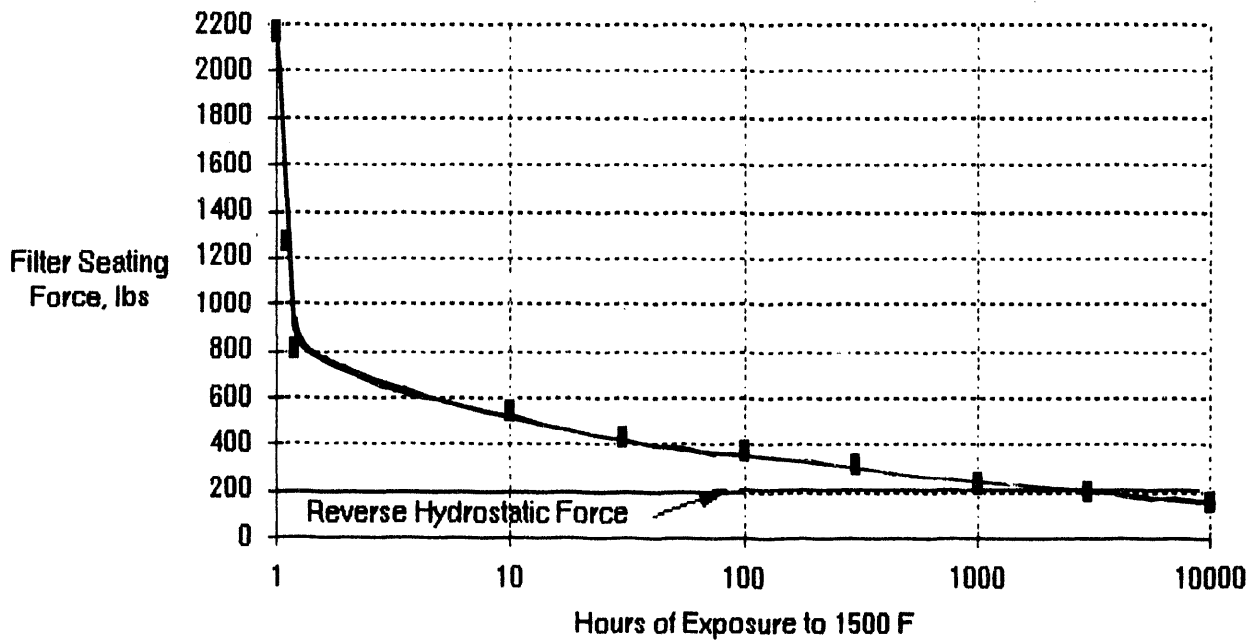
Figure E.15 - Effect of Bolt Relaxation on Filter Seating (Current Design)

As described previously, the filter gasket is preloaded with an initial seating force of 2430 lbs. The 0.25 inch 316 stainless steel bolts, however, relax at high temperature causing a reduction in the effective seating force on the gasket. Using the isochronous stress-strain curves for 316 stainless steel the gasket seating force was calculated for various exposure times at 1500°F temperature. As shown in Figure E.15, the actual seating force deteriorates to about 10% of the initial value after 1000 hours or about 260 lbs. Given the non uniform loading characteristics of the clamp discussed above and the closeness of the residual seating force to the reverse hydrostatic force generated during pulse cleaning, it is probable that the elements are partially lifted and/or severely vibrated during each pulse. Because the Interam pad placed between the clamp and the flange crumbles to powder at high temperature there is virtually no resilient layer to absorb any impact of the ceramic flange with the metal plate.

Because of the differential thermal expansion between the ceramic flange and the metal ledge, the 0.125 inch gap is opened during high temperature operation. After 1000 hours the creep relaxation behavior of the bolts substantially reduces the gas sealing characteristics of the gaskets allowing dust laden gas to permeate through the gasket and

form a dust cake in the cavities outside the gasket and in the gaps between the flanges and the metal fixture. Because this cake is normally thicker than the cake depositing on the filter walls, it is unlikely to be removed during on-line pulse cleaning. Upon shutdown when the metal cavity contracts a residual stress is exerted laterally into the flange body. The wedging effect of the fines was particularly visible on the bottom element which had to be forcibly ejected out of the metal fixture causing a cleavage of the flange during disassembly. The lateral forces would principally be manifested during the cold shutdown periods after about 1000 hours of hot operation when the seating forces on the gasket have substantially relaxed allowing the buildup of dust in the cavities.
