APPENDIX I

1. CHARACTERIZATION OF THE ASH AND CHAR FINES USED
IN SIMULATOR TESTING
2. CHARACTERIZATION OF ALUMINA/MULLITE FILTERS EXPOSED
IN THE WESTINGHOUSE PFBC DURABILITY TEST FACILITY

2. CHARACTERIZATION OF ALUMINA/MULLITE FILTERS EXPOSED IN THE WESTINGHOUSE PFBC DURABILITY TEST FACILITY

**DESCRIPTION OF CROSS FLOW FILTER DURABILITY
DURING PFBC SIMULATOR THERMAL TRANSIENT TESTING**

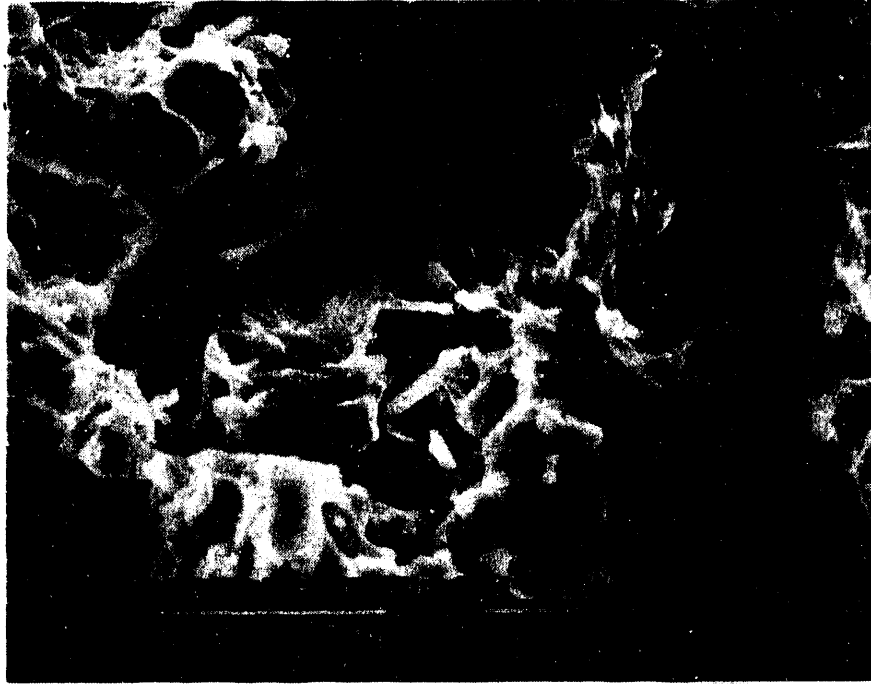
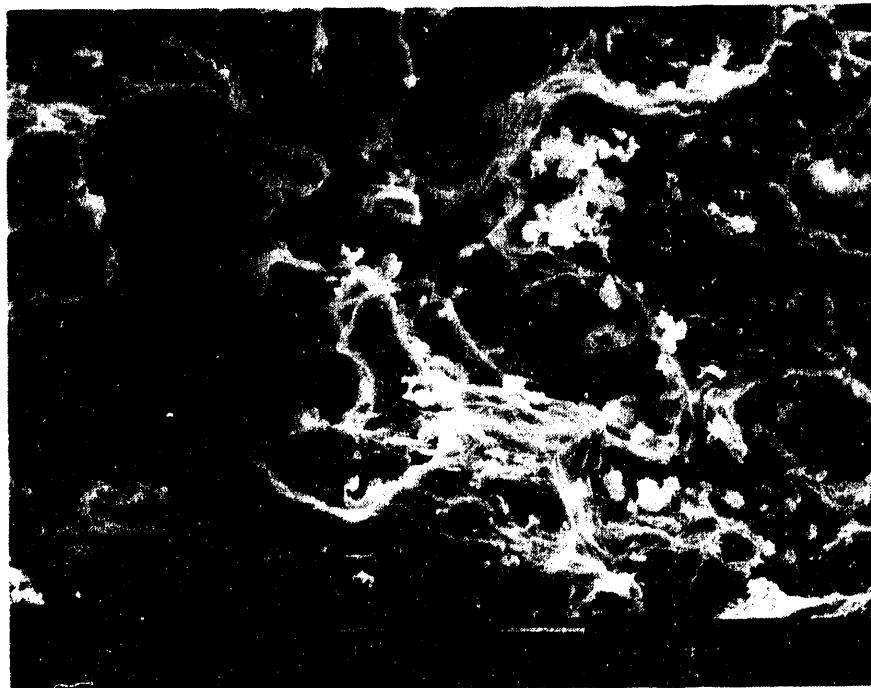
Figure I.2.3a - Scanning Electron Micrographs Illustrating the Morphology of the Alumina/Mullite Filter Matrix After 366 Hours of Exposure in the Westinghouse PFBC Durability Test Facility

filter lot, porosity appears to be relatively similar. Both filters appear to contain a uniform pore size, and do not contain large (i.e., 300-500 μm) voids. The relatively high conditioned permeability of both filters (WRTX-1 = 27%; WRTX-10 = 27%) reflects the absence of fines and subsequently negligible surface pore closure after 366 or 1300 hours of exposure to simulated PFBC test conditions.

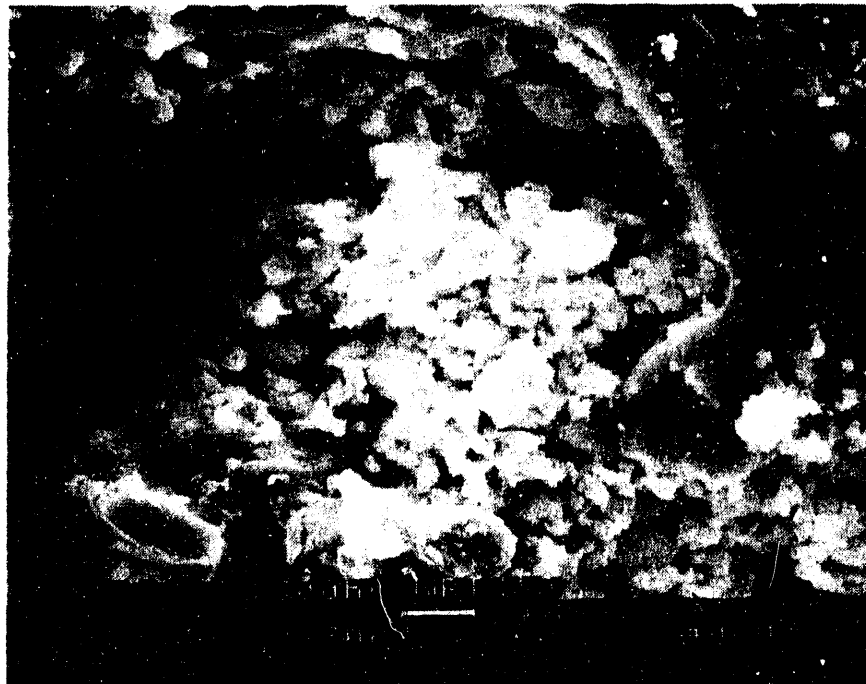
Figure I.2.4a - Scanning Electron Micrographs Illustrating the Morphology of the Alumina/Mullite Filter Matrix After 1300 Hours of Exposure in the Westinghouse PFBC Durability Test Facility

After 1300 hours of exposure in the simulated PFBC test environment, the majority of the edges along the dirty gas filter channels, close to where the Eremco paint is applied at the seams, appear to have been removed. One last analysis was attempted along these regions to identify possible changes in the filter matrix which may have attributed to cracking or erosion of the matrix. The matrix

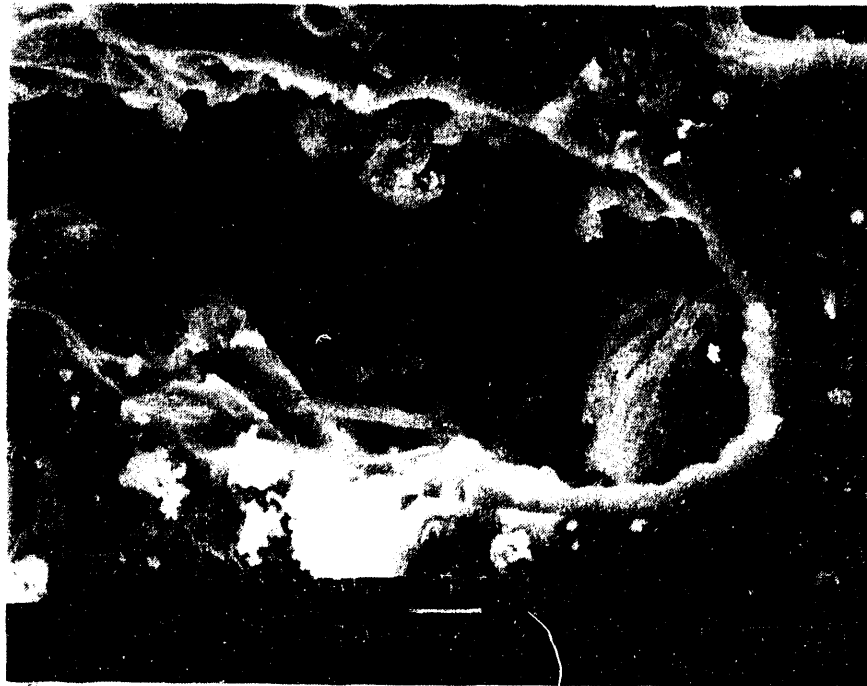
Figure I.2.4b - Scanning Electron Micrographs Illustrating the Morphology of the Alumina/Mullite Filter Matrix After 1300 Hours of Exposure in the Westinghouse PFBC Durability Test Facility

The actual surface of the alumina/mullite dirty gas channel from the 1300 hour exposed filter was characterized, and is shown in Figure I.2.5. Note the relative abundance of "blunted" crystals which are considered to be the ends of the mullite rods which are embedded in the "amorphous" phase. After 1300 hours in the simulated PFBC environment, the dirty channel surface "amorphous" phase is retained, while mullite appears to be surfacing.

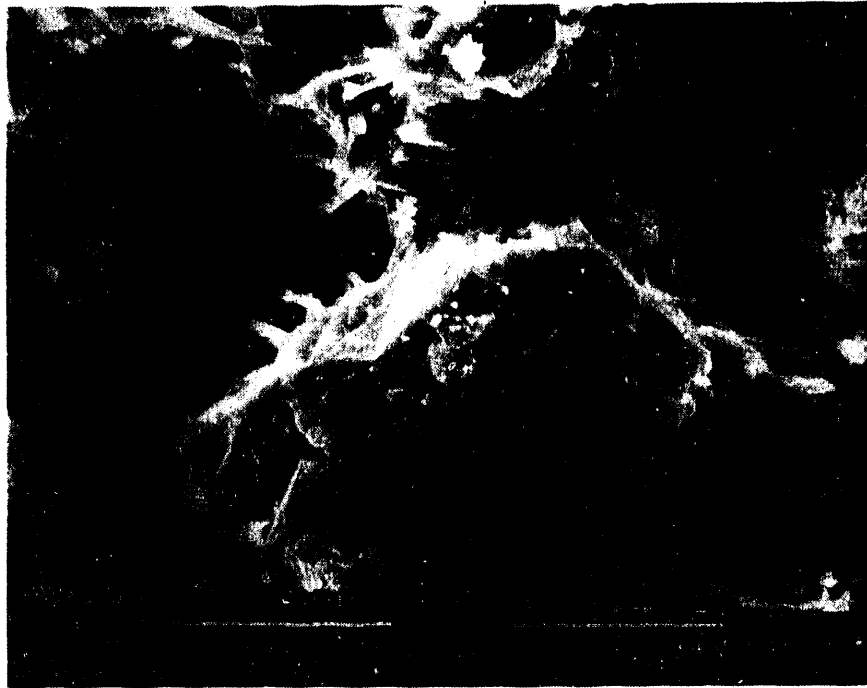
Figure I.2.4c - Scanning Electron Micrograph Illustrating the Morphology of the Alumina/Mullite Filter Matrix After 1300 Hours of Exposure in the Westinghouse PFBC Durability Test Facility

morphology is comparable with that of sections removed from various locations within the filter. At this time we feel that either cracking of the Aremco paint has occurred, pulling with it a portion of the underlying matrix, or that after long term exposure to dust fines, erosion at the sharp corners of the dirty channels may have occurred. Further effort will be necessary to resolve this issue.
