4.0 CONCLUSIONS AND OBSERVATIONS

4.1 Fuel Characteristics

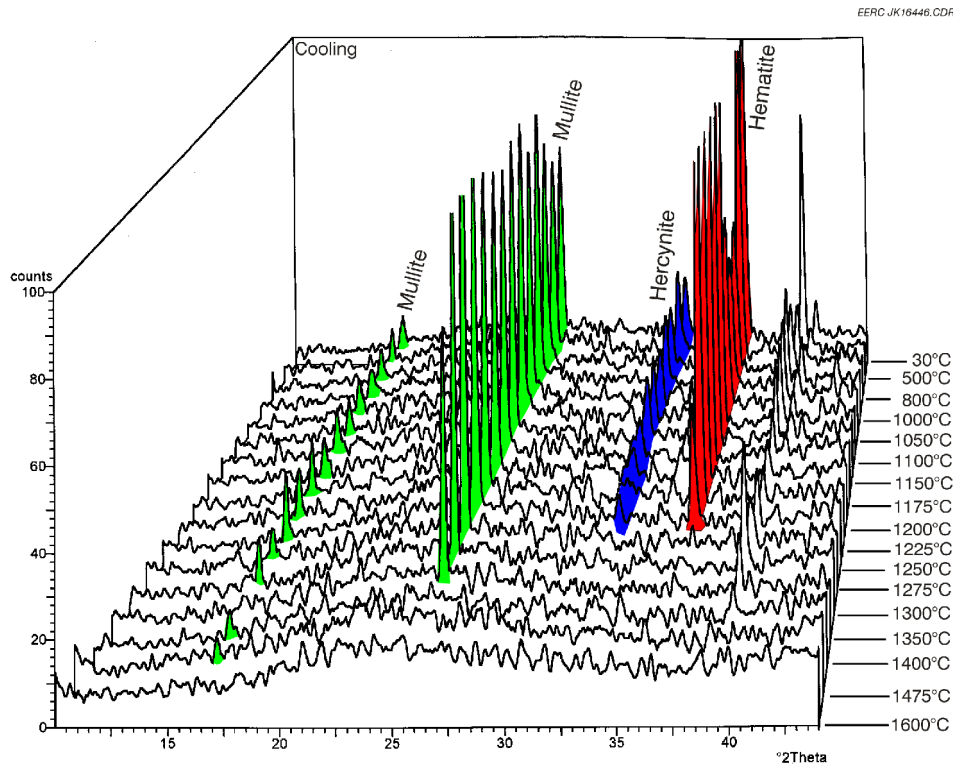
Figure 3-69. X-ray diffractograms for the eastern Kentucky slag tap sample measured while cooling from the melting point.
