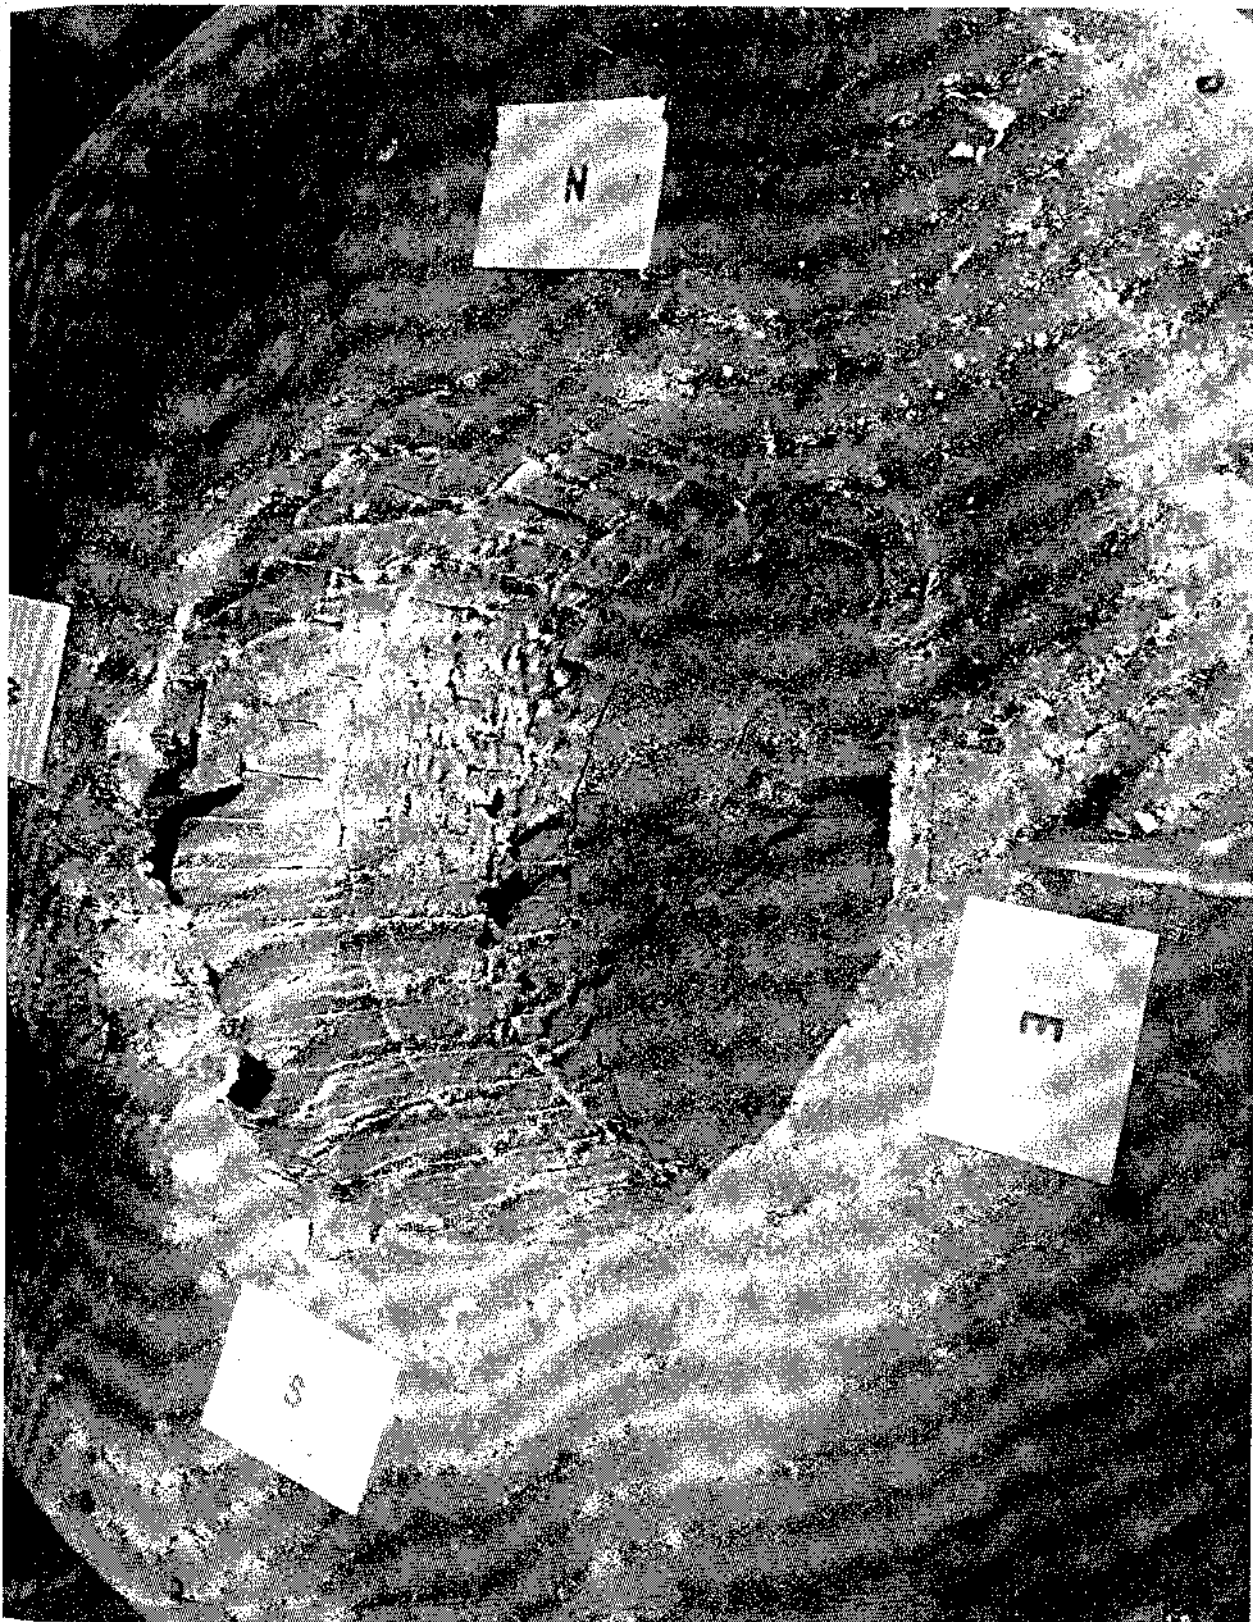
Figure 18. - View of primary zone looking toward point of entry of B burner after run 34.
